**ACTIVE TAILINGS AND PRODUCTION ROCK SITE
2019 ANNUAL REPORT**

Hecla Greens Creek Mining Company

April 29, 2019

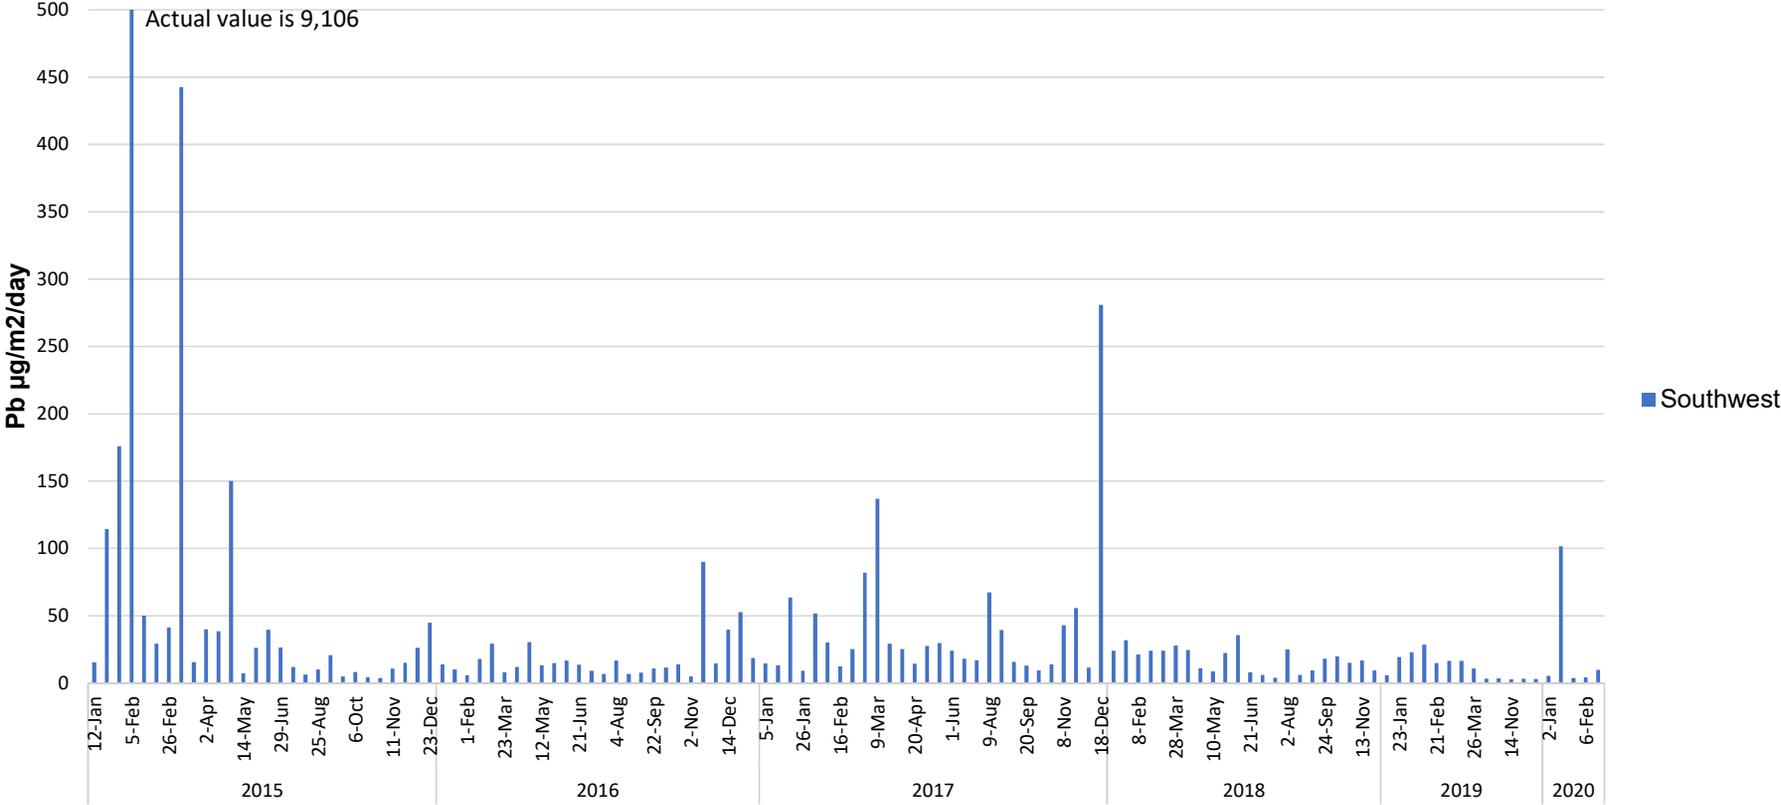
Lead daily loading of the ADP on the southwest side of the tailings disposal facility over a 5 year period.

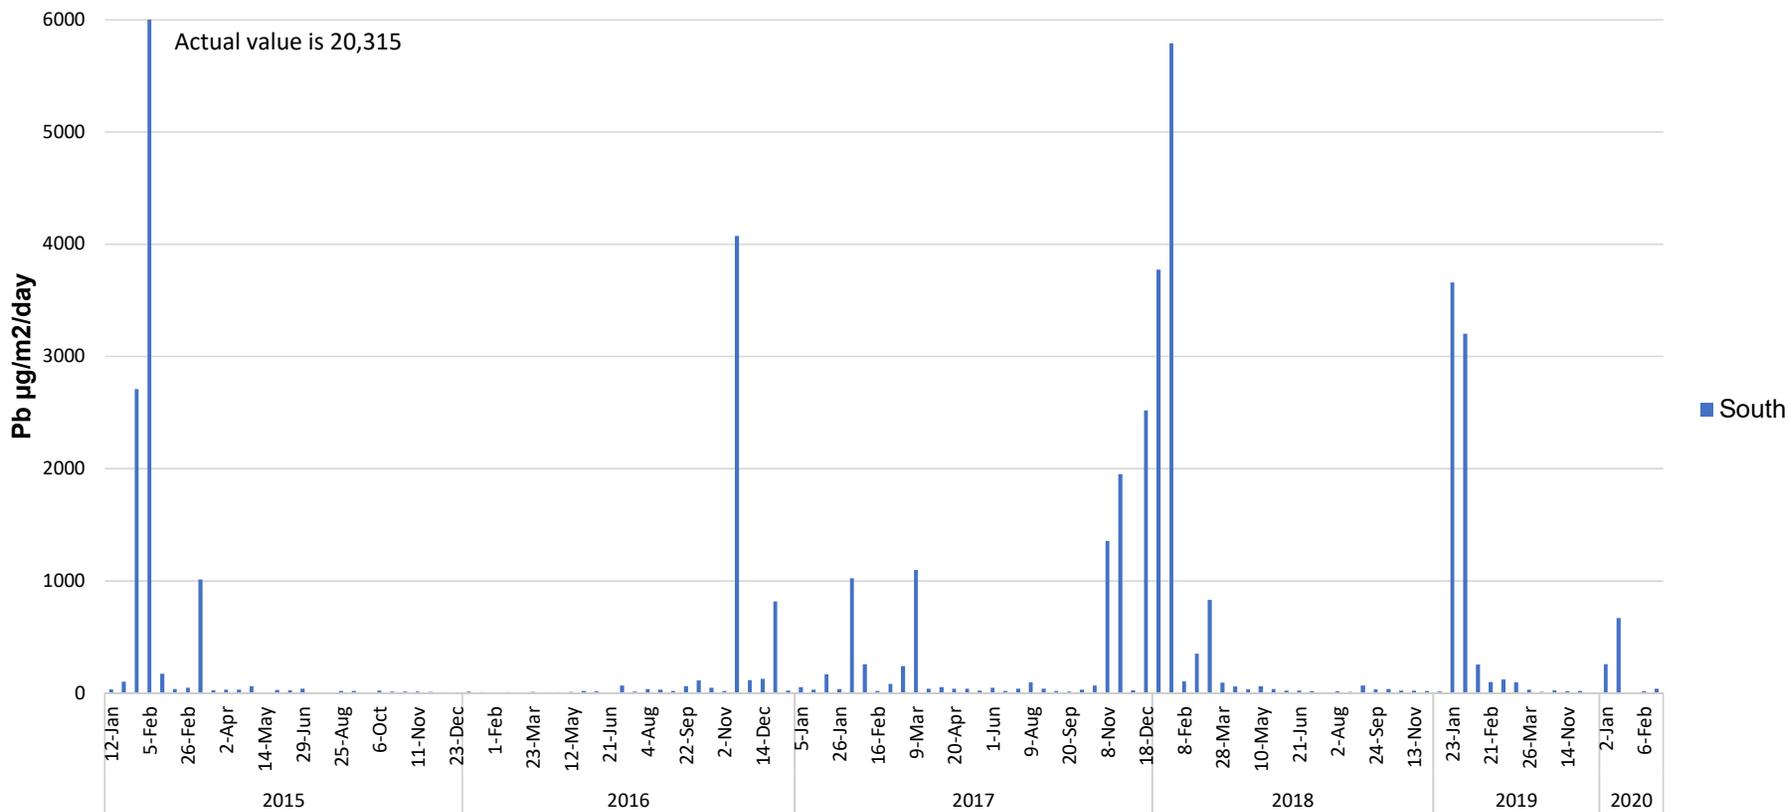
For 2019, the south ADP had the highest yearly accumulative lead load of 83,897 µg/m² followed by the southeast system with accumulative lead load of 49,252 µg/m². The west, southwest, east and northeast systems were comparable with values between 1,000 and 4,000 µg/m².

Lead daily loading of the ADP on the south side of the tailings disposal facility over a 5 year period.

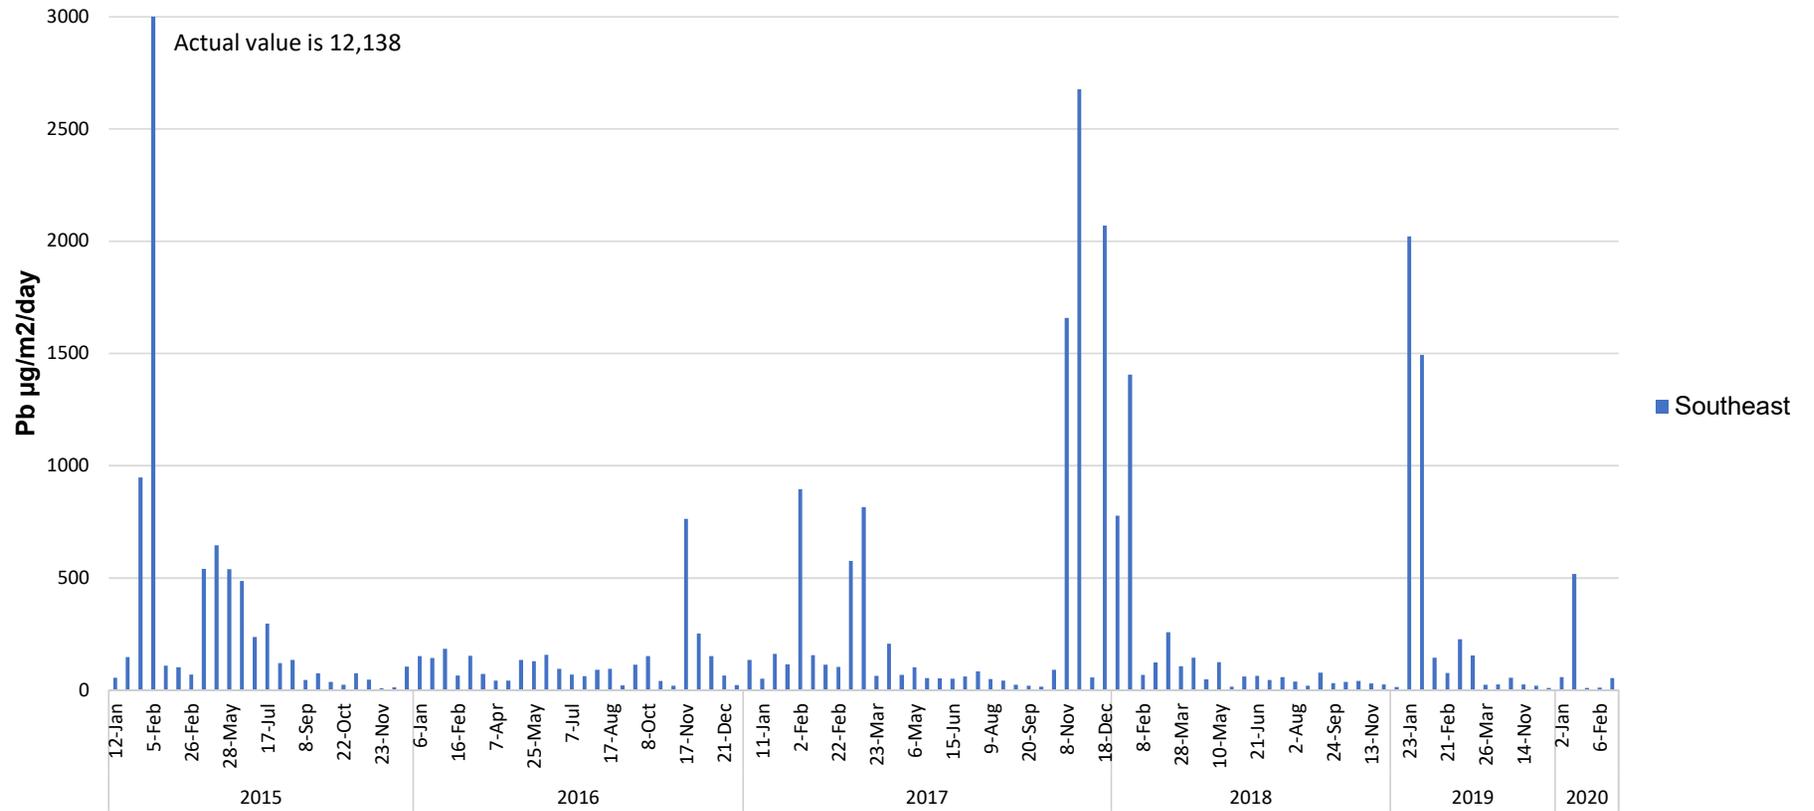
Lead daily loading of the ADP on the southeast side of the tailings disposal facility over a 5 year period.
