INSPECTION REPORT: GREENS CREEK MINE

Date of Inspection: Friday August 4, 2017
Date of Report: Monday August 21, 2017
USDA Forest Service Inspector: Richard Dudek

Ranger District: Admiralty National Monument, Juneau Ranger District
Weather Conditions: Sunny Temperature: mid 60's (°F).

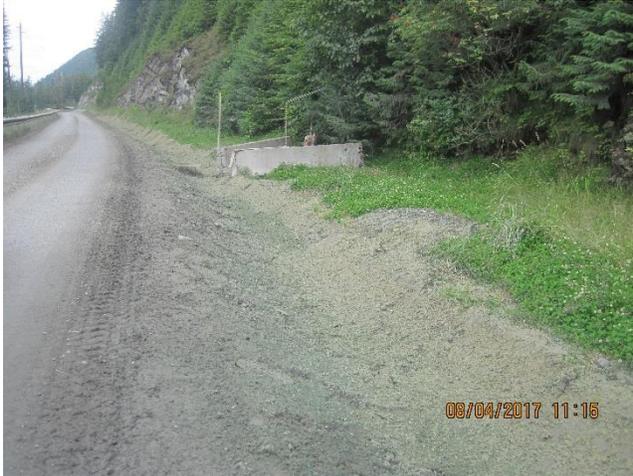
The access roads are in good condition, and comply with HGCMC's BMP Plan Appendix 8 for Road Operations and Maintenance. Surface operations recently improved sections of the drainage ditch along the 2.0-2.6 mile B-road (Photo1). The improvements made were to manage stormwater runoff, and

channel water more effectively. After the improvements made to the ditch, HGCMC personnel applied hydroseed to stabilize the soils (Appendix 5 BMP Plan; page 13).

Photo 1. Improved drainage ditch in the vicinity of 2.0 Mile B-road.

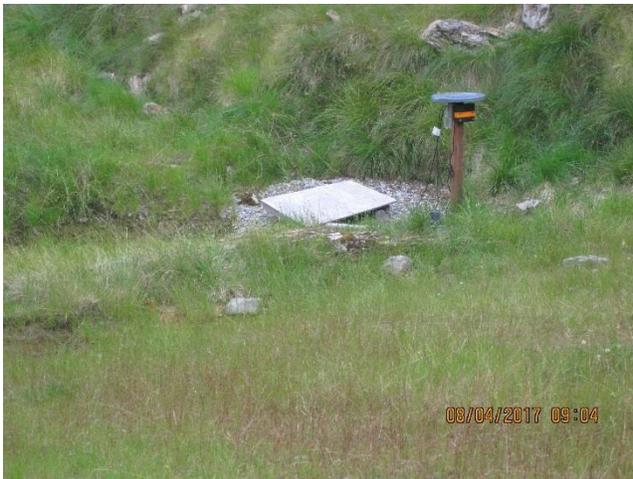
The trench and pump are working as intended (Photo 2), and the grass is growing well in the area. The trench and pump are located approximately 200 feet upgradient from FWMP site 13.

Photo 2. The 1350 trench and pump.

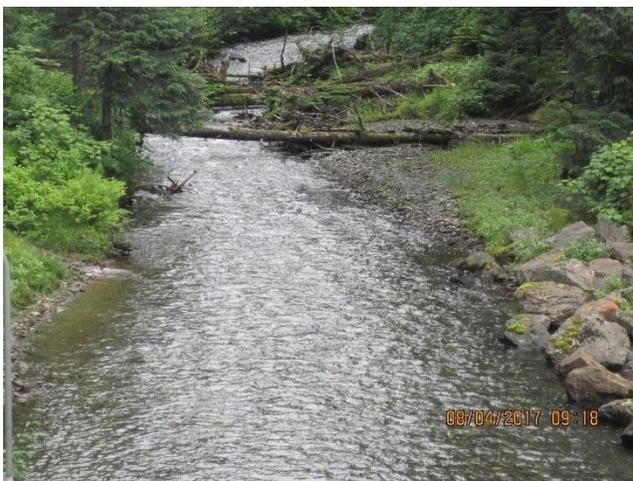
The recorded flow rate for Greens Creek (Photo 3) on 08/04/2017 was 33.5 cubic feet per second (cfs), and the daily water withdrawal for the 920 water system remains at 1.5 cfs.

Photo 3. An upstream image of Greens Creek.

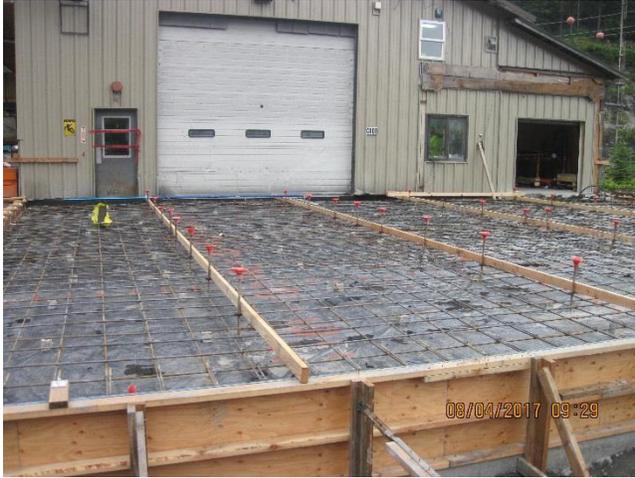
The 920 warehouse expansion's foundation frame (Photo 4) is completed. At the time of the site inspection, contractors were performing maintenance on the cement batch plant (Photo 5). Once the maintenance is completed, cement trucks will begin hauling the cement for the foundation.

Photo 4. The foundation frame for warehouse expansion.

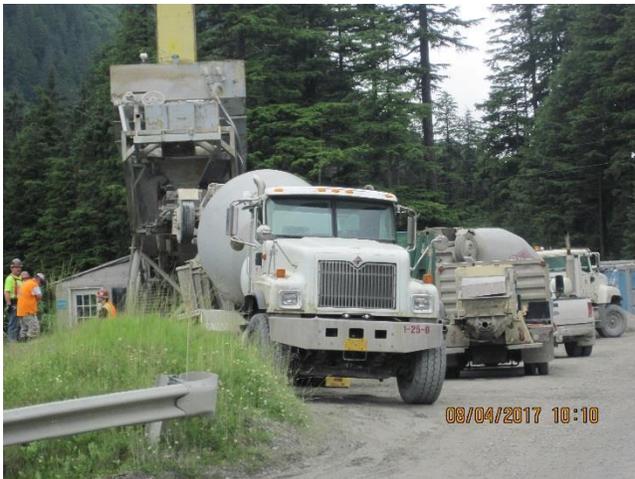
Photo 5. The batch plant located at 8.0 mile B-road.

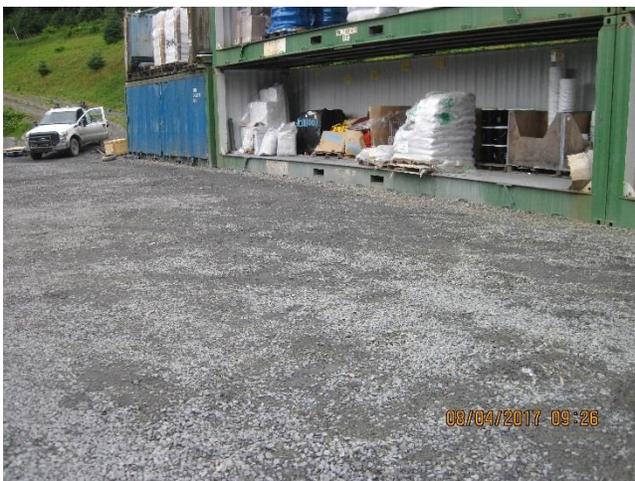
The 920 warehouse storage area (Photo 6) meets the guidelines for good housekeeping practices (Appendix 5 BMP Plan; pages 39-40).

Photo 6. 920 warehouse storage area.

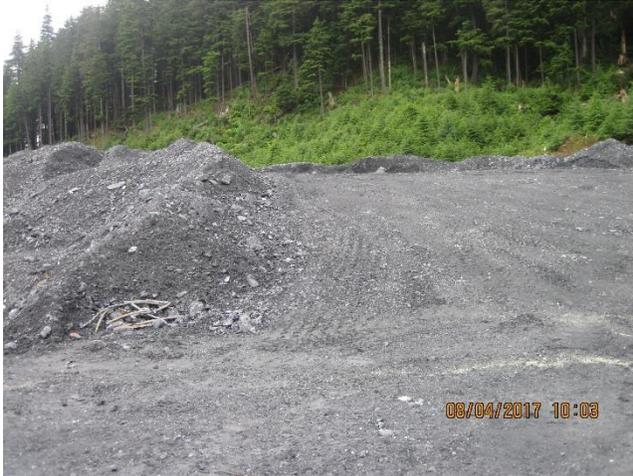
HGCMC continues to utilize Class 1 waste rock (Photo 7) on the outer slopes of the TDF, and additional Class 2/3 waste rock (Photo 8) was recently stockpiled at this location (Appendix 1; Section 3.1).

Photo 7. Class 1 waste rock.

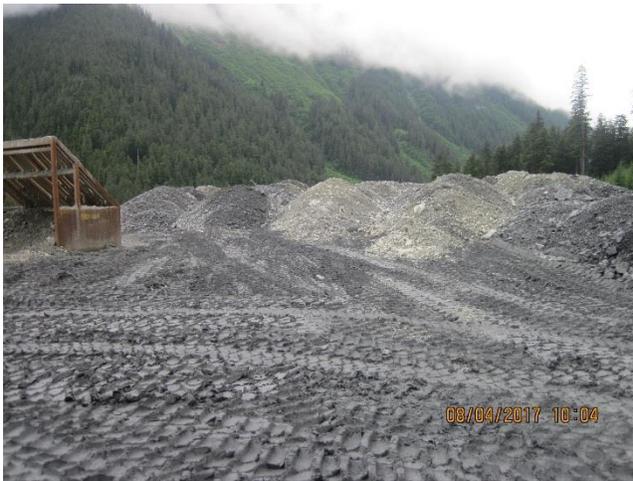
Photo 8. Class 2/3 waste rock.

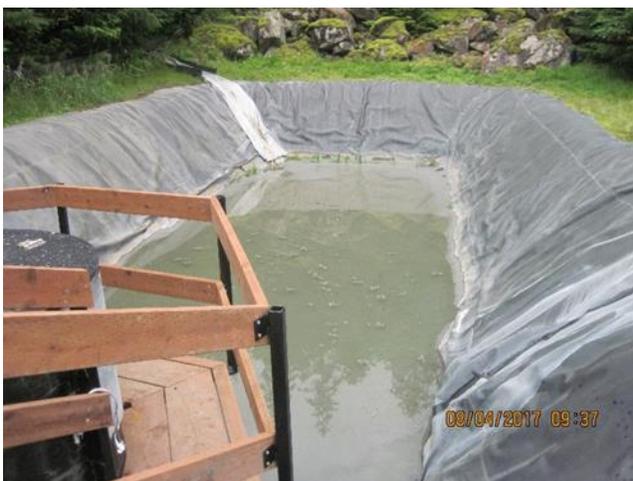
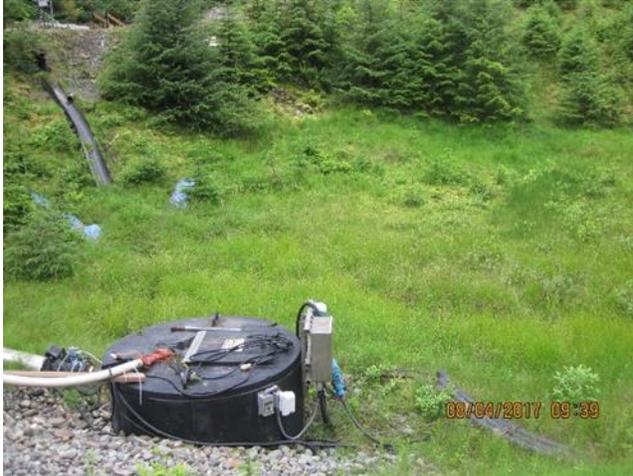
Pond C is a stormwater runoff retention pond for the 860 area. Both upper/lower ponds (Photos 9-10) were functional, and the site was well kept (Appendix 5 BMP Plan; page 8).

Photo 9. Upper Pond C.

Photo 10. Lower Pond C.

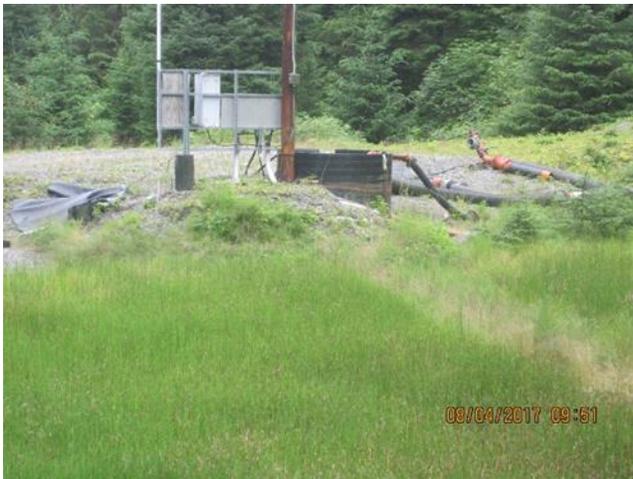
Pond D is a stormwater runoff retention pond for site D (Photo 11). The retention pond is currently functioning as intended, and the site was in order (Appendix 5 BMP Plan; page 7).

Photo 11. Pond D.

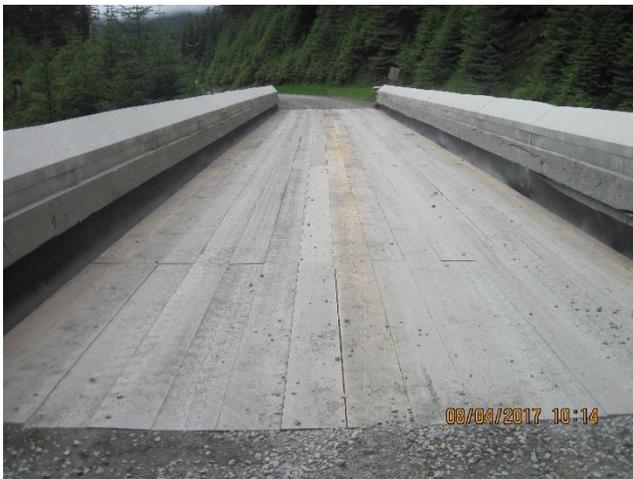
On 8/02 /2017, HGCMC personnel re-decked and re-lined the bridge (Photo 12). The bridges splashguards appear to be effectively working by preventing sediment splash over into the creek (Photo 13).

Photo 12. 7.4 mile B-road bridge (Killer Creek Bridge).

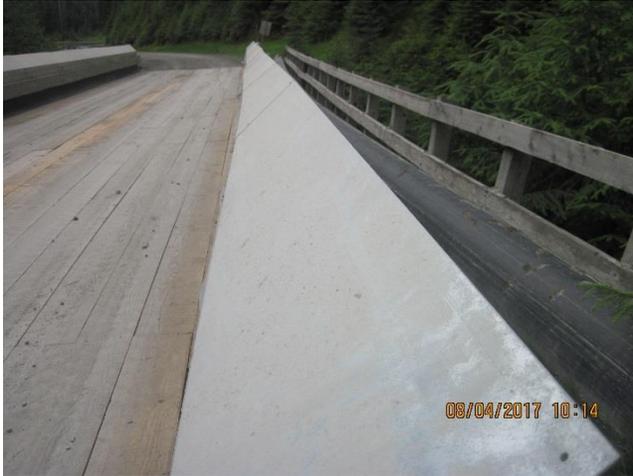
Photo 13. 7.4 mile B-road Bridge splashguards (Killer Creek Bridge).

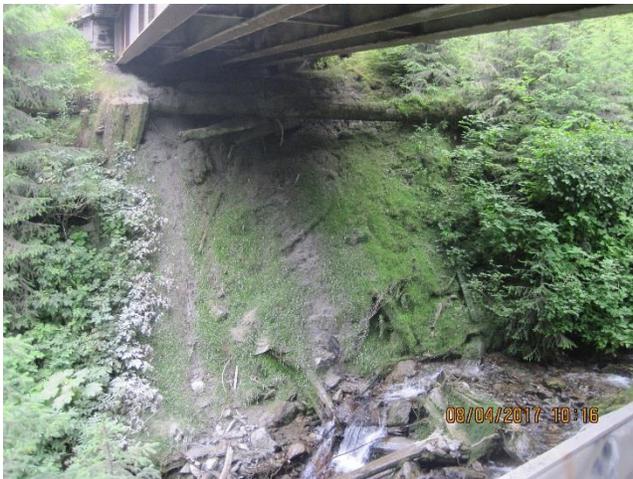
Vegetation has established on the downhill abutment (Photo 14). This mitigation will help stabilize the slope and prevent sediments from entering the creek (Appendix 5 BMP plan; page 13). New bridge designs are in progress, and in 2019 HGCMC could potentially replace the bridge.

Photo 14. Image shown is the downhill side abutment for Killer Creek Bridge.

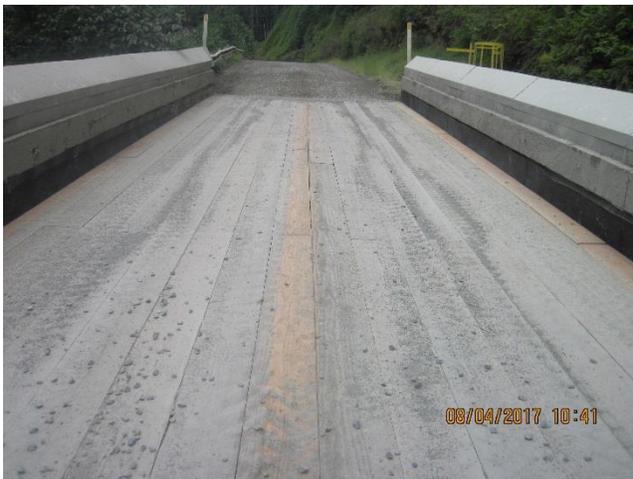
Photo 15. The 3.4 mile B-road bridge (Falls Creek Bridge).

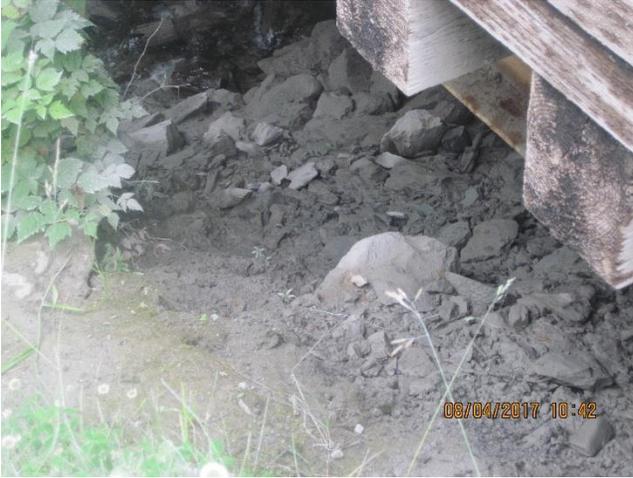
On 8/03/2018, HGCMC personnel re-decked and relined the bridge (Photo 15). Residual sediments from surface water runoff remain under the bridge (Photo 16). Surface operations will continue to monitor the accumulation around the bridge, and will remove the sediments when deemed necessary (Appendix 5 BMP Plan; page 19). New bridge designs are in progress, and in 2018 HGCMC could potentially replace the bridge.

Photo 16. Sediments observed below Falls Creek Bridge.

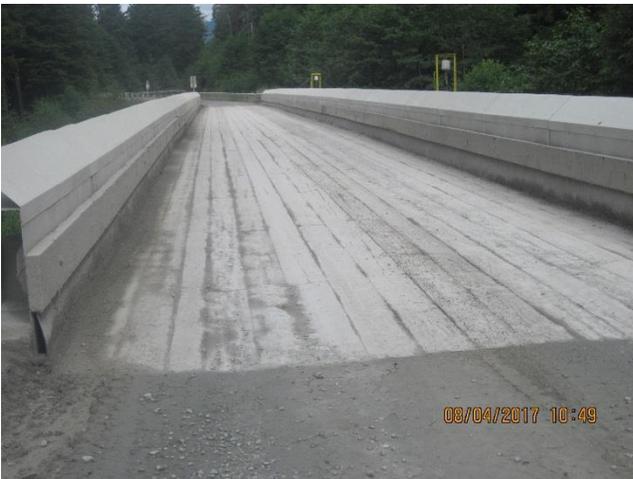
HGCMC plans to re-deck and reline the bridge in mid-August 2017 (Photo 17). HGCMC Environmental operations have a tentatively scheduled plan to clean out the abutment drainpipe (Photos 18-19). The BMP structures located on the uphill/downstream side are functioning as intended (Photo 20). The maintenance for the 3.1 mile B-road removable sediment screen (Photo 21) is included with the inspection/mucking of these BMP structures (Appendix 5 BMP Plan; pages F-34, F-35).

Photo 17. 3.0 mile B-road bridge (Zinc Creek Bridge).

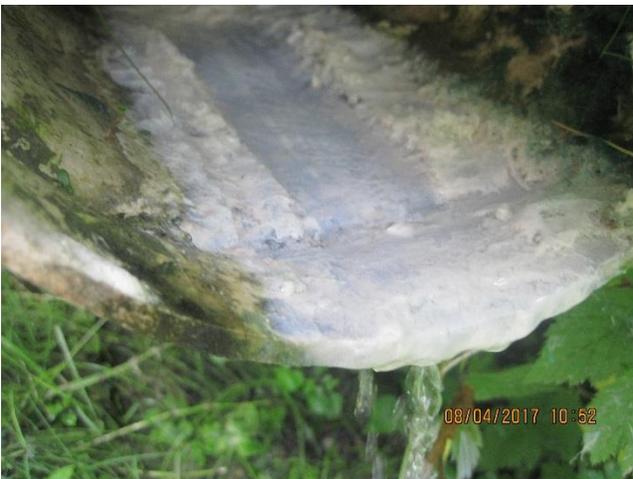
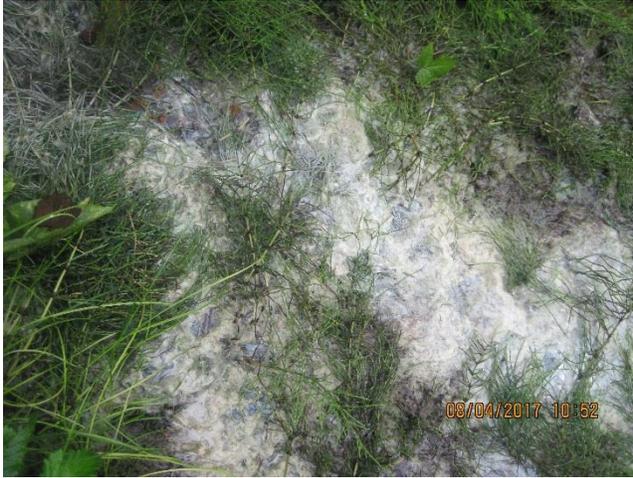
Photo 18. White precipitate exiting the abutment drain (Image 1 of 2).

Photo 19. The White precipitate was observed on the ground below the drain's outlet (Image 2 of 2).

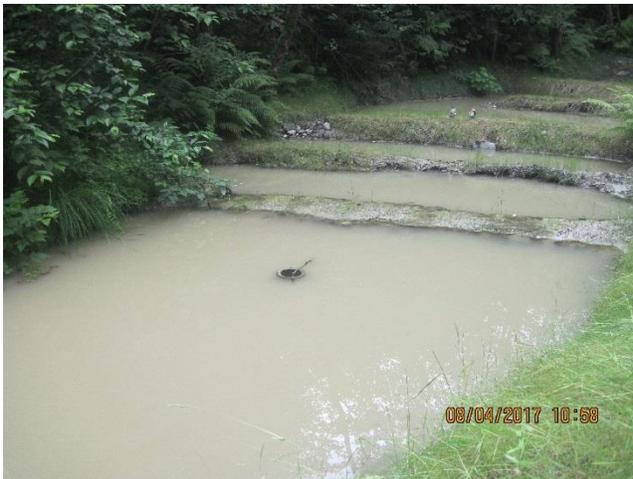
Photo 20. 3.0 mile B-road bridge (Zinc Creek Bridge) uphill abutment BMP's.

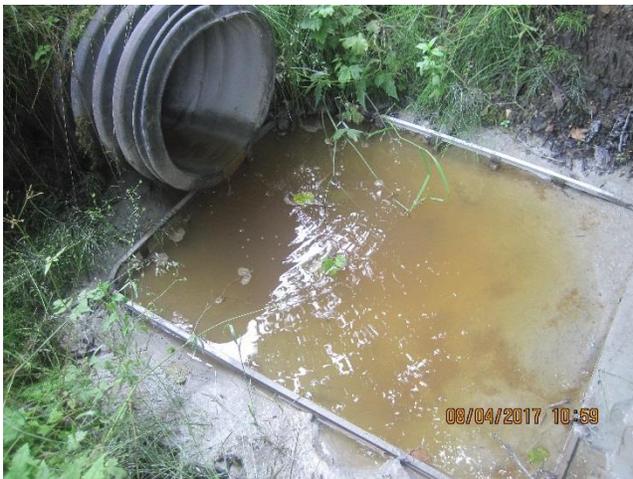
Photo 21. 3.1 mile B-road removable sediment screen.

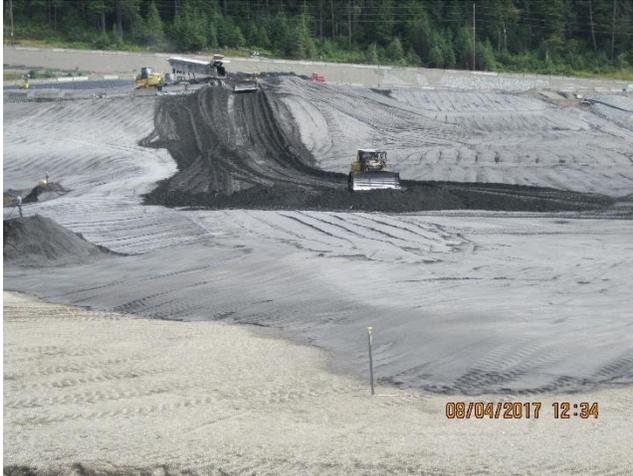
HGCMC continues to deposit tailings in the S3P1 TDF expansion area (Photo 22). The construction for the concrete flow control structure is completed (Photo 23). HGCMC is currently engaged in the review process with the Alaska Department of Natural Resources (ADNR) Alaska Dam Safety Program for authorization to use Pond 10 (Photo 24) and the concrete flow control structure.

Photo 22. S3P1 TDF expansion area.

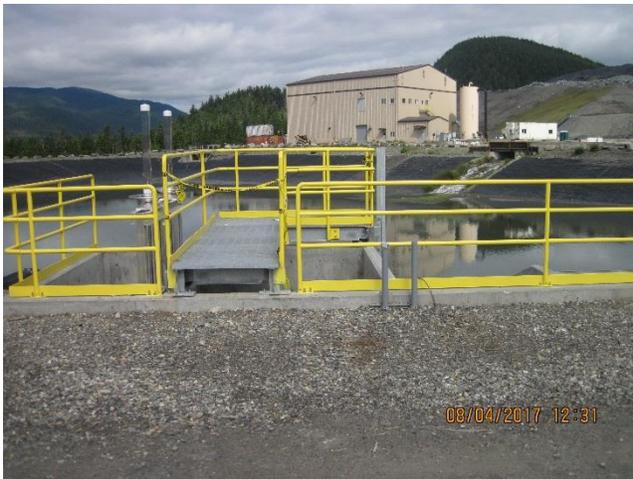
Photo 23. Pond's 7 and 10 concrete flow control structure.

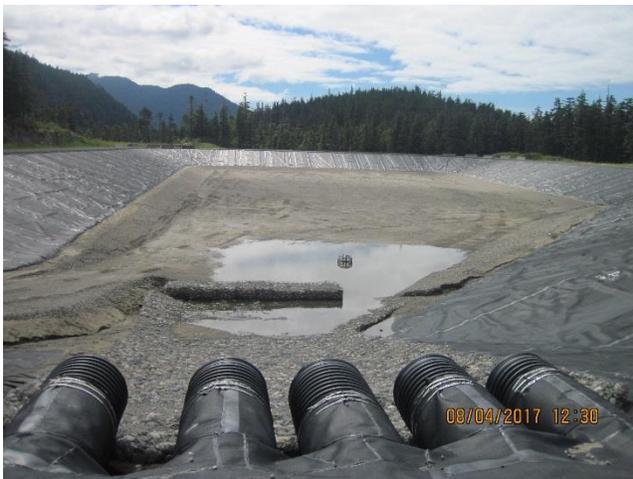
Photo 24. TDF area Pond 10.

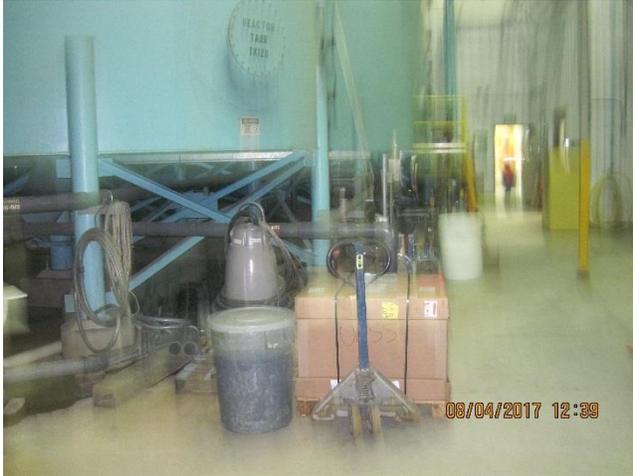
At the time of this inspection, the water treatment plant was discharging 590 gallons of water per minute (gpm) through outfall 002. All discharge through this outfall "002" is limited and monitored per APDES permit requirements. The water treatment (Photo 25) plant was tidy and in order (Appendix 5 BMP Plan; pages 39-40).

Photo 25. The TDF water treatment plant.

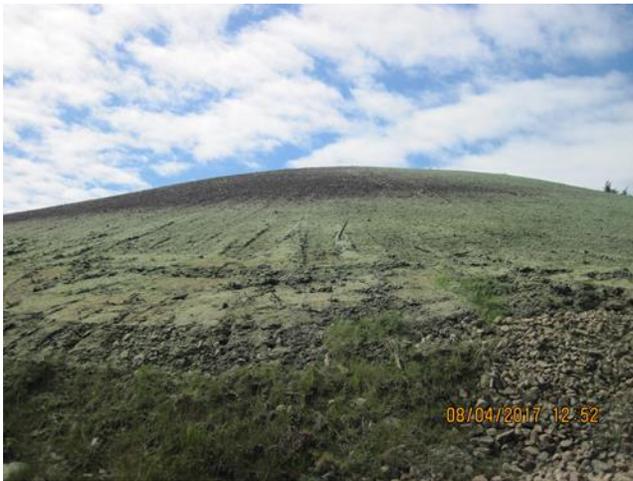
HGCMC personnel recently hydroseeded the northwest slopes (Photo 26) of the TDF area.

Photo 26. The slopes of the northwest TDF slope was hydroseeded.

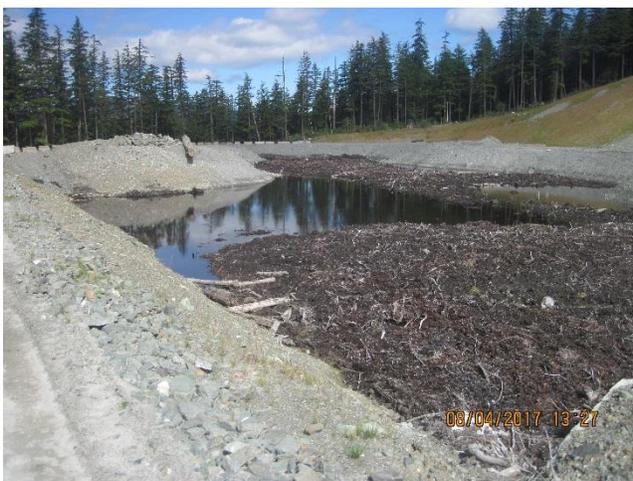
This site is currently inactive (Photo 27).

Photo 27. Sand Pit (1.4 mile A-road).
