**TAILINGS AND PRODUCTION ROCK SITE
2013 ANNUAL REPORT**

Hecla Green Creek Mining Company

April 15, 2014

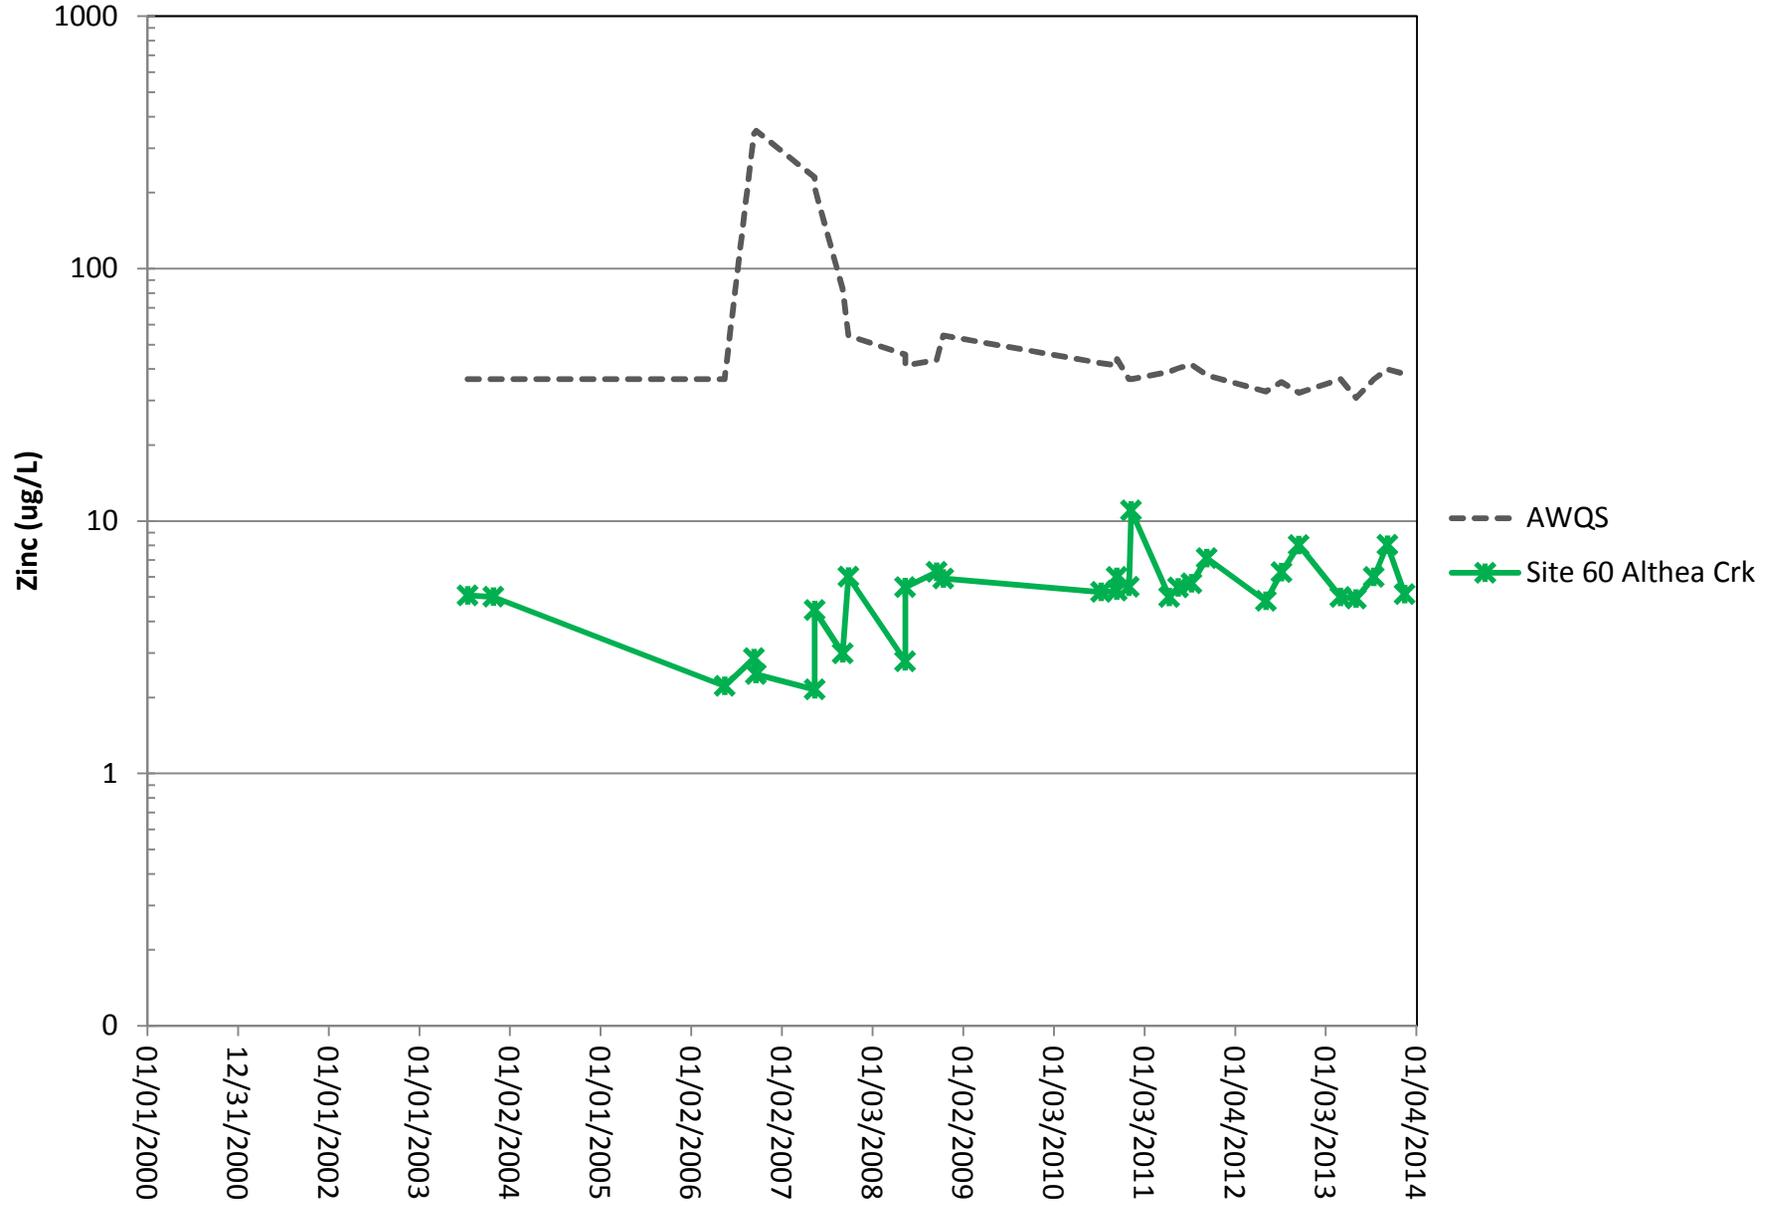
Figure 2.42 Site 60 Zinc Concentration

- Zinc and lead concentrations at Site 60 area shown in Figures 2.42 and 2.43. Zinc concentrations are very low (< 10 ug/L). As the hardness at Site 60 decreases toward background conditions, the AWQS for lead, which is hardness dependent, may approach the lead concentration at Site 60. This was the case in 2012 when a slight increase in lead and a continued decrease in hardness caused an exceedance of the AWQS for lead at Site 60. There were no measured exceedances for lead or zinc in 2013.

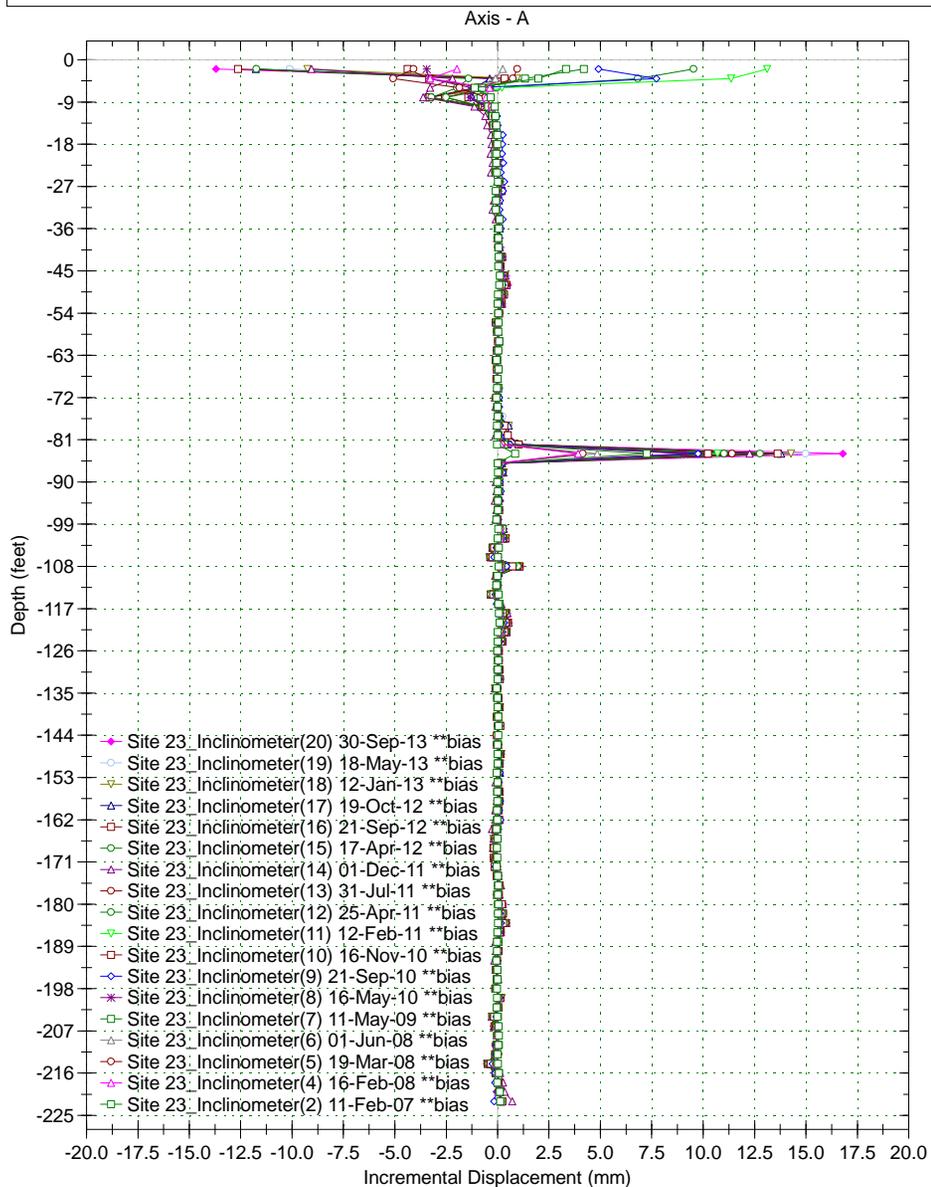
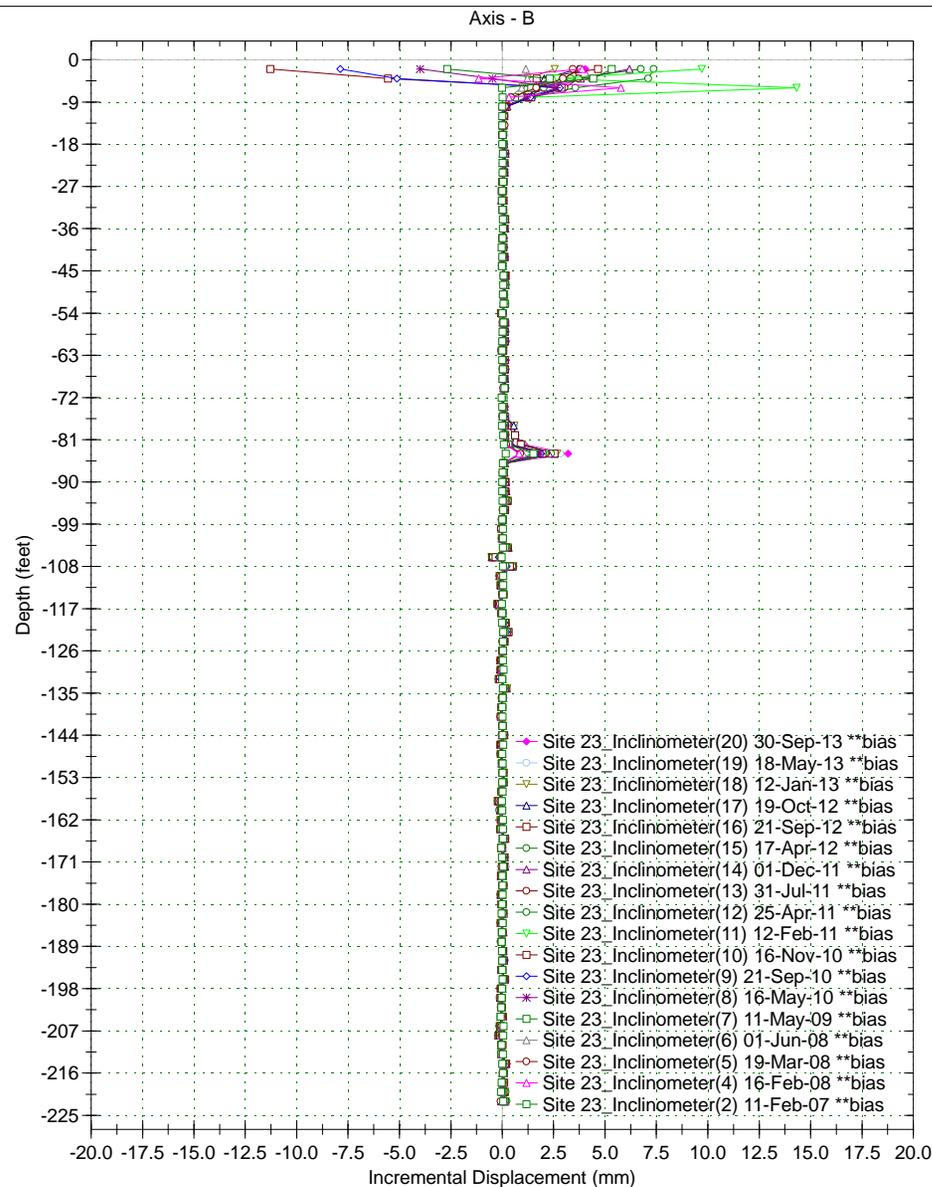
Figure 3.30 Site 23 Inclinometer Incremental Displacement

Note:
 Zero reference is top of casing, at -4.7 ft above ground surface.
 Top section of casing replaced at joint in July 2011 due to damage.
 Bias-shift correction by pinning data sets at 150-ft depth (A-B axes).

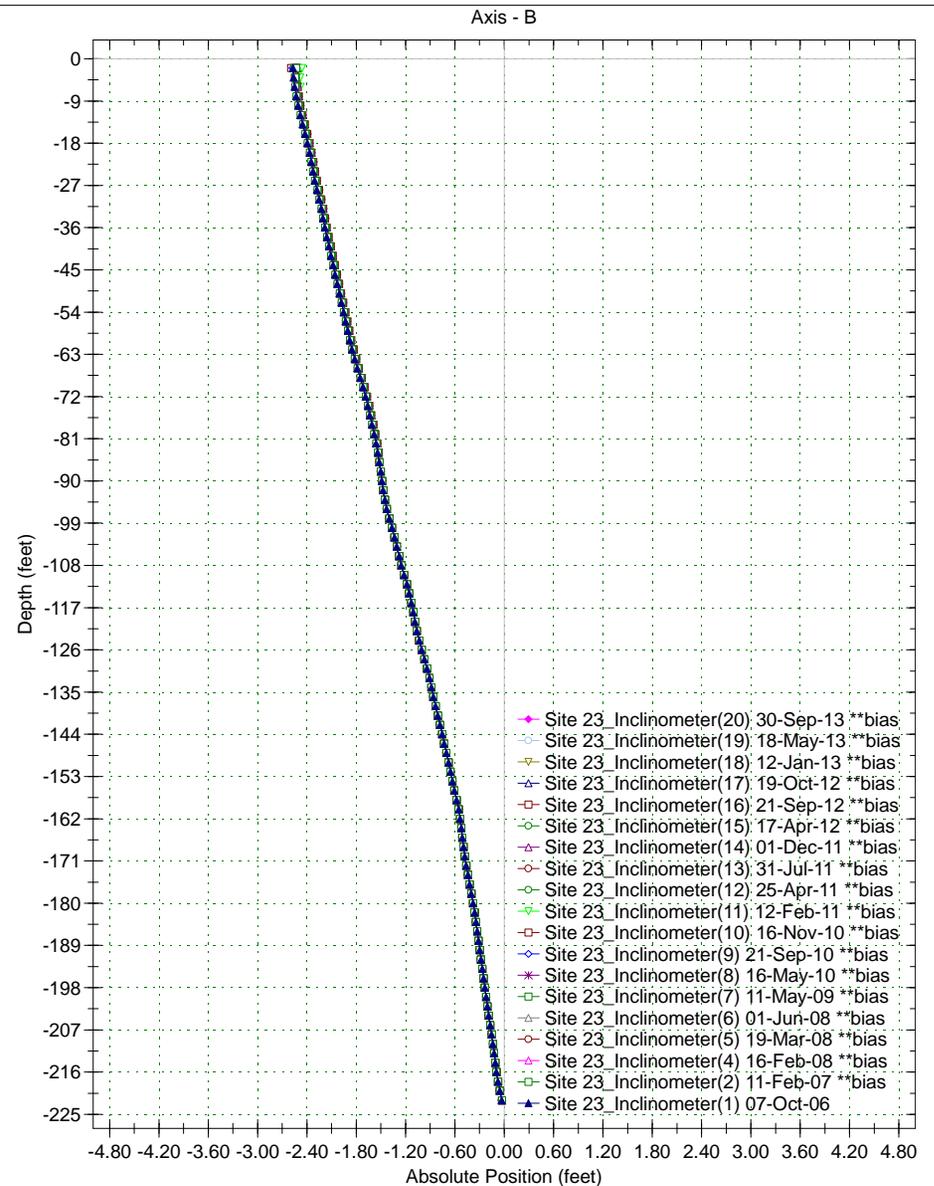
Figure 3.31 Site 23 Inclinerometer Absolute Displacement

Note:
 Zero reference is top of casing, at -4.7 ft above ground surface.
 Top section of casing replaced at joint in July 2011 due to damage.
 Bias-shift correction by pinning data sets at 150-ft depth (A-B axes).
