INSPECTION REPORT

Alaska Department of Environmental Conservation
 Division of Water
 410 Willoughby Ave, Juneau, AK 99811

Name and Location of Site/ Facility Inspected		Entry Time	Permit Effective Date
Kensington Lower Slate Lake (LSL) Dam construction and Acid Rock Drainage Area adjacent to LSL.		08:00	September 1, 2005
		Exit Time 12:00	Permit Expiration Date August 31, 2010
Loc: Lat: 58d 49' 58"N Long: 134d 57' 58"W Source: NPDES permit			
On-Site Representative		Additional Participants:	
Clyde Gillespie (Surface Ops Mgr), Kevin Eppers, (Env. Tech.)		Chad Hood, USFS	
Responsible Official(s):			
Clyde Gillespie			
x Contacted			
Clyde: 523-3309 Kevin: 523-3328			
		Yes No	
		Samples Taken?	X
		Photos Taken?	X
		Analytical Results?	X

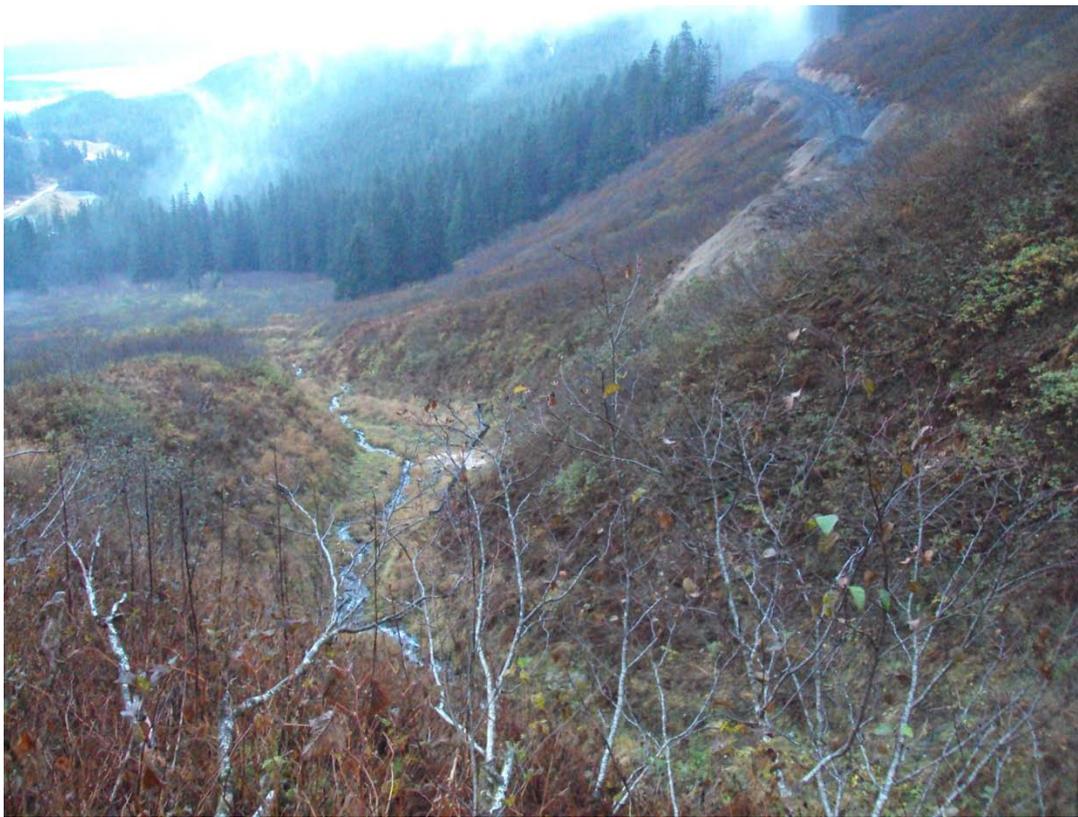
Photograph 1. Snow Slide Gulch. Note: silt fence (barely visible in photo) was partially damaged from a small material slide. Fence was ordered to be repaired the same day as the inspection.

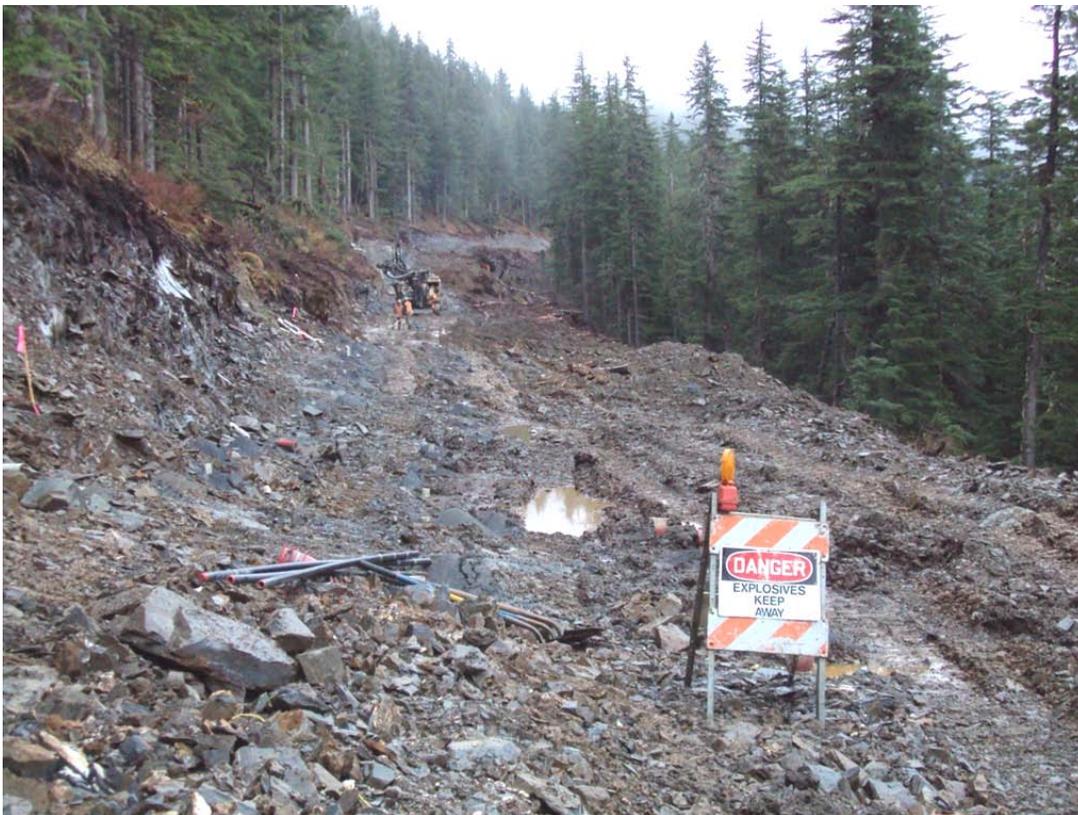
Photograph 2. Snow Slide Gulch Road – Road construction – drilling and blasting.

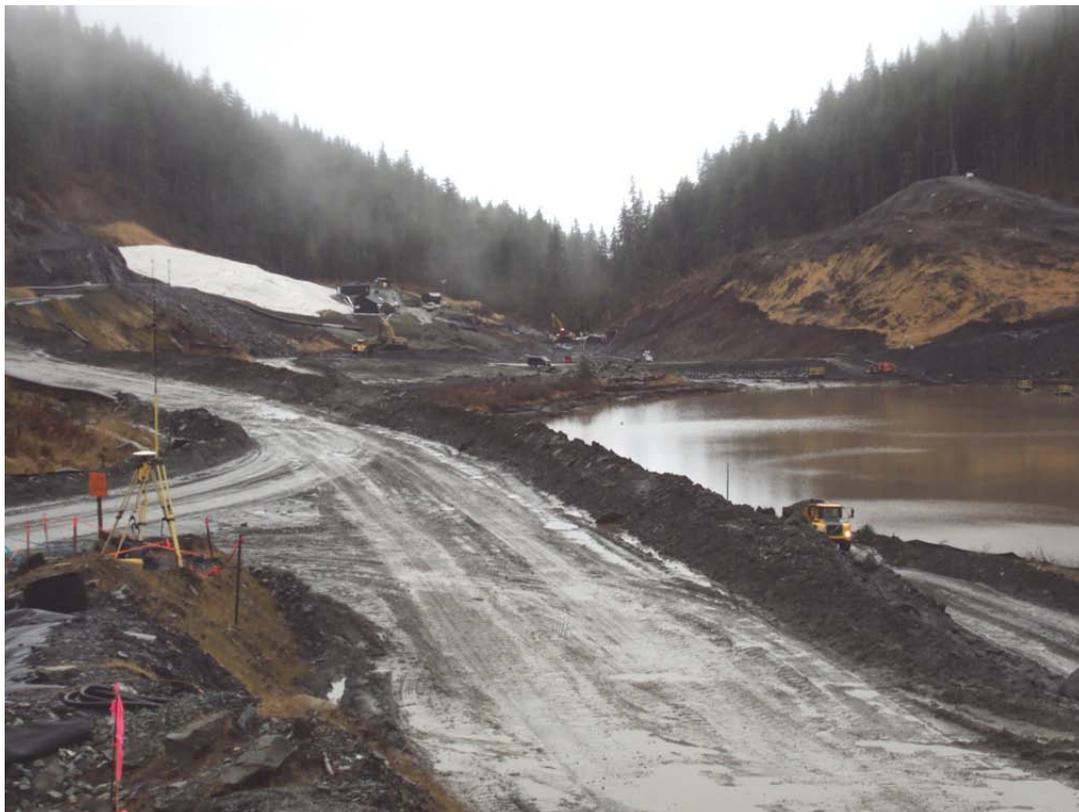
Photograph 3. Lower Slate Lake looking towards the Water Treatment Plant and TDF dam excavation.

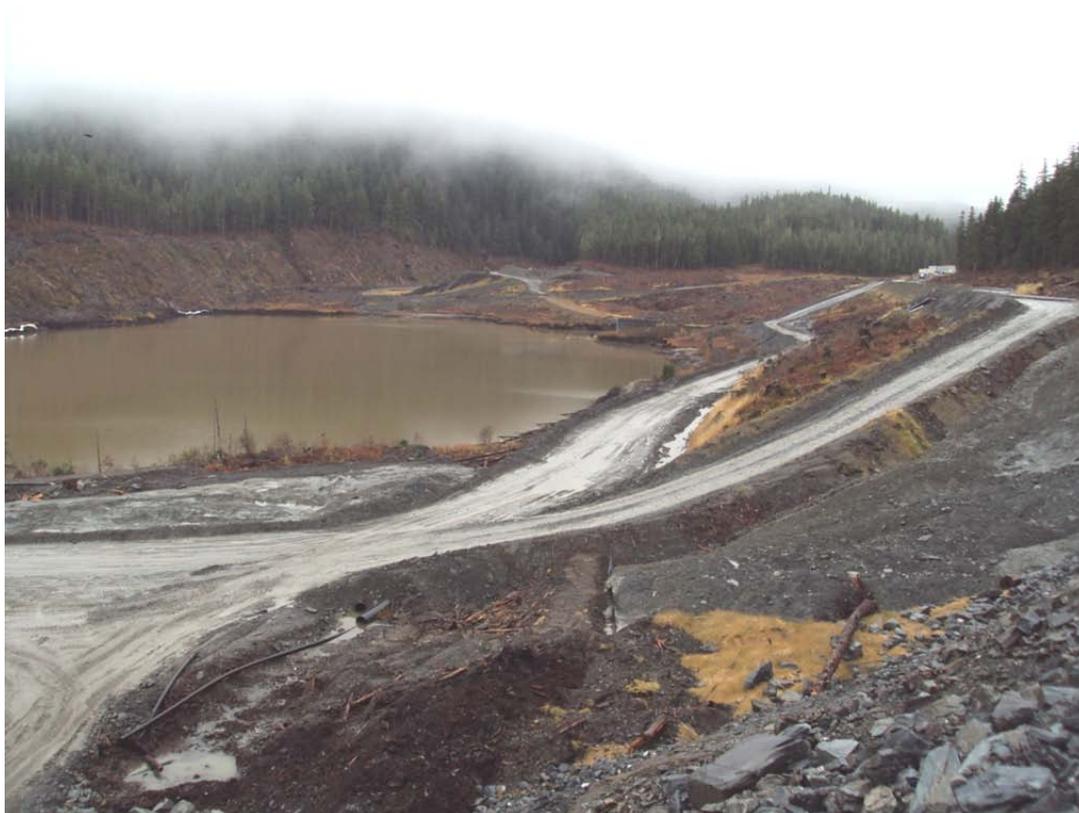
Photograph 4. Lower Slate Lake looking towards Upper Slate Lake.

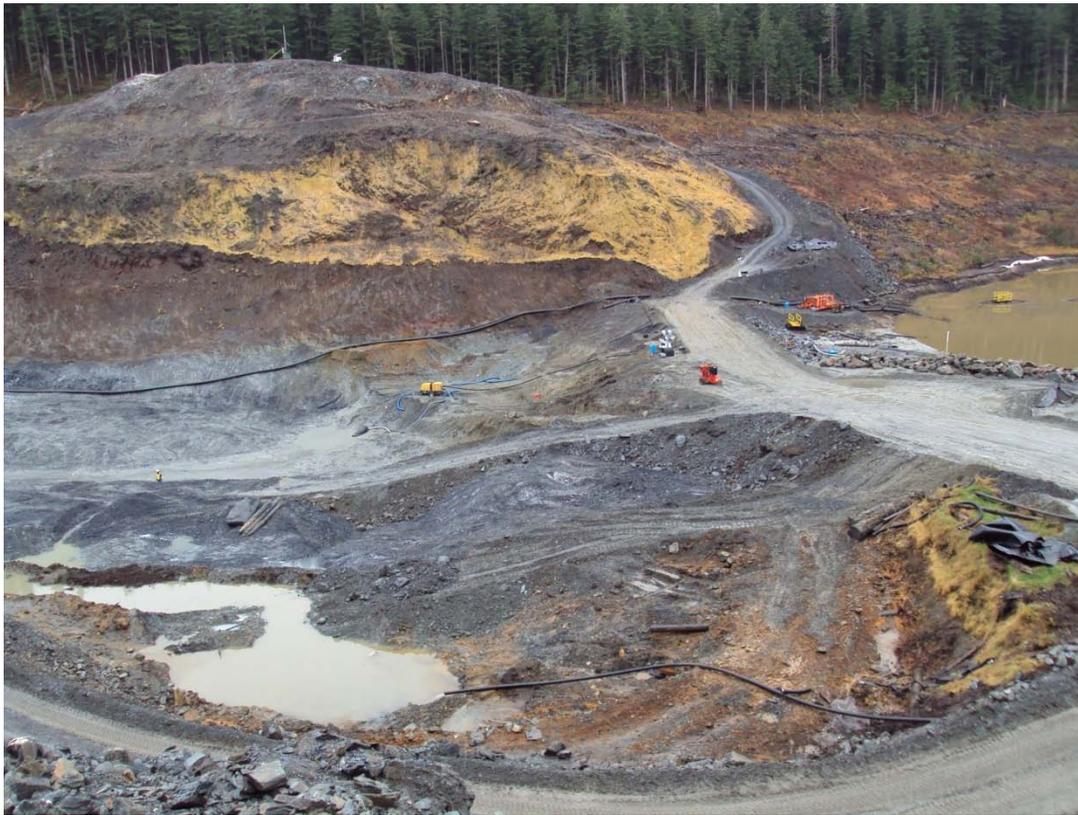
Photograph 5. Lower Slate Lake. TDF dam excavation to bedrock. Pond in foreground is the remnant of the former "Big Hole". Smaller pond in back ground, called "Storm Water Pond" collects treated WTP effluent and is pumped back into LSL.

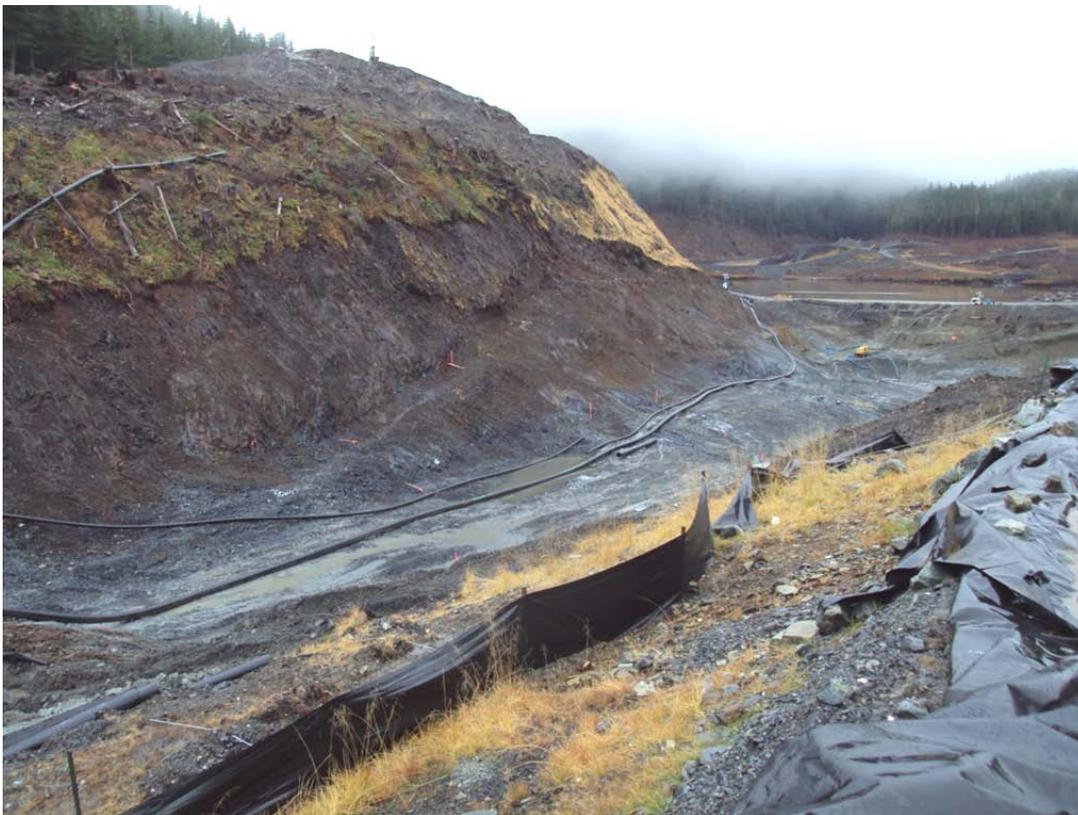
Photograph 6. TDF dam excavation, looking towards LSL.

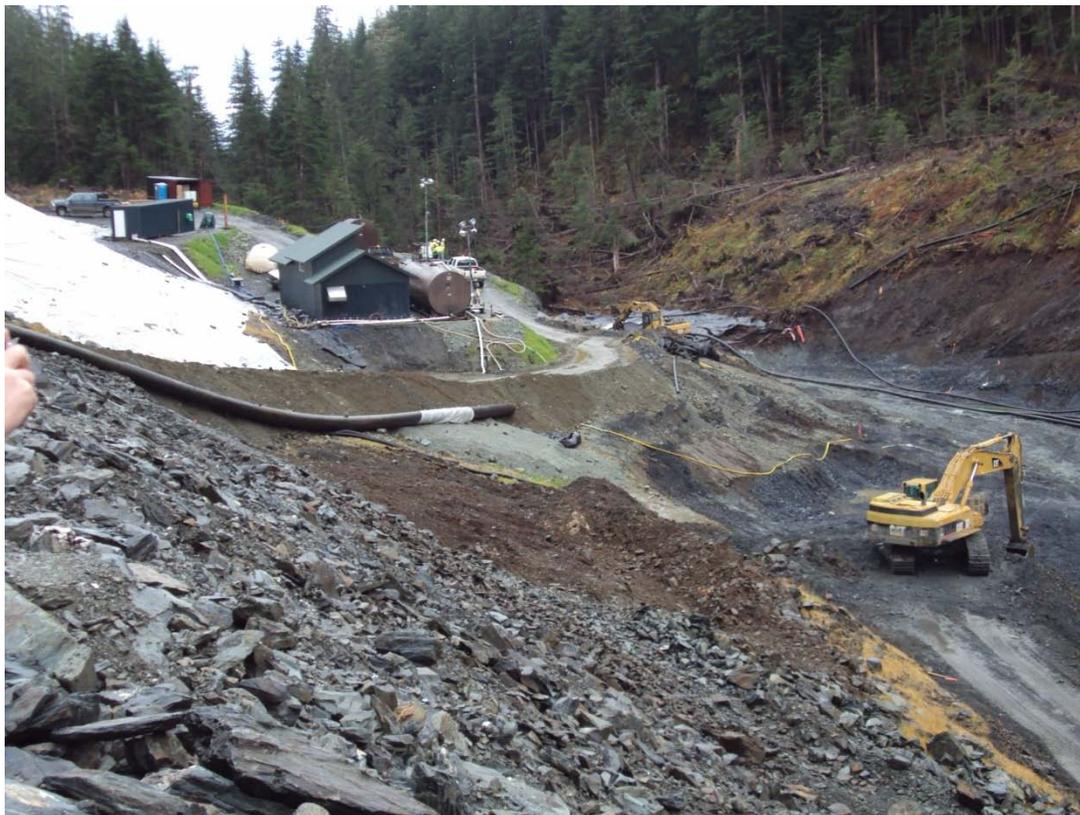
Photograph 7. Water Treatment Plant near head waters of East Fork Slate Creek.

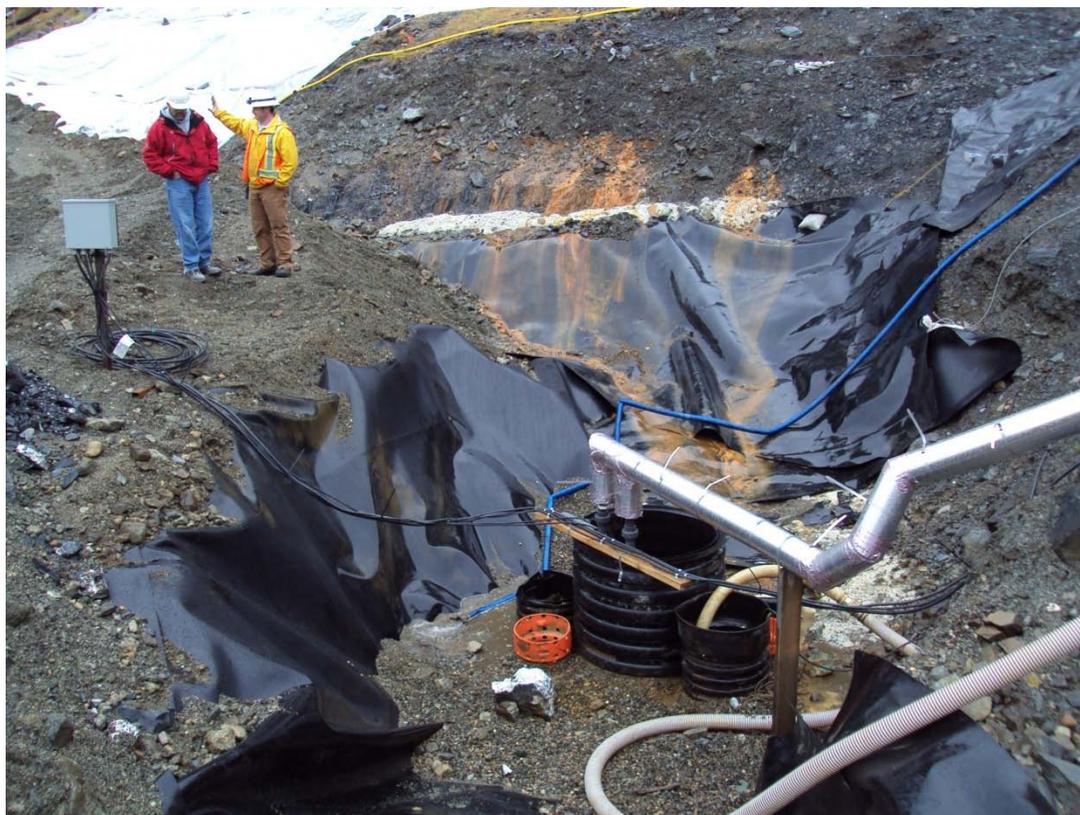
Photograph 8. ARD seepage collection system. Seepage is piped into a storage tank and is treated in the WTP.

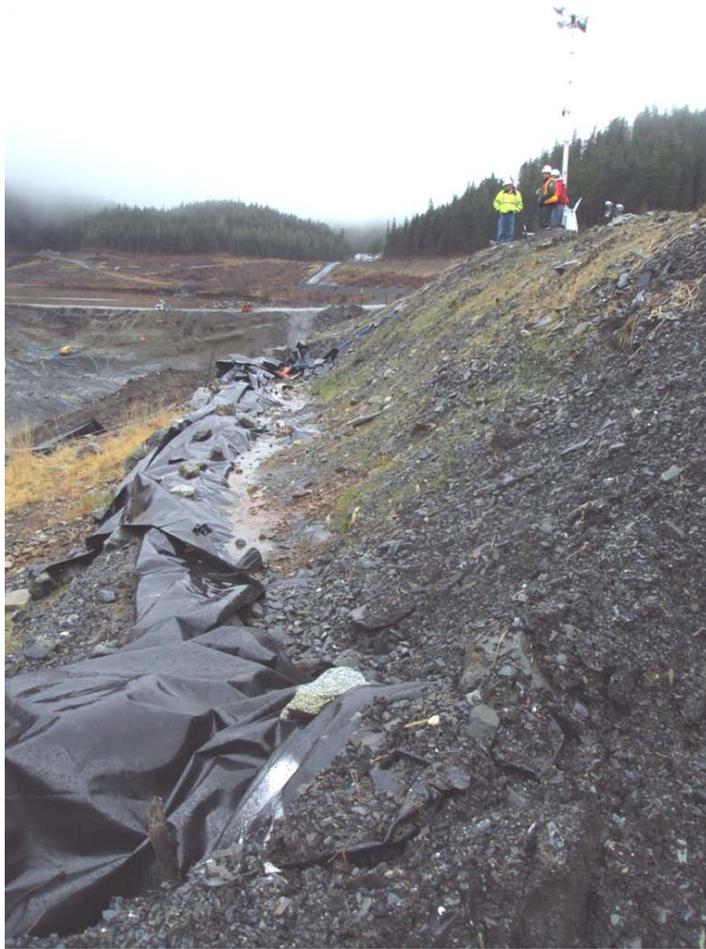
Photograph 9. Second seepage collection system below the WTP. Collected seepage is pumped into the primary seepage collection system (shown in photo 8).

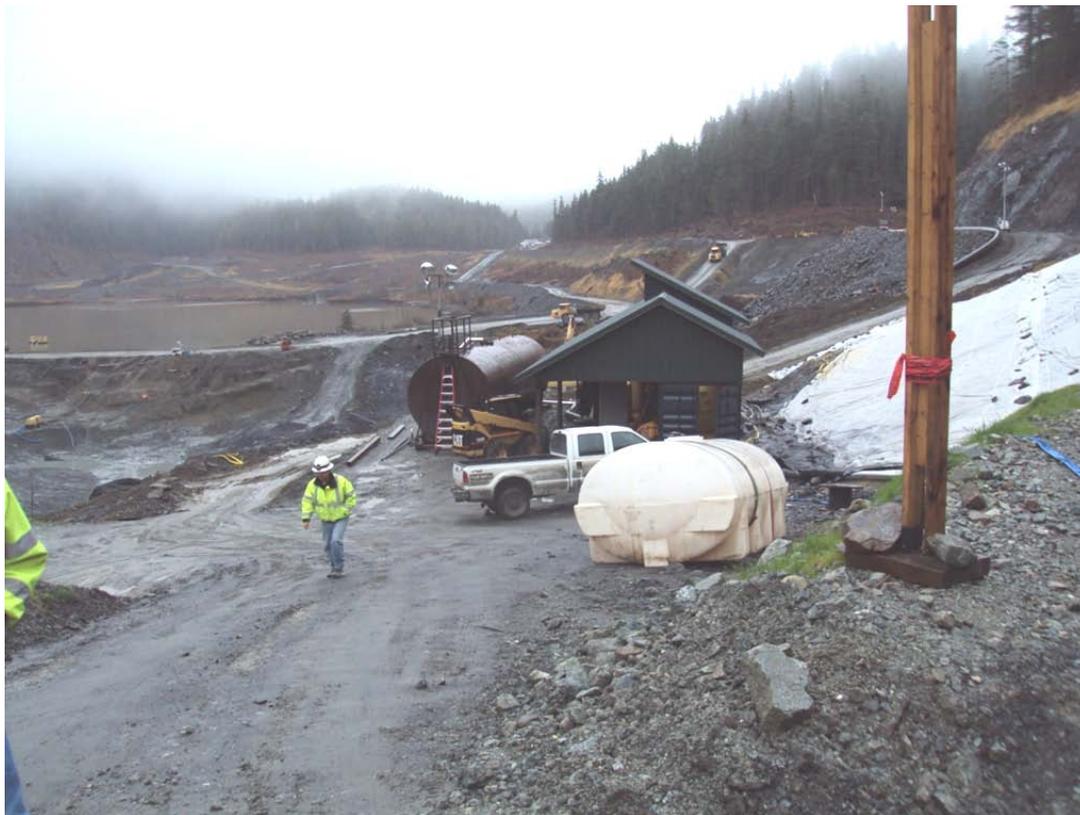
Photograph 10. WTP looking toward LSL.

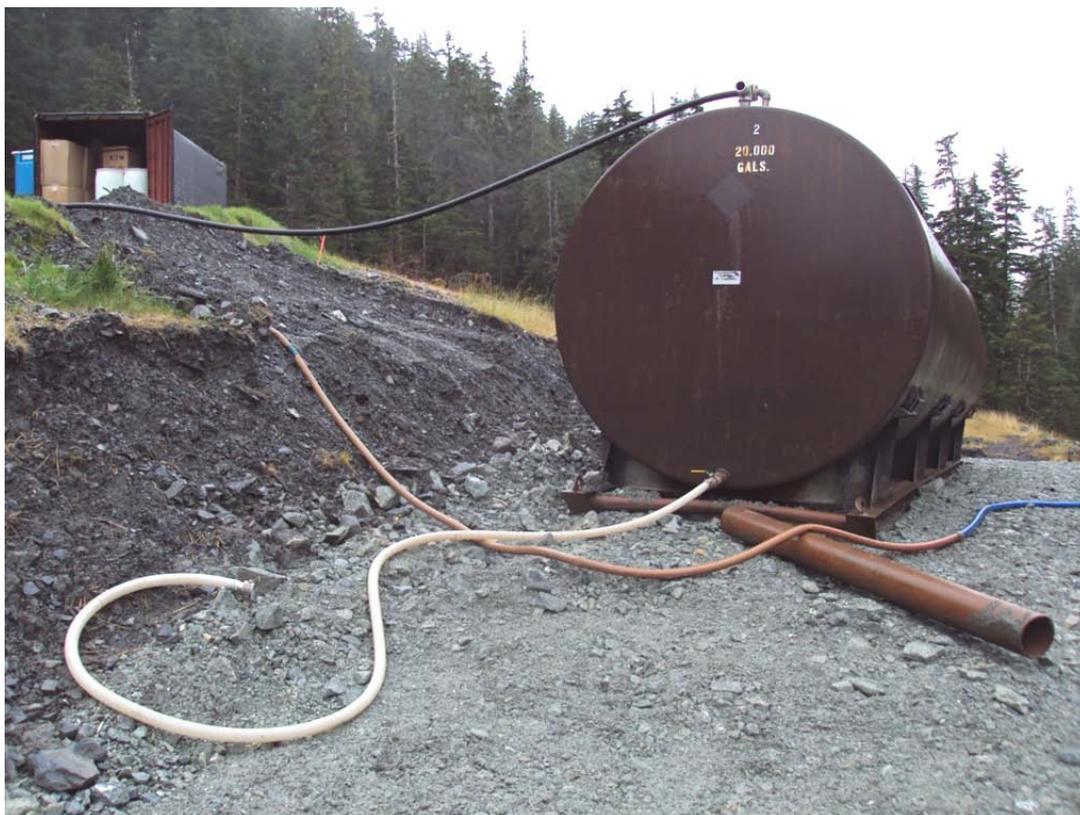
Photograph 11. WTP, treated water storage tank. Water is pumped from this tank to supply road watering trucks.

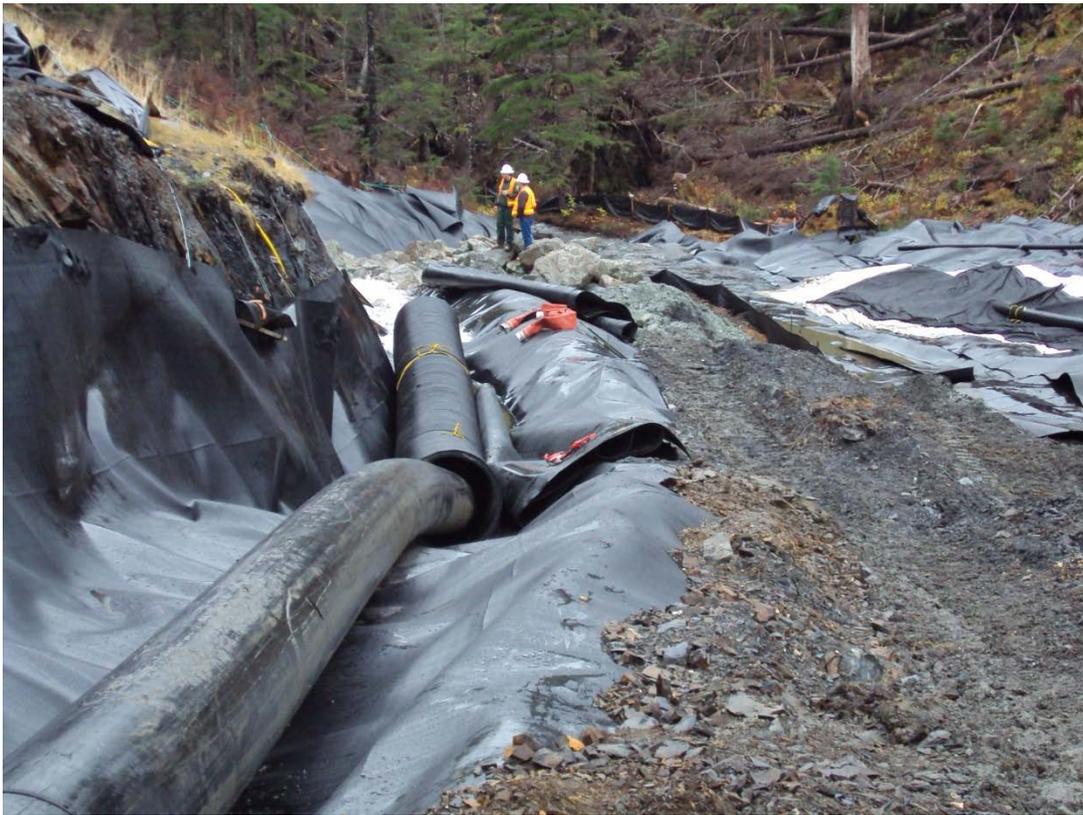
Photograph 12. Bypass outfall at headwater of East Fork Slate Creek.

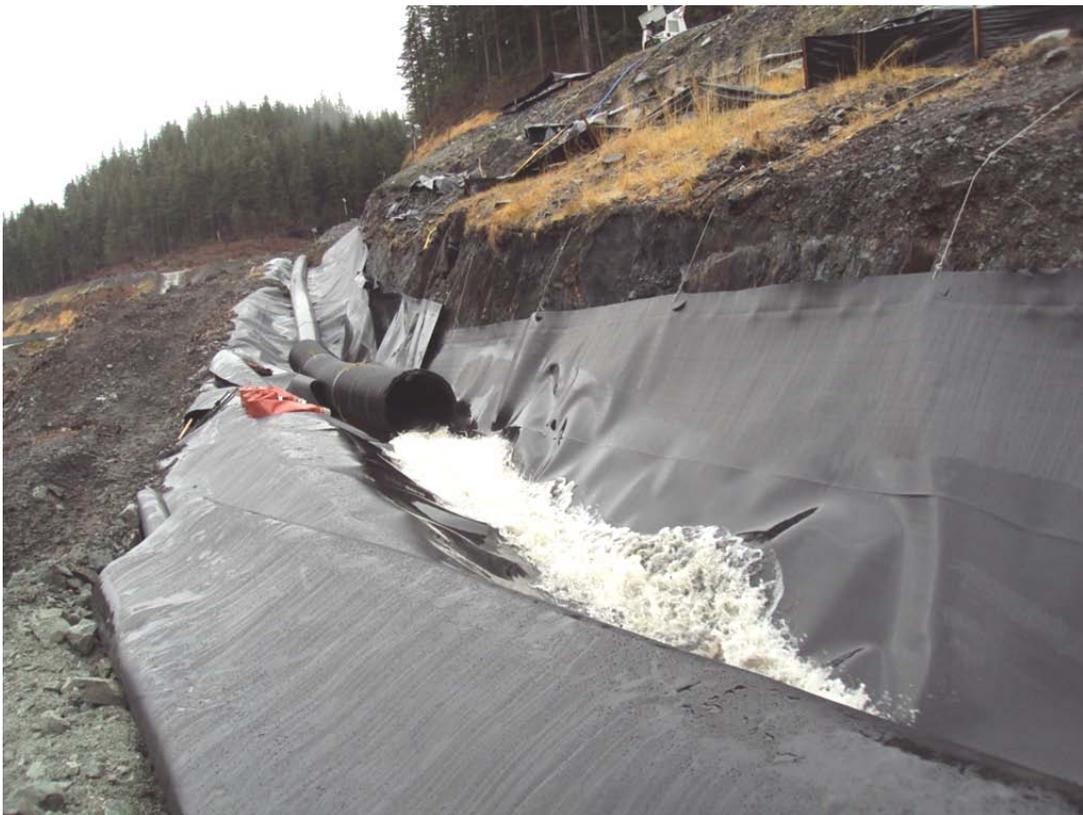
Photograph 13. Bypass outfall at headwater of East Fork Slate Creek.

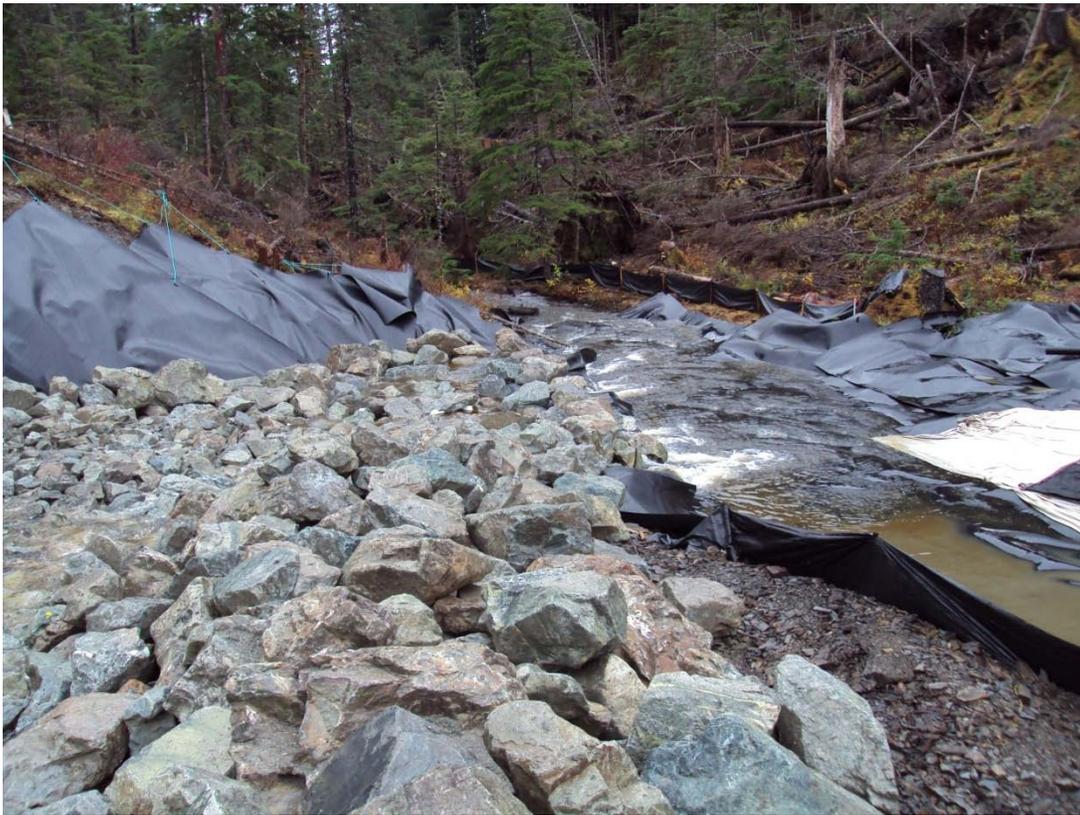
Photograph 14. Bypass outfall at headwater of East Fork Slate Creek. Rip rap used for energy dissipation prior to entering East Fork Slate Creek.

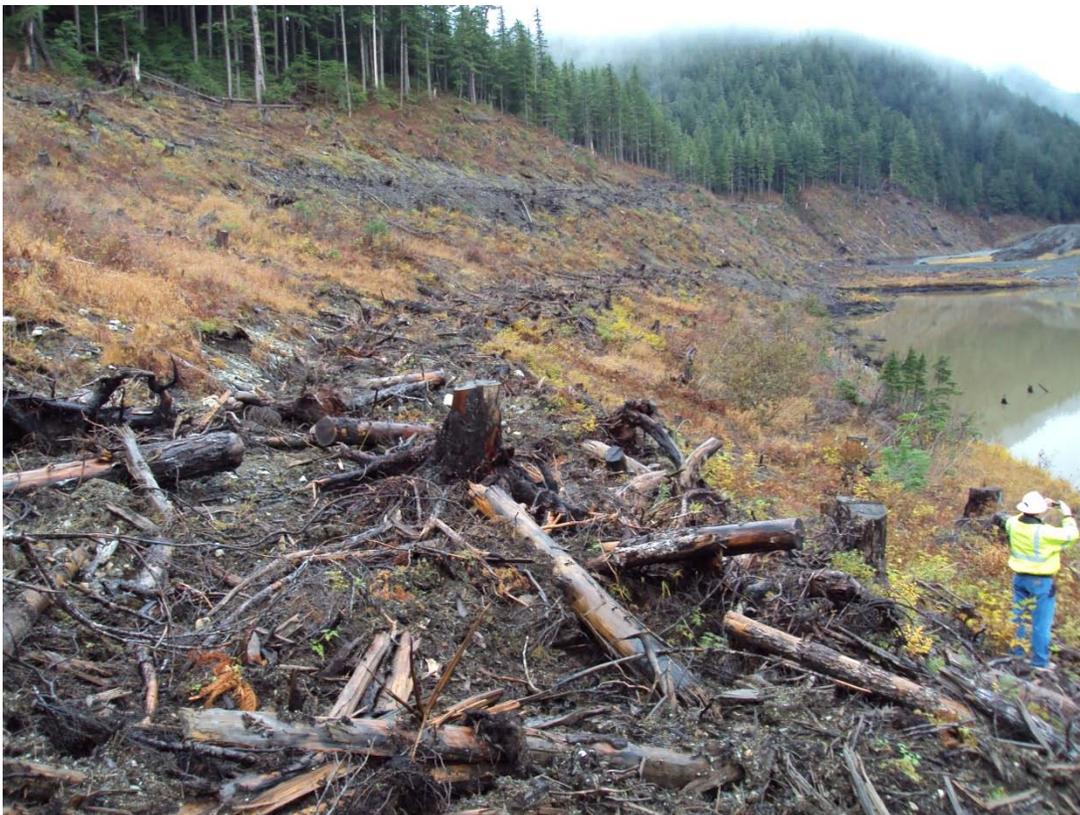
Photograph 15. Shoreline above LSL. Possible location for temporary land application.

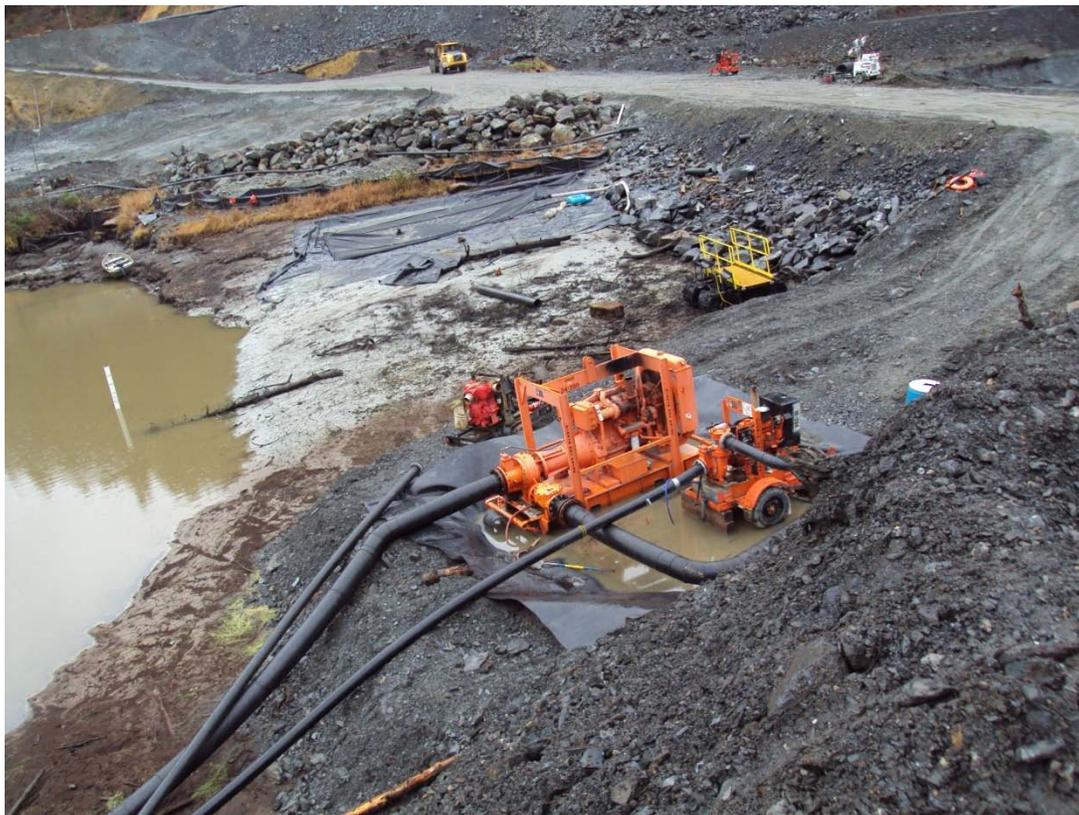
The water in the lake remains brown and turbid. The sediment bags had been newly replaced during the inspection and water was not being pumped from the lake at the time of this inspection. Prior to the sediment bag replacement, pumping had been reduced to approximately 1000 gpm to reduce turbidity impacts to East Fork Slate Creek.

Photograph 16. Cofferdam at LSL and dewatering pumps. Note the reduction of water level in LSL. Turbidity in LSL believed to be caused by runoff of exposed lake sediments.

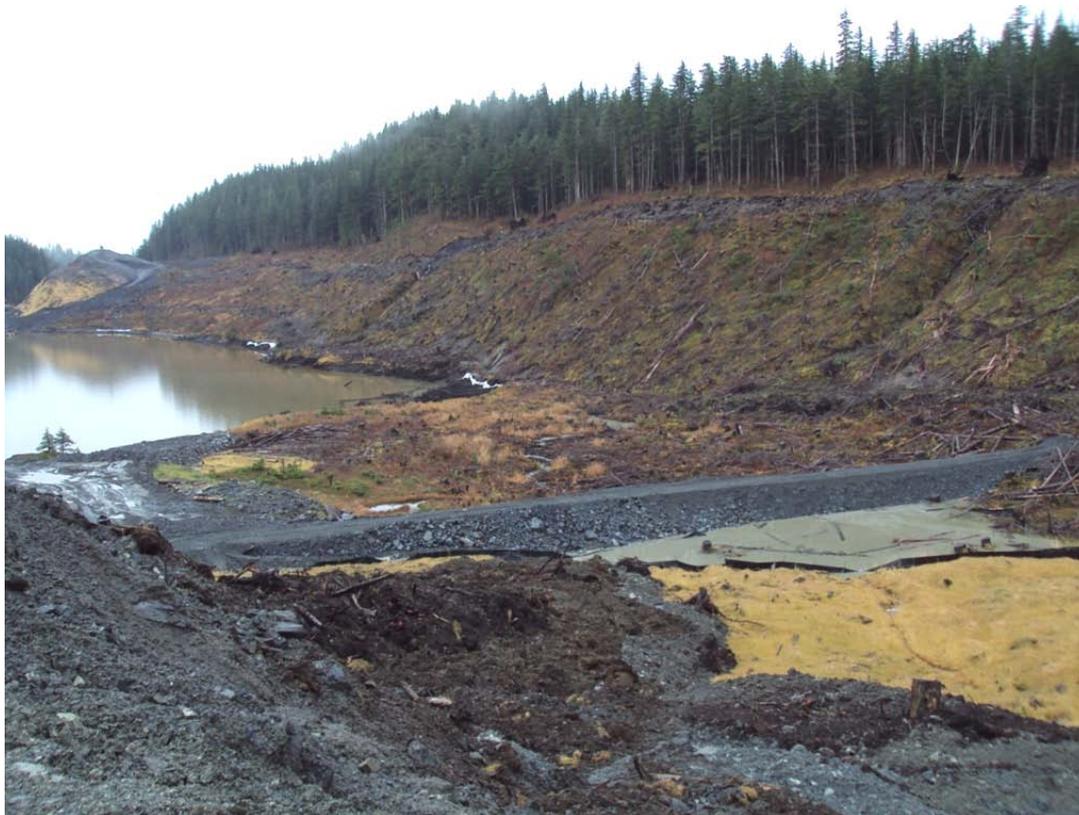
Photograph 17. Upper portion of LSL.

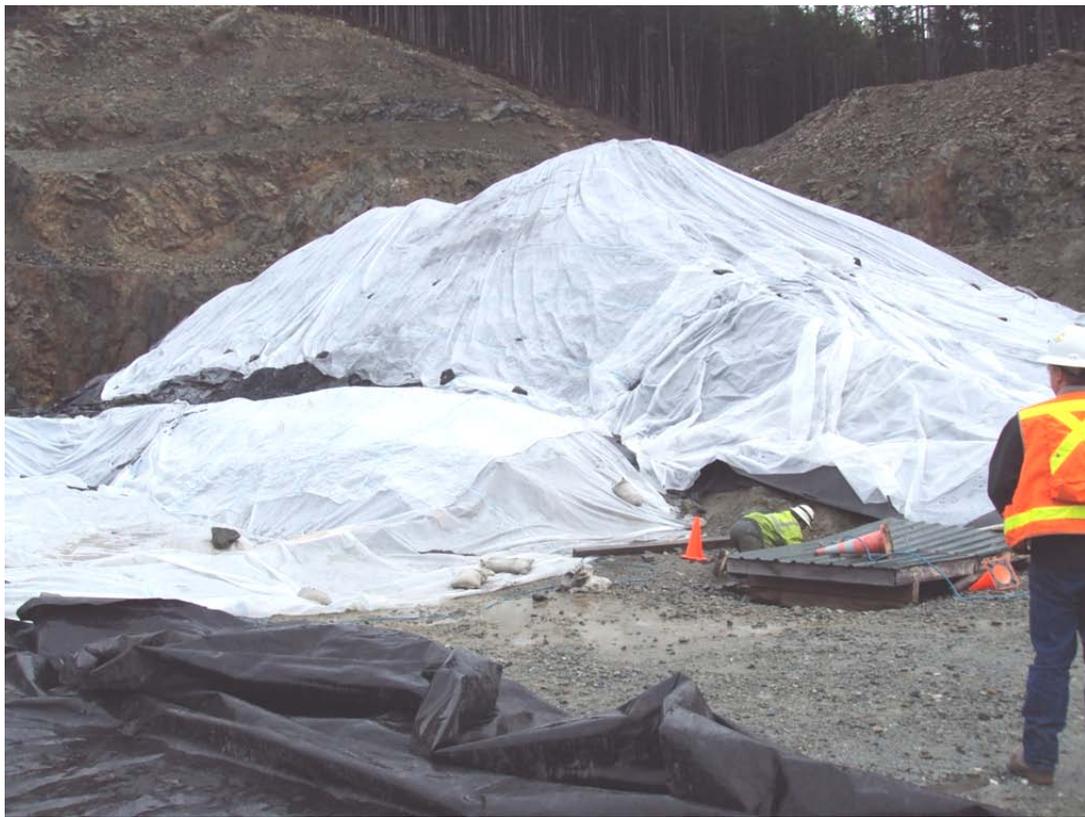
Photograph 18. Graphitic Phyllite temporary storage area at Site 3. Note sump in foreground.
