APDES INSPECTION REPORT

Alaska Department of Environmental Conservation

PHOTO ADDENDUM – KENSINGTON MINE

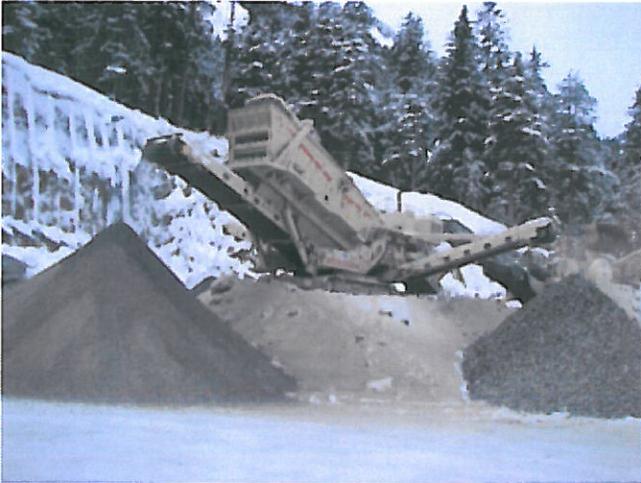
PHOTO 1: PORTABLE ROCK CRUSHING EQUIPMENT

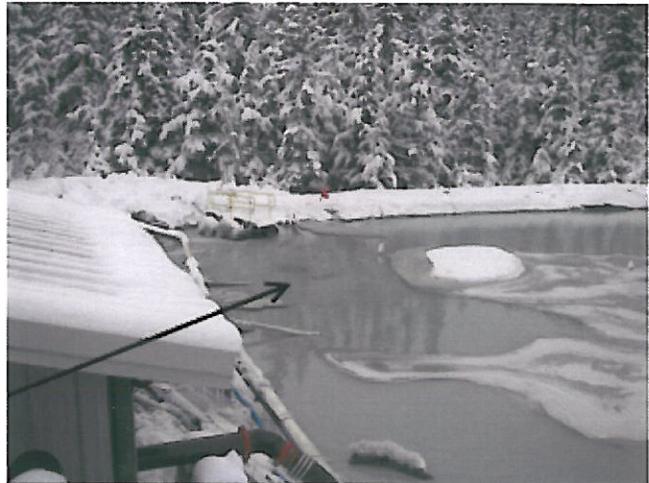
After donning safety equipment, we proceeded underground and went to the Comet Beach side of the facility. Pond 1 has visible sediment accumulation (Photo 2) and appears very close to full capacity (Photo 3). Accumulated sediment is visible

Pond 1 appears close to storage capacity and contains significant visible sediment.

PHOTO 2: POND 1, ACCUMULATED SEDIMENT IS VISIBLE ON SURFACE

1. Ensure stormwater discharges are not impacted by uncovered or uncontained chemicals storage containers
2. Provide a detailed explanation of maintenance plans or procedures specific to Pond 1
3. Update QAP to ensure expired standards are unavailable for use

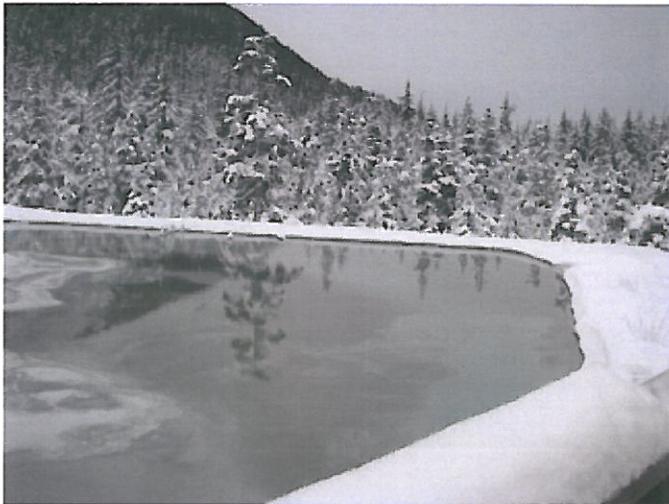
- If the pond's purpose is to provide storage capacity, then it appears the capacity has been limited such that removal of sediment/ maintenance appears necessary. The truck that is used to pump sediment was inoperable at time of inspection.
- If the pond's purpose is to provide treatment (settling), then the treatment capacity appears to be significantly diminished.

PHOTO 3: POND 1 APPEARS FULL

In either case, DEC believes a more aggressive maintenance schedule needs to be implemented. Additional treatment such as sediment bags or increased WTP capacity do not preclude KGM's responsibility for operating and maintaining the ponds as intended and outlined in the APDES permit.

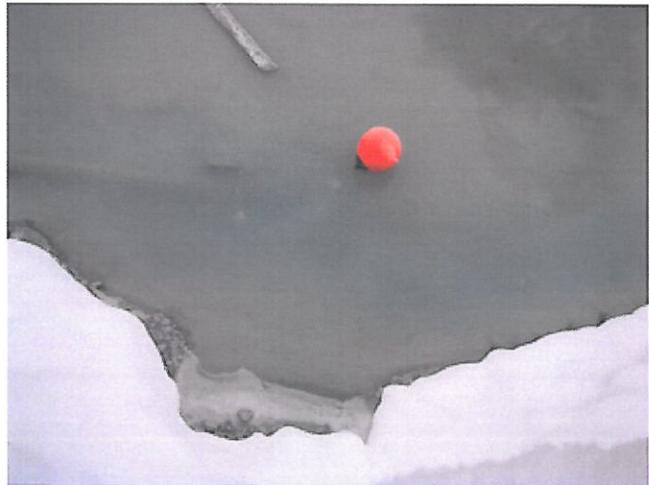
around the perimeter of the pond (Photos 4). Pond 2 is covered with snow (Photo 5). Pond 1 was not flowing into Pond 2 during inspection. The truck responsible for evacuating sediment from the ponds was inoperable (Photo 6). We then walked through the new expansion of the mine water treatment plant (MWTP).

PHOTO 4: SEDIMENT VISIBLE AROUND PERIMETER OF POND 1

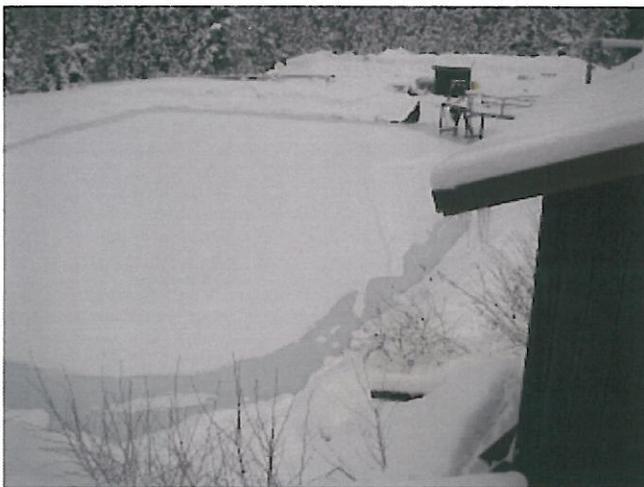
PHOTO 5: POND 2

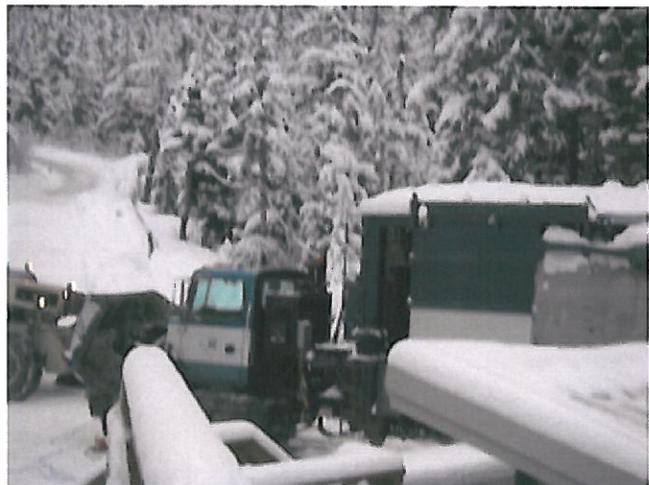
PHOTO 6: PUMPER TRUCK INOPERABLE DURING INSPECTION

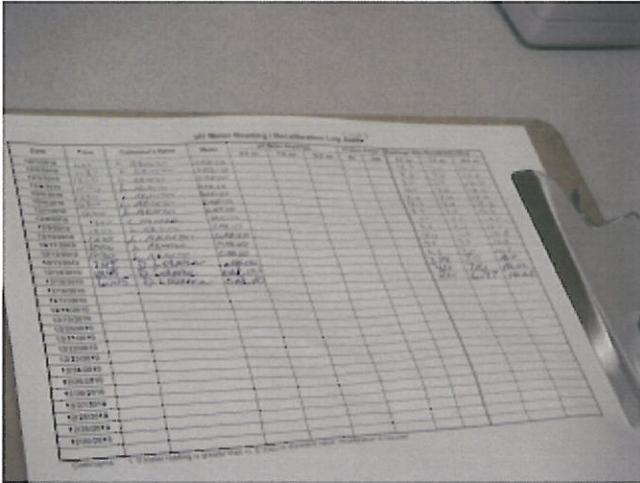
PHOTO 7: PH METER LOG

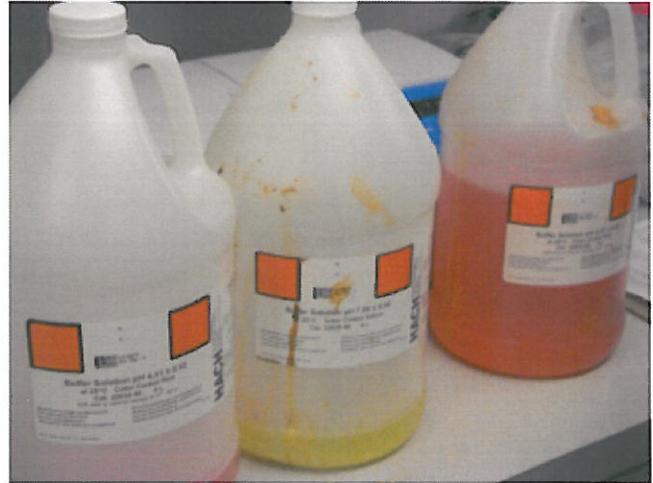
Next, we proceeded to the sampling shack. Mr. Eppers explained that the sample collection location was changed when the MWTP was expanded. One sample is collected then split into 3 sub-samples for analysis. Sampling is conducted after treatment is complete, mixing the old plant effluent and the expansion effluent. We discussed sampling procedures and reviewed calibration logs (Photo 7) for the continuous monitoring pH and turbidity meters. We checked expiration dates for pH buffer solutions (Photo 8) and observed that the 10.01 +/- .02 blue Hach manufactured solution was expired. Other buffer solutions were current.

Expired pH buffer standards were observed onsite. The use of expired standards for calibration purposes is in conflict with Part B6.2 of the QAP (Appendix 1), which states that expired standards are never used for calibration or calibration check procedures.

PHOTO 8: HACH PH BUFFER SOLUTIONS

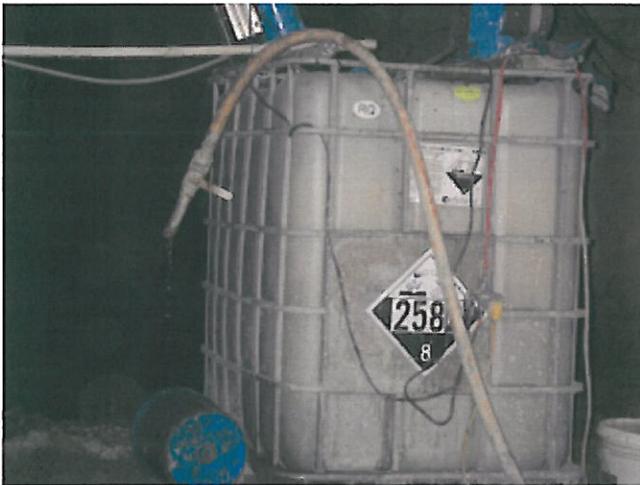
The incorrectly placarded tote underground has potential to prove confusing if danger to human health or safety required emergency responders to determine human health and safety risks based on (incorrect) placarding. Mr. Eppers confirmed later during inspection that the tote did not contain ferric chloride (corrosive) contents requiring bulk placarding, and had been re-used to contain a non-hazardous polymer without removing the corrosive placards. It is unknown whether this practice is in violation of Mine Safety and Health Administration or other regulations.

PHOTO 9: IMPROPERLY PLACARDED BULK CONTAINER UNDERGROUND (NOT APDES ISSUE)

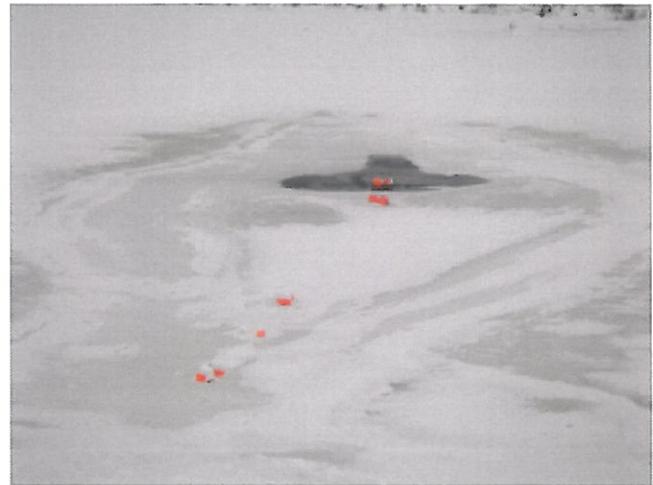
PHOTO 10: TAILINGS TREATMENT FACILITY/ LOWER SLAT LAKE

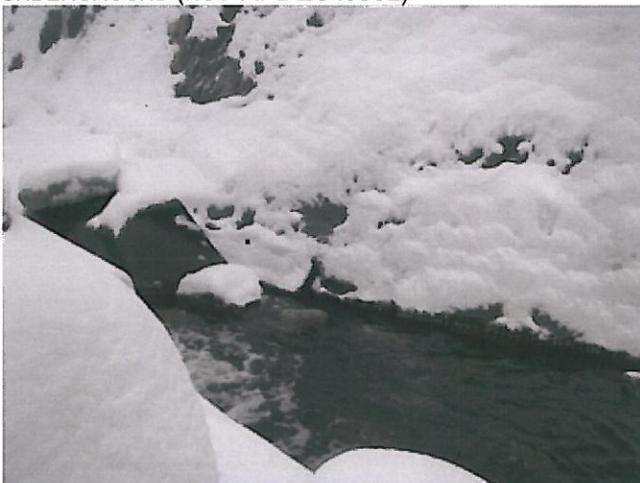
PHOTO 11: RE-CONSTRUCTED FLUME

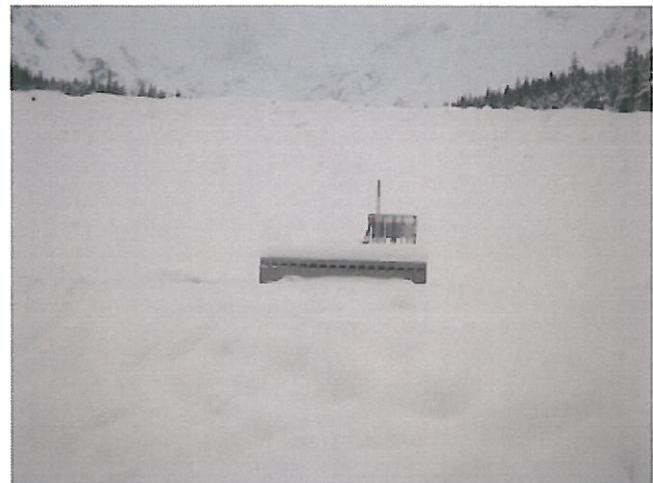
PHOTO 12: SEEPAGE COLLECTION SYSTEM

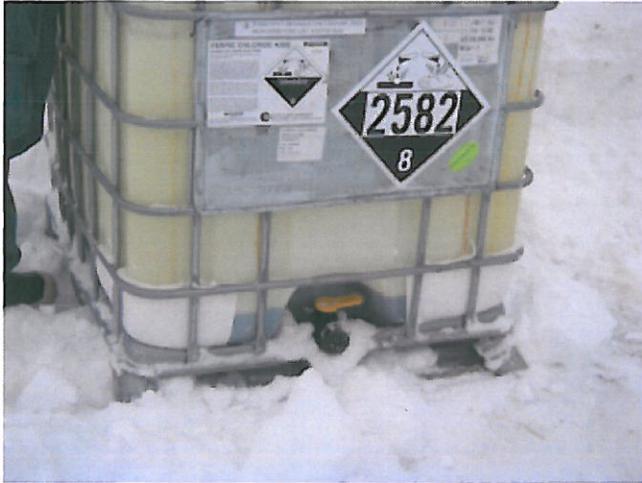
The MSGP 2008 regulates stormwater discharges not associated with another (APDES) permit. Uncovered tote containing hazardous material (ferric chloride) absent secondary containment is located outside WTP. It is unknown whether a stormwater discharge from the WTP area has potential to reach waters of the United States.

PHOTO 13: TOTE ABSENT SECONDARY CONTAINMENT OUTSIDE WTP

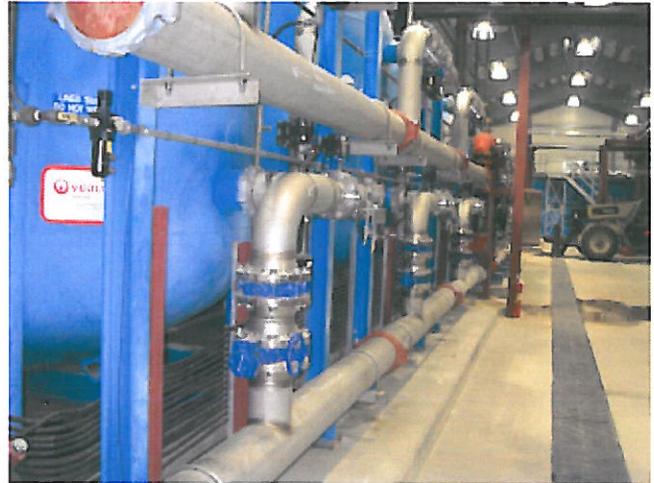
PHOTO 14: NEW CROWN SOLUTIONS FILTERS AT WTP

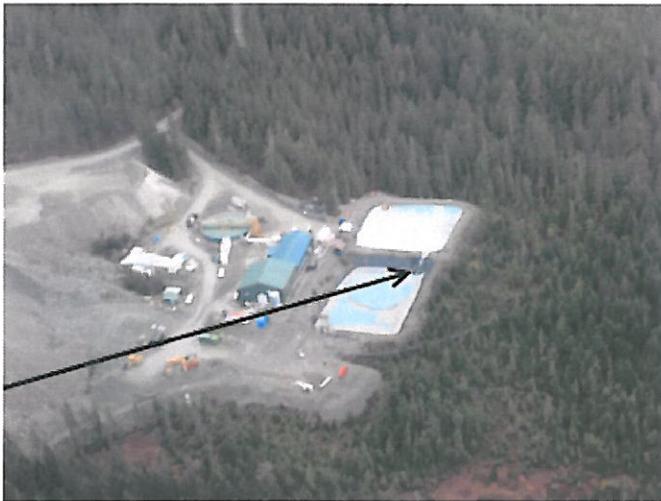
Pond 1 appears close to capacity and contained significant visible sediment. On November 9, 2010, DEC and USFS personnel visited the mine with the intention of inspecting the Comet Beach side of the facility, but could not enter the mine because new ventilation equipment was being commissioned. While departing, an aerial photograph (Photos 15 and 16) of the Comet Beach side was taken. The photograph shows Pond 1 discharging overflow into Pond 2.

PHOTO 15: **NOVEMBER 9, 2010** PHOTOGRAPH EFFLUENT FLOWS FROM POND1 TO POND 2

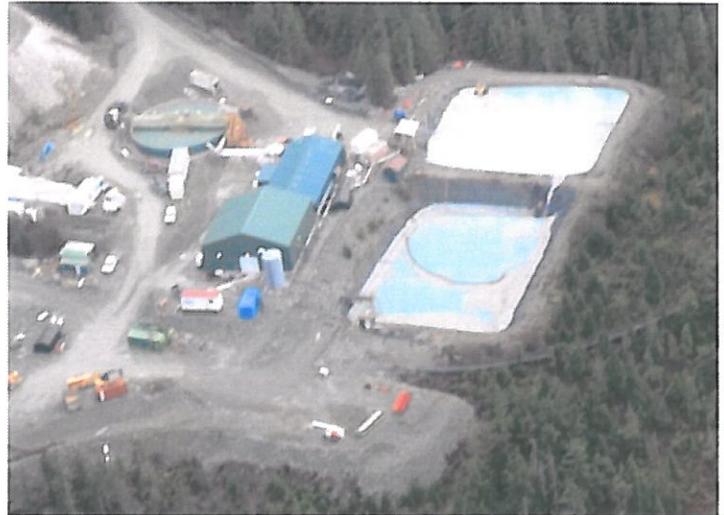
PHOTO 16: NOTE VISIBLE SEDIMENT IN BOTH PONDS. (ENLARGEMENT OF PHOTO 15, FROM **NOVEMBER 9, 2010**)
