DEPARTMENT OF ENVIRONMENTAL CONSERVATION

FIELD INSPECTION REPORT COEUR ALASKA/KENSINGTON MINE

Inspection Date: July 11, 2013, 07:30 – 10:30
Report Date: July 18, 2013
Weather: Calm, overcast, temperature ~ 60-70F

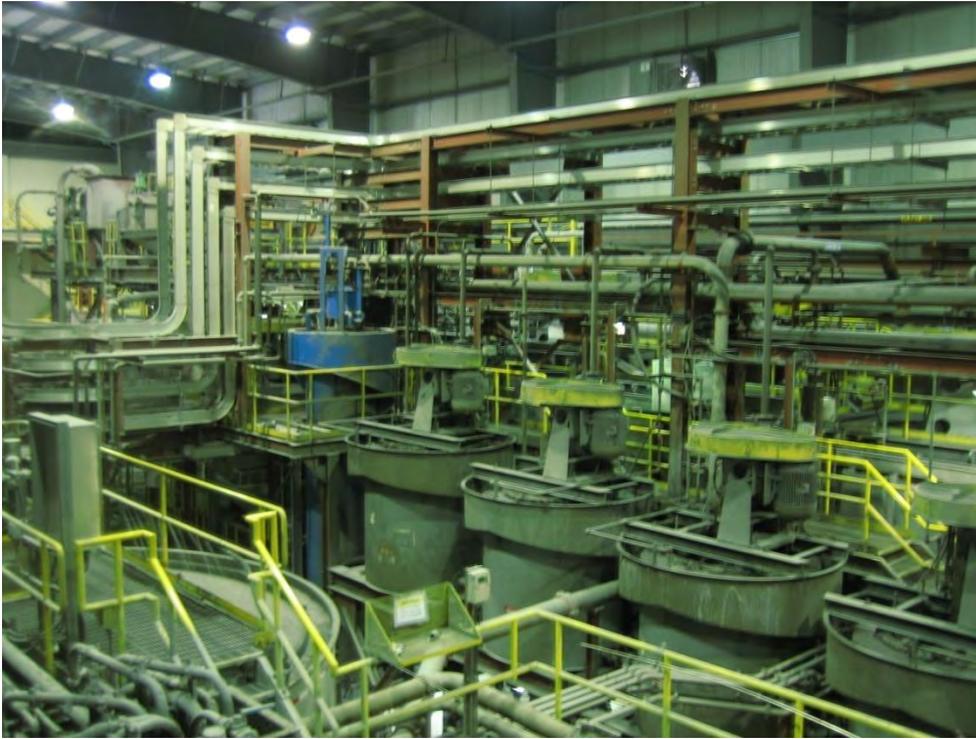
The mill processes 1700 tons/day of ore and generates a concentrate of 16-20 oz. gold per 2-ton sack.

Photo 1 – Mill

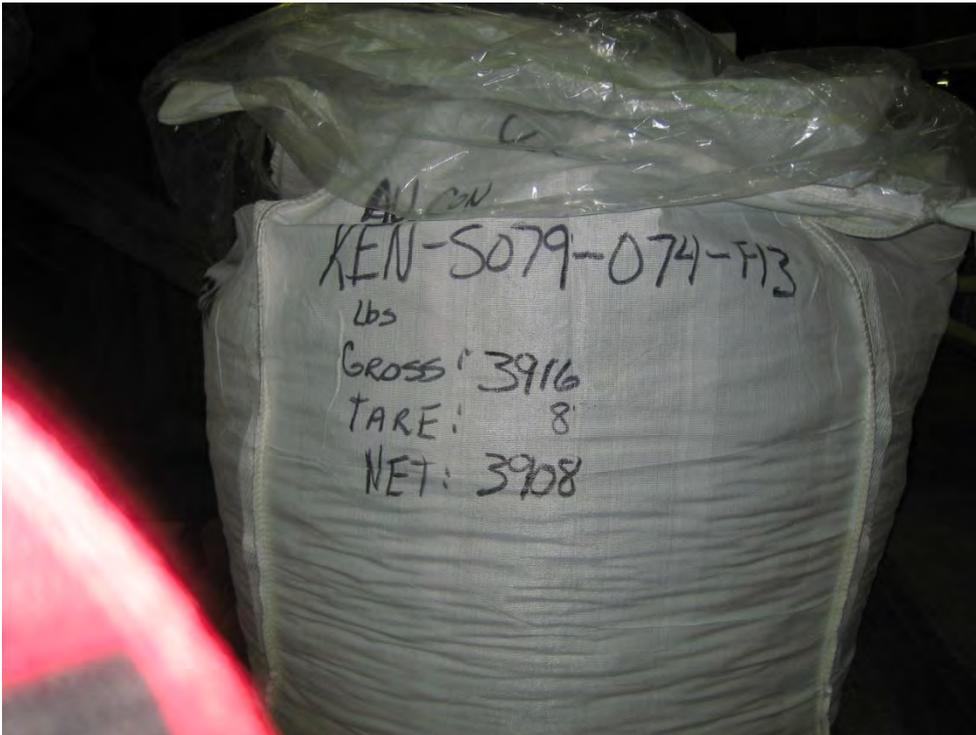
Photo 2 – Concentrate sack

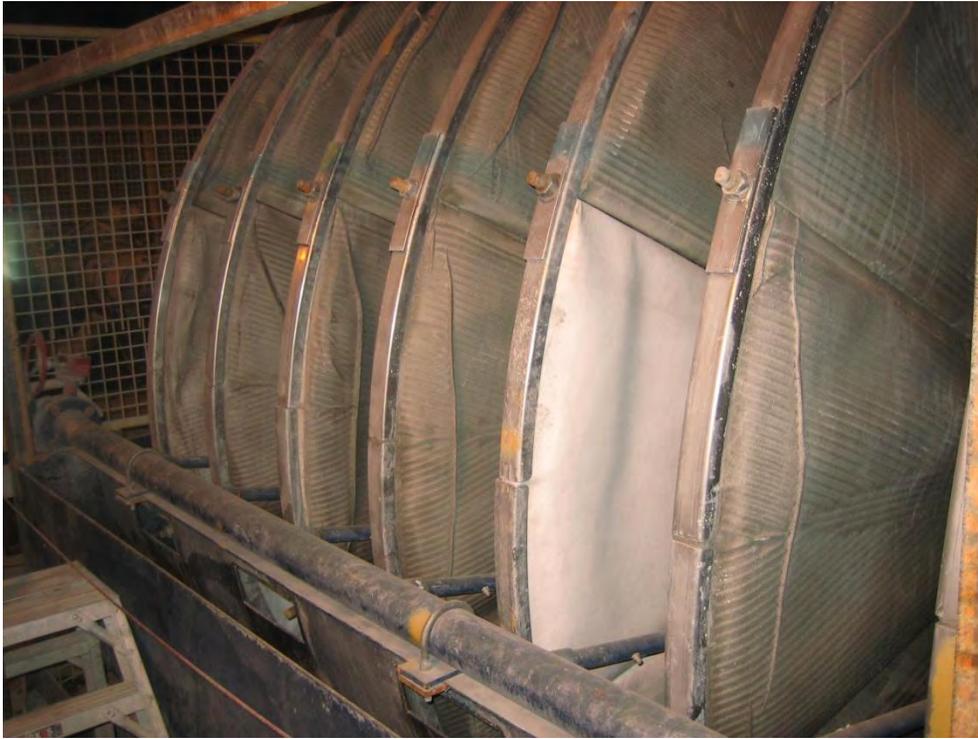
The underground paste plant was operating at the time of the visit.

Photo 3 – Paste plant vacuum dewatering

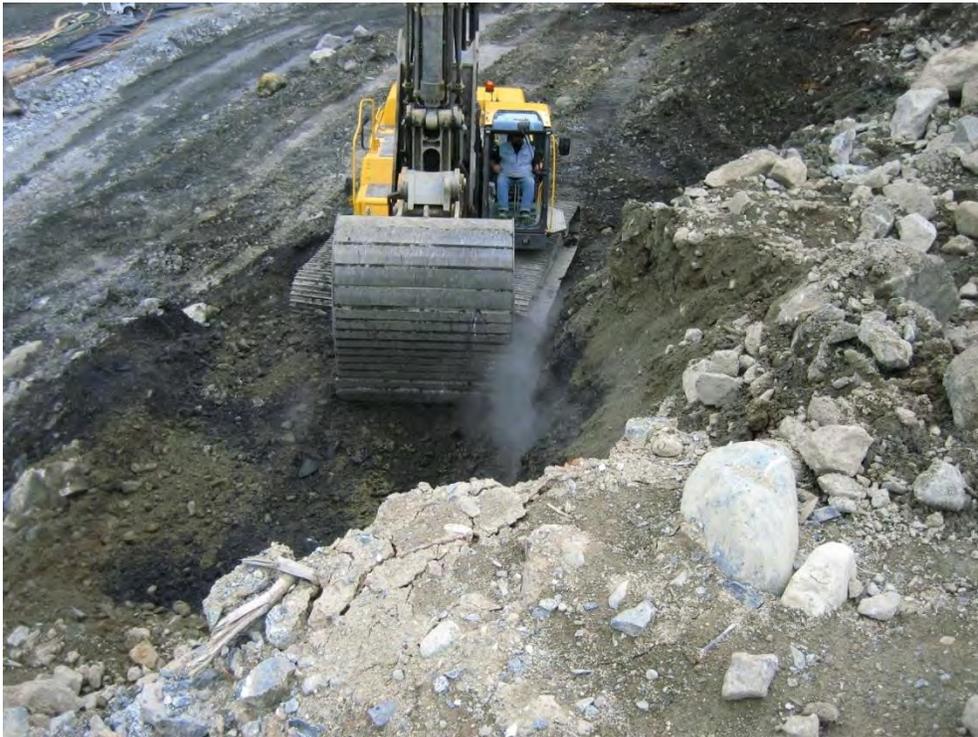
At the Lower Slate Lake Tailings Disposal Facility a visit was made to the north end where acid generating graphitic material had been deposited. This material generated orange-colored seeps and is being removed and placed underground. At the time of the visit 4,000 cy had been removed and an estimated additional 3,000 cy were still to be removed, which was estimated to take until early August.

Photo 4 – Removal of graphitic phyllite / steam rising from the rock pile

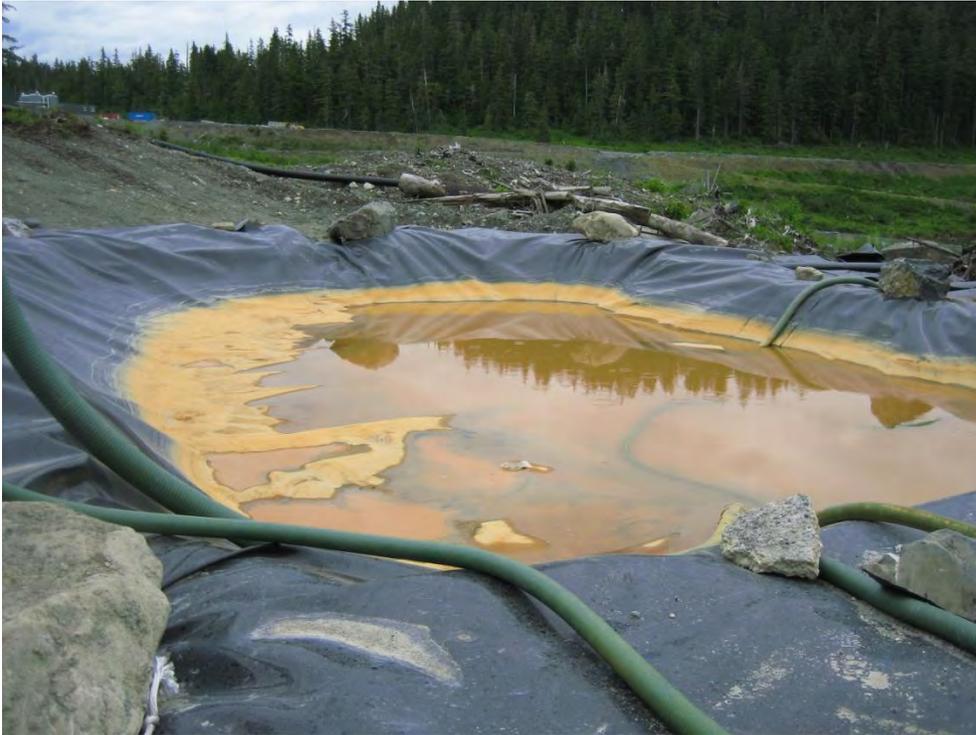
Photo 5 – Seepage water collection pond

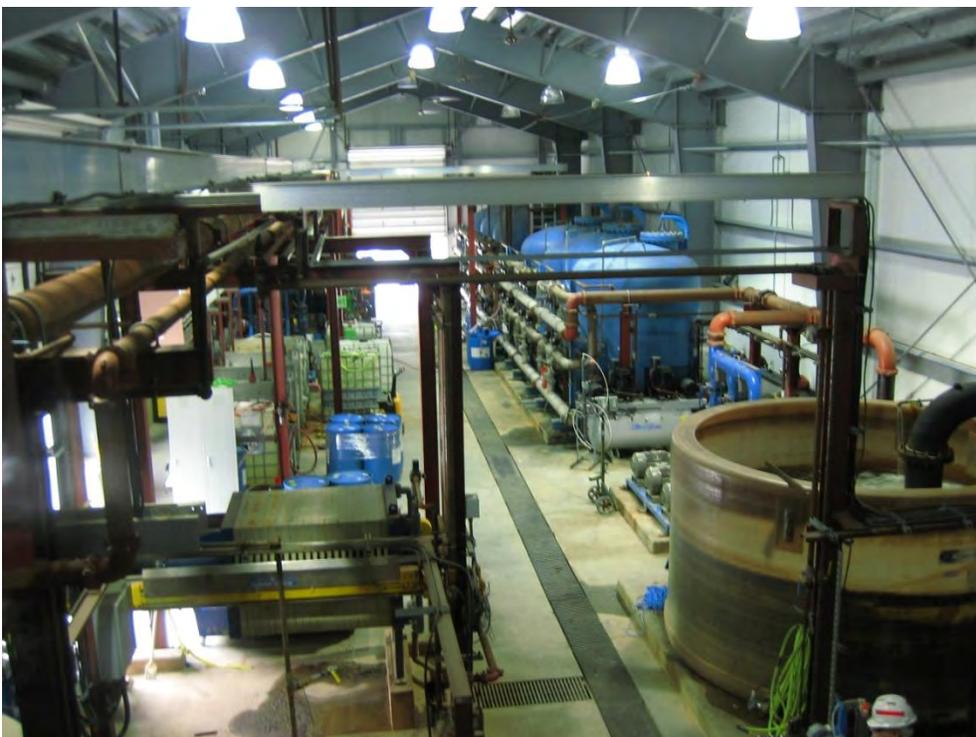
Photo 6 – Tailing Disposal Facility Treatment Plant
