INSPECTION REPORT: KENSINGTON GOLD MINE

Tongass National Forest Minerals Group
8510 Mendenhall Loop Rd
Juneau, AK 99801
(907) 789-6275– office
(907) 586-8808 – fax

Date of Inspection: Thursday December 21, 2017
Date of Report: Wednesday January 10, 2018
USDA Forest Service Inspector: Richard Dudek

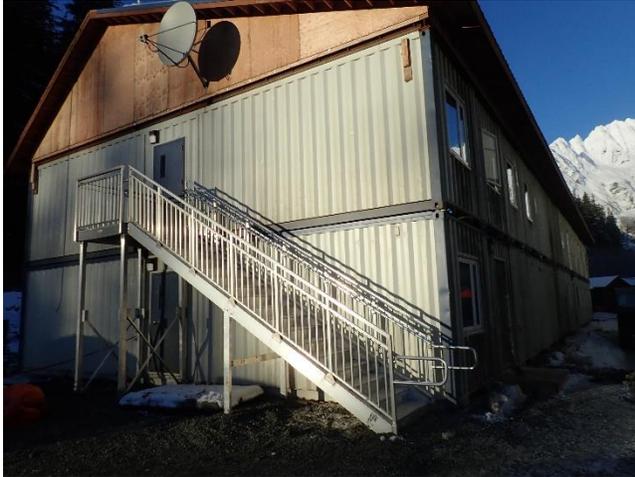
The construction for the modular housing units is almost completed (Photo 1).

Photo 1. The new modular housing units.

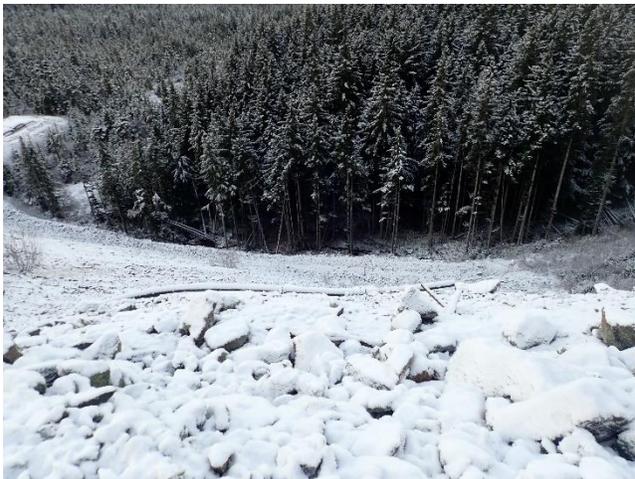
No additional waste rock has been stockpiled at this location (Photo 2).

Photo 2. The Comet development pile.

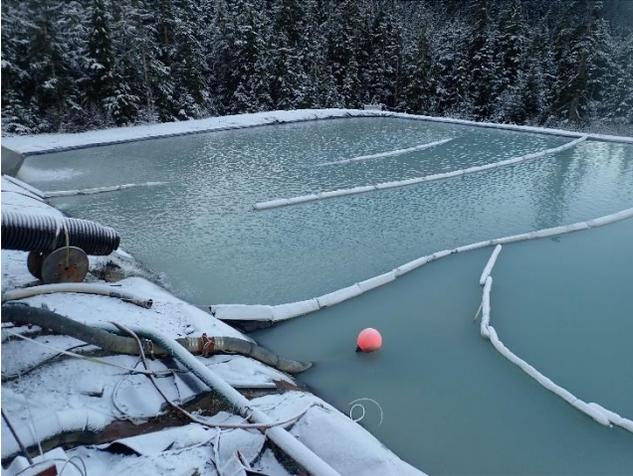
On 12/21/2017, the CWTP was treating 1,625 gallons of water per minute (gpm). Pond-1 (Photo 3) was receiving mine site water, and Pond-2 (Photo 4) was receiving backwash from the CWTP. Good housekeeping practices (2016 BMP plan Table 4-1) were observed inside the CWTP.

Photo 3. Pond 1 at the Comet water treatment plant.

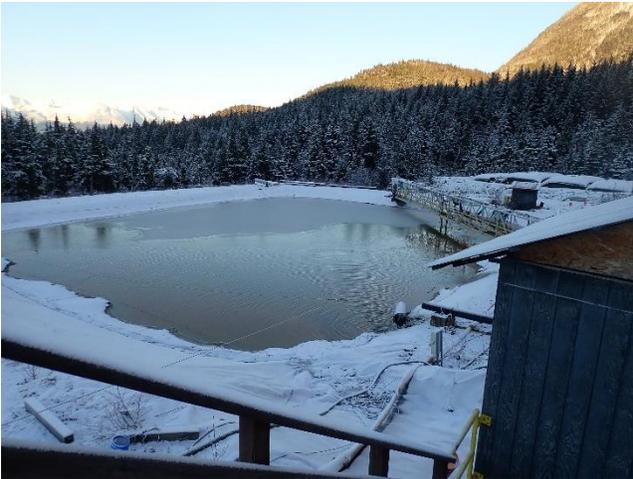
Photo 4. Pond 2 at the Comet water Treatment plant.

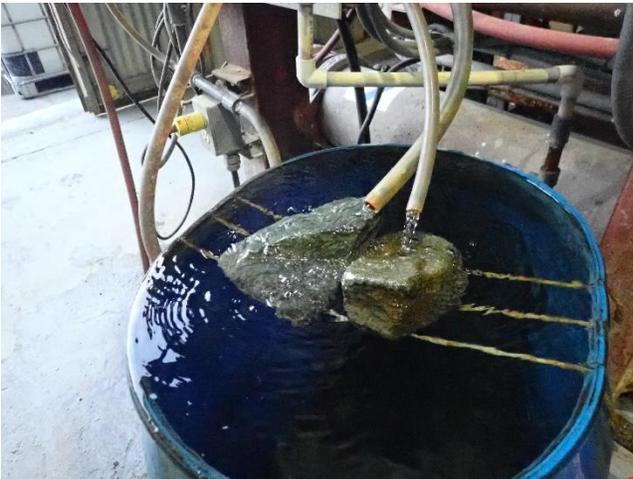
No white material observed on the test rock/barrel used for monitoring white material in treated mine site water (Photo 5).

Photo 5. The test rock/barrel used for monitoring white material.

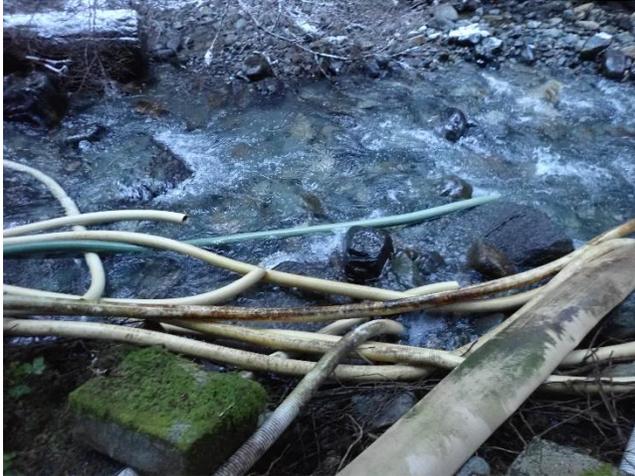
No white material was observed in Sherman Creek (Photo 6). As part of the current APDES permit, Coeur personnel monitor the outfall weekly for white material.

Photo 6. Sherman Creek Outfall 001.

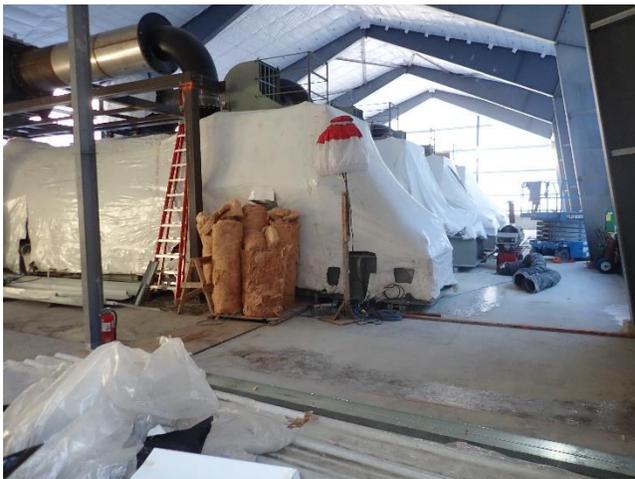
Contractors continue with the construction of the new powerhouse station (Photo 7).

Photo 7. Construction is still ongoing for the new powerhouse station.

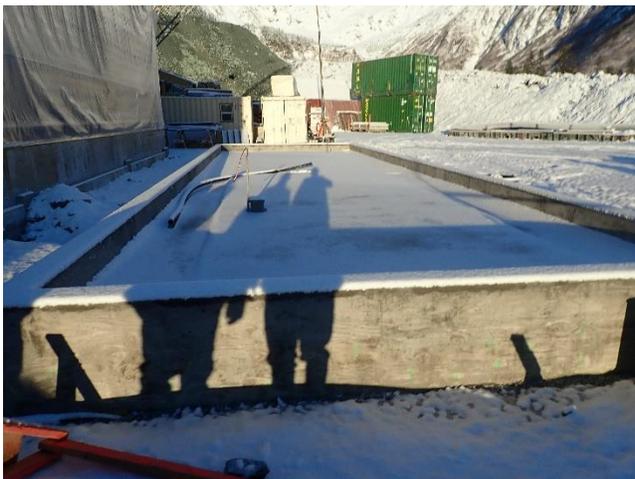
The 30,000-gallon day tank's new concrete pad with secondary containment is completed (Photo 8).

Photo 8. The new concrete pad for the 30,000-gallon refueling tank with secondary containment.

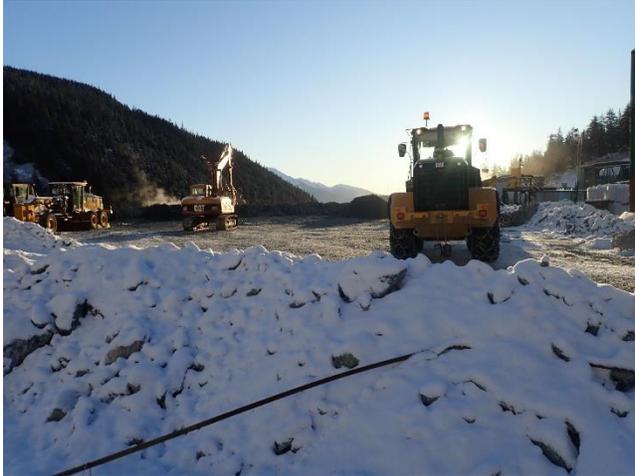
All waste rock generated from the underground workings is currently being deposited at the Kensington development pile (Photo 9).

Photo 9. The Kensington development pile.

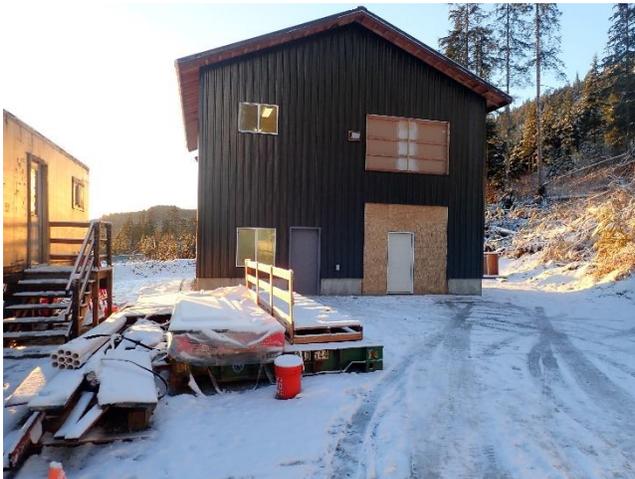
Contractors continue with construction of the new carpenters shop (Photo 10).

Photo 10. Construction for the new carpenters shop is nearly completed.

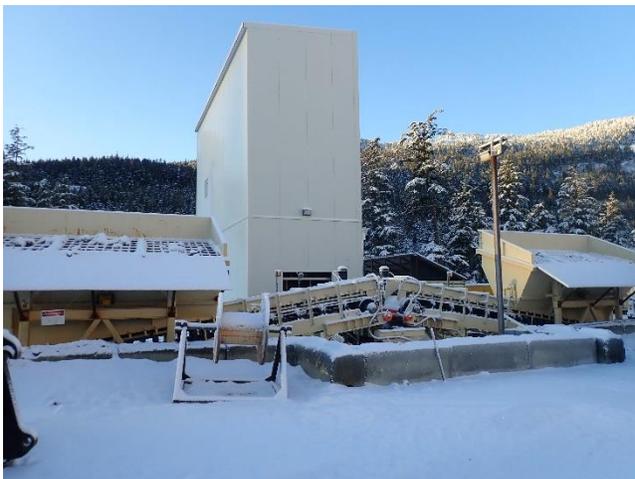
The Pug plant is inactive for the winter months (Photos 11). A temporary liner covers the graphitic phyllite (GP) stockpile that is used as feedstock for the pug plant (Photo 12).

Photo 11. The Pug plant located at Pit 4.

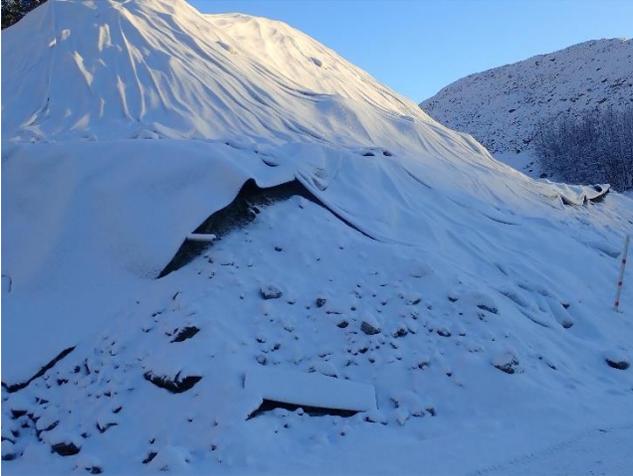
Photo 12. The temporary GP stockpile covered by a liner at Pit 4.

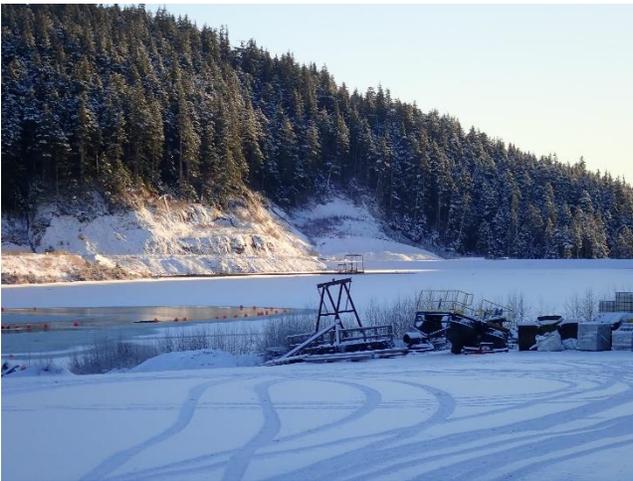
The TTF was mostly frozen over and the recorded water level on 11/28/2017 was 700.6 feet (Photo 13).

Photo 13. The TTF area.

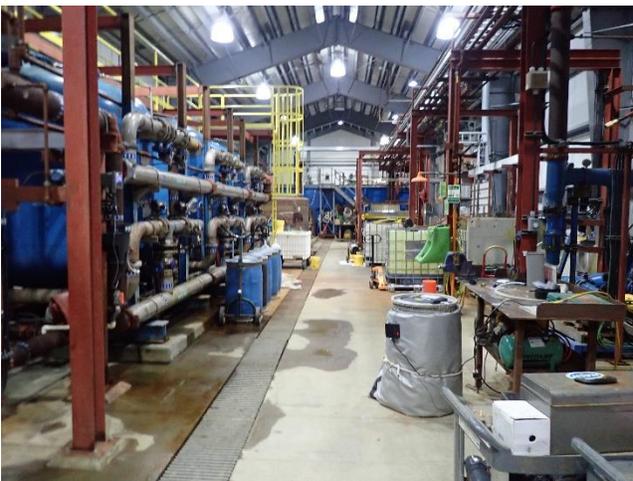
The day of this inspection, the water treatment plant was treating 1,450 gpm. Good housekeeping practices (BMP plan Table 4-1) were observed inside the water treatment plant (Photo 14). At the northern TTF area, the ARD collection ditch was mostly frozen over and covered in snow (Photo 15).

Photo 14. The TTF water treatment plant.

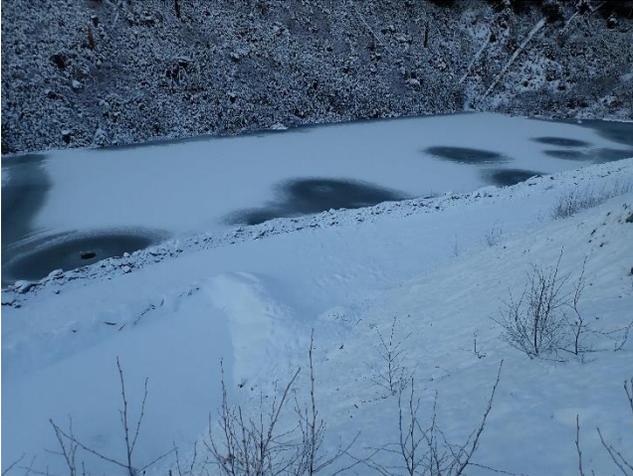
Photo 15. The northern TTF area.

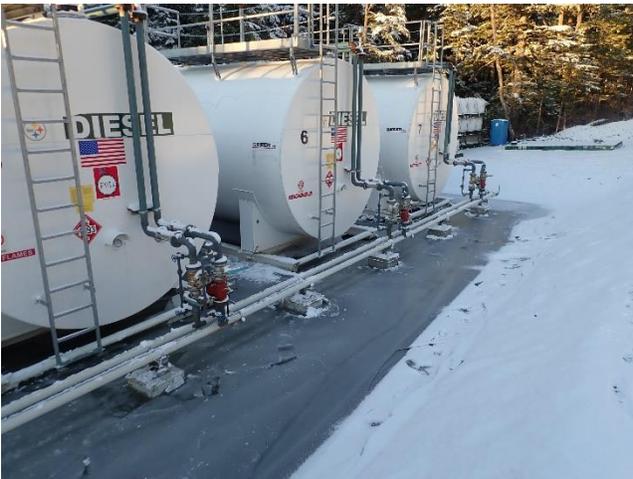
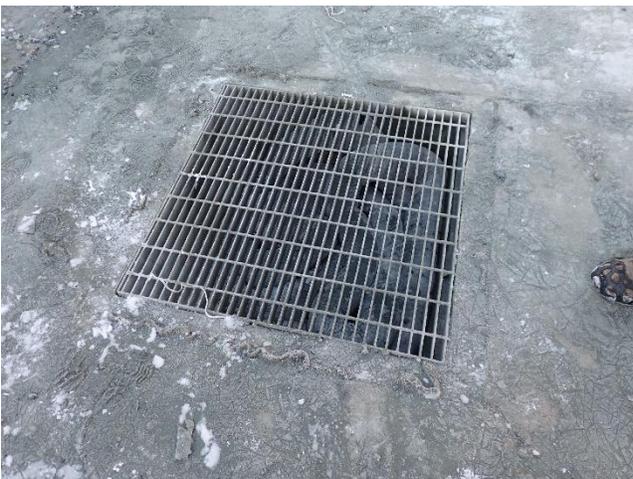
On November 18, 2017, Petro Marine reported to Coeur Alaska that 20 gallons of diesel fuel spilled during refueling at tank 6. The water and residual fuel was pumped to the refueling pad's secondary containment, which allowed residence time for the hydrocarbon booms and absorbent pads to capture the diesel before the water was discharged. The cleanup was suspended until warmer conditions persist, and the hydrocarbon containment booms remain in place in the refueling pad's secondary containment (Photos 16-17).

Photo 16. The Fuel depot.

Photo 17. The fuel depot's refueling pad with secondary containment.

- Residual fuel requires cleanup at the fuel depot when warmer temperatures persist.
