## Inspection Report: Kensington Gold Mine

Date of Inspection: Wednesday, August 21, 2013  
Date of Report: Tuesday, August 27, 2013  
USDA Forest Service Inspector: David Schmerge

Ranger District: Juneau Ranger District  
Weather Conditions: Cloudy. Temperature in the 60s.

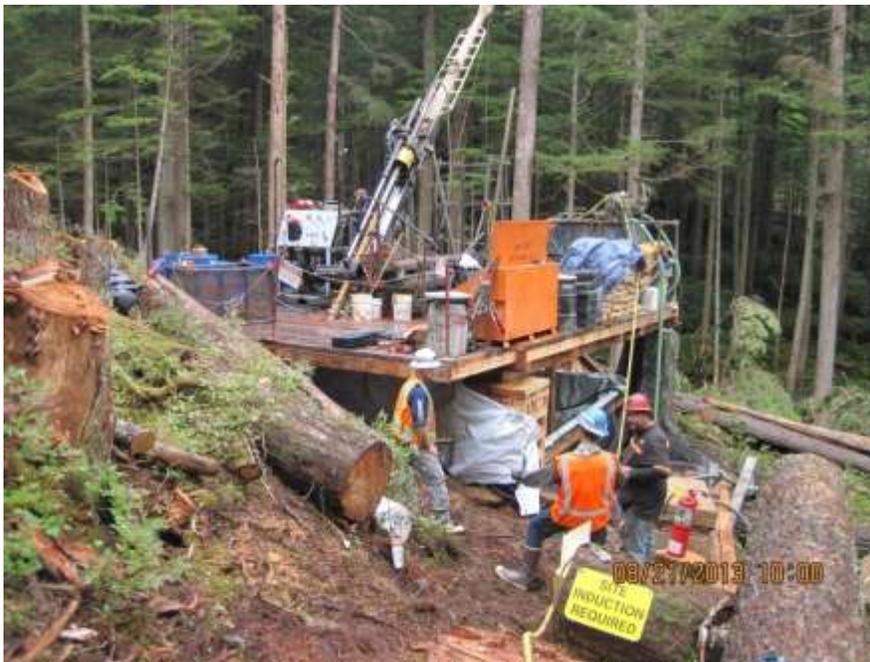
The surface exploration drill rig was in a cleared area about a quarter mile northeast of Pit 4 (photo 01). It was near a small valley that contains a mapped Class III stream. The stream was about 100 feet away. We did not hike down to inspect the stream, but we did not hear flowing water, so we assumed it was probably intermittent. The 2013 Surface Exploration Annual Work Plan (Plan) requires the drill contractor to complete an environmental pre-shift checklist; the checklist states that if drill water is within 200 feet of running water, this must be fixed before drilling resumes. At the beginning of each shift, the drill contractor should be certain that there is no flowing water in this stream. If flowing water is present, then drilling should stop until the flow stops.

Photo 01. The drill rig is located about a quarter mile northeast of Pit 4. An intermittent stream is about 100 feet away.

1. Before each shift, the drill contractor should check the intermittent stream. If water is flowing, then drilling should not resume until the flow stops.

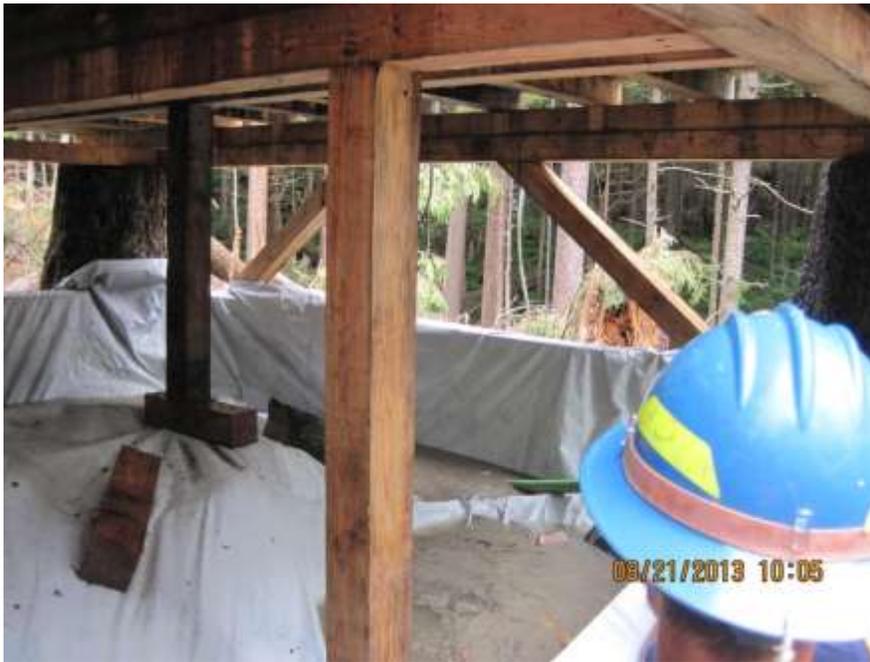
A sump below the drill platform was capturing the drill water and cuttings (photo 02). The Plan

states that the sumps will be dug into the ground or constructed using cut timber, and lined with geo-fabric; it also states that upon termination of drilling, all non-native materials will be removed and drill cuttings will remain within the constructed sumps. The sump is lined with plastic instead of geo-fabric, so it needs to be removed upon termination of drilling. Before removing the liner, the drill water and cuttings will need to be disposed. Scott said they could be pumped into the drill hole.

Photo 02. The sump under the platform is effectively capturing the drill water and cuttings.

2. Upon completion of drilling, the drill water and cuttings should be pumped into the drill hole, and the plastic sump liner should be removed.
3. Before drill sites are cleared or otherwise disturbed, field personnel should be certain that the site will comply with the requirement that the drill water is not to be within 200 feet of running water. It is appropriate to move the site several hundred feet from the proposed location if necessary in order to comply with this requirement.

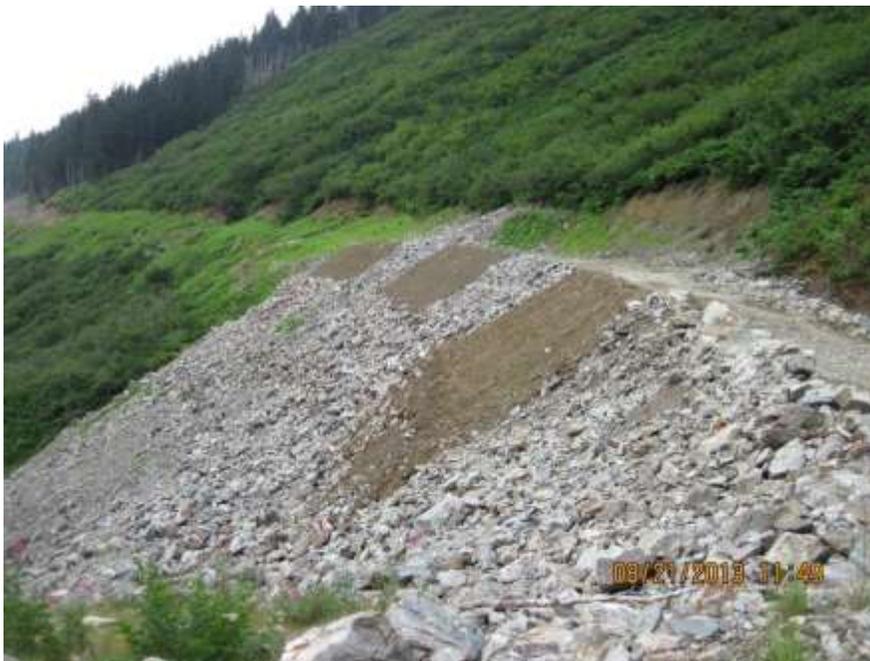
Grass is germinating in each of the three reclamation test plots at Snowslide Gulch (photo 03). Kevin stated that the qualitative and quantitative monitoring has started, and is being done once per week. The Reclamation Test Plot Plan requires reference site(s) for the monitoring, and Coeur is to consult with the Forest Service during reference site selection. Coeur has not yet consulted with the Forest Service to select the reference sites. Ellen Anderson (Botanist, U.S. Forest Service) should be consulted as soon as possible.

Photo 03. The three reclamation test plots are germinating. Kevin stated that Plot 3 (the far plot) contains the biopolymer; I previously reported that the biopolymer was in Plot 2.

4. For the Reclamation Test Plot Plan, consult with Ellen Anderson to select the reference site(s) as soon as possible.
5. Secure the field test cells with a fence as soon as possible.

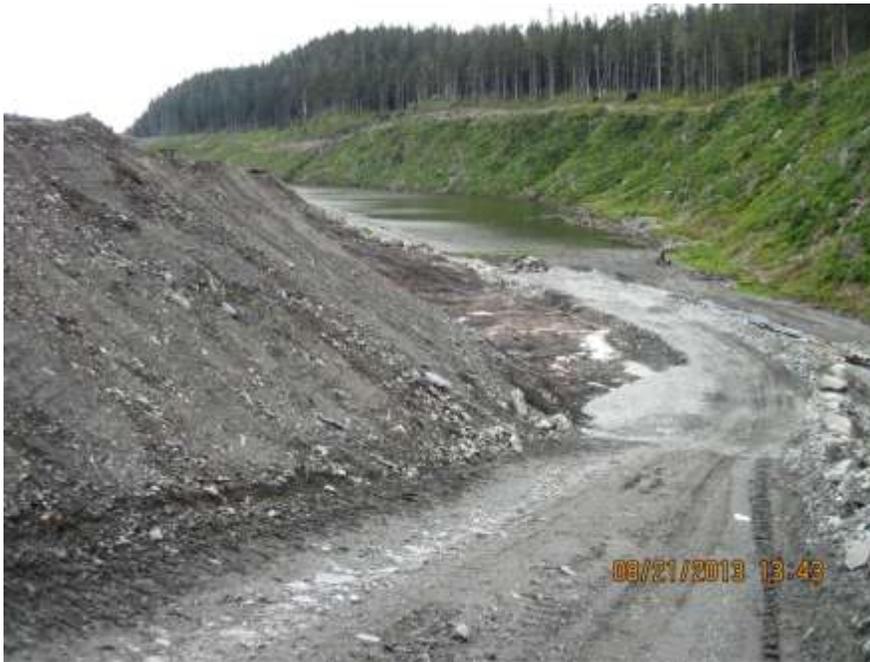
Most of the graphitic phyllite (GP) has been excavated at the Tailings Treatment Facility (TTF) (photo 04). There may be a little more GP to be excavated because some ARD is still visible (photo 05), but the pH at the sump (photo 06) has improved to 5 (It was 3 on July 29, and 4.5 on August 6). At the north end of Lower Slate Lake (photo 07), the pH was about 6, and at the northwest pond (photo 08) it was about 5.5.

Photo 04. Most of the Graphitic Phyllite at the north end of the TTF has been excavated.

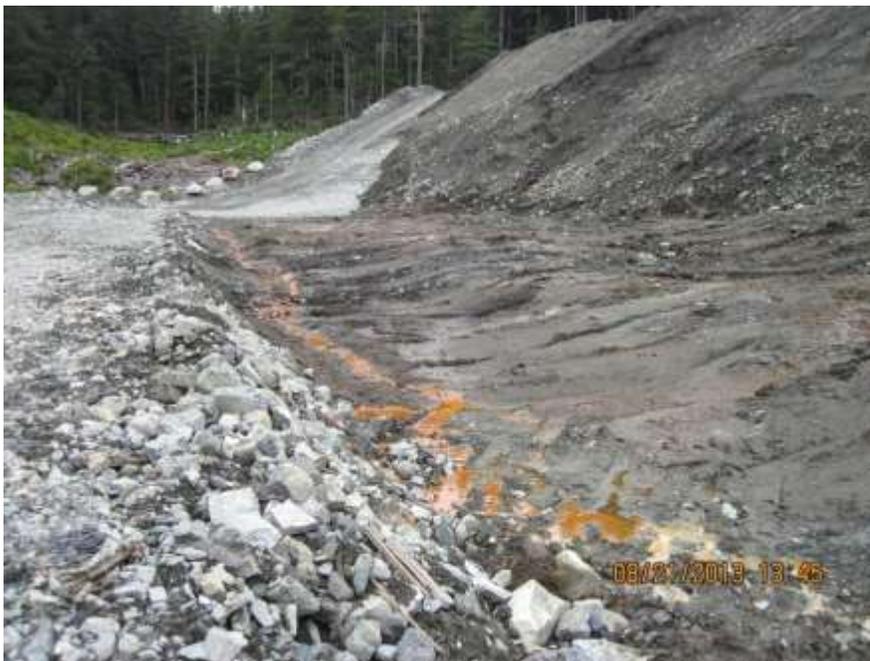
Photo 05. There is still some visible ARD seepage.

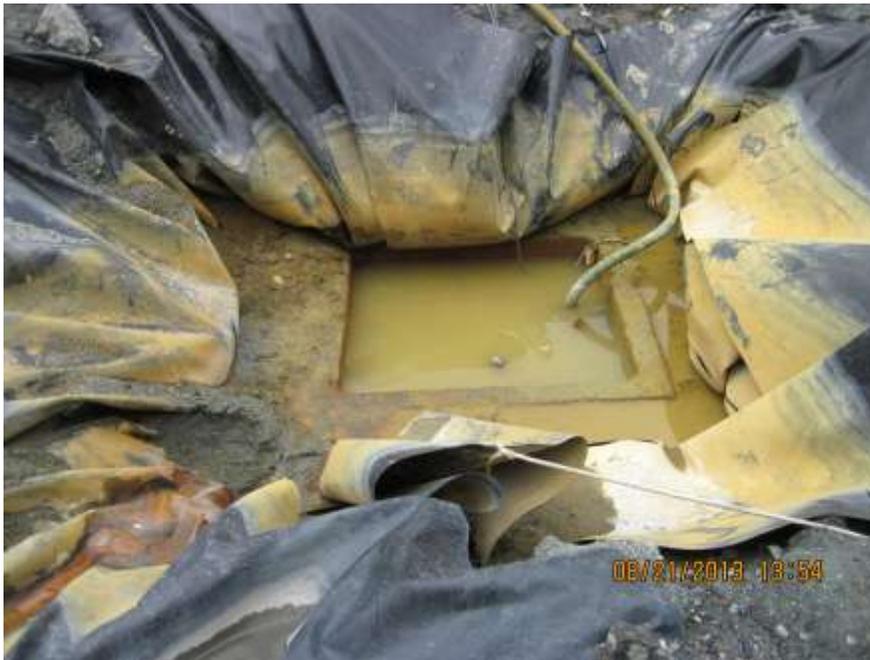
Photo 06. The pH at the sump was 5.

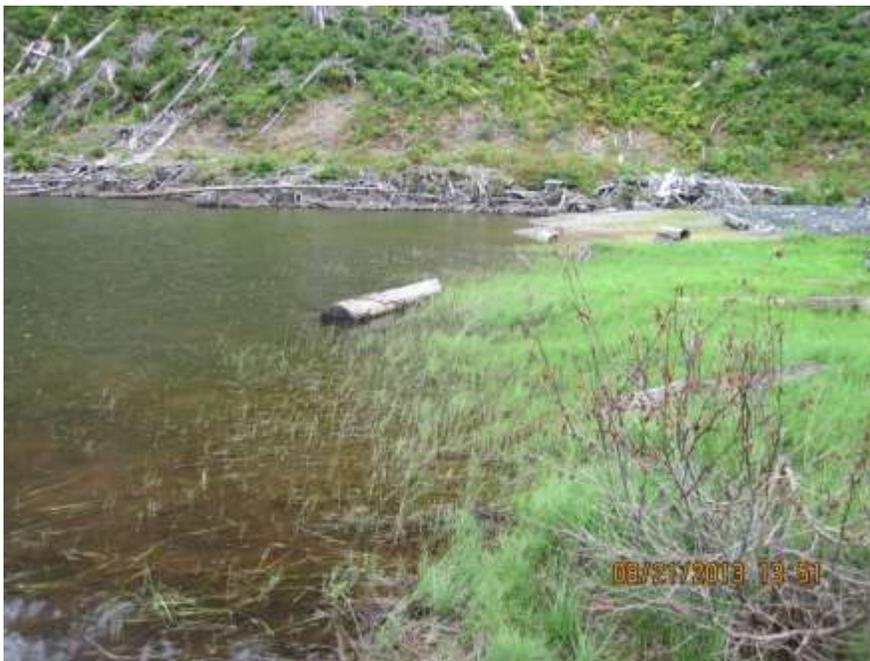
Photo 07. The pH at the north end of Lower Slate Lake was about 6.

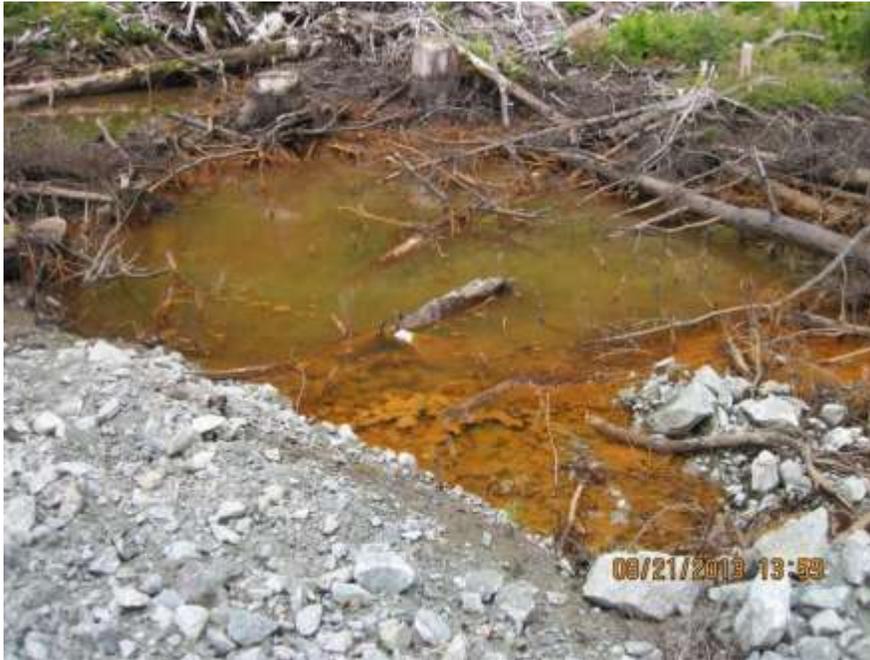
Photo 08. The pH at the northwest pond was about 5.5.

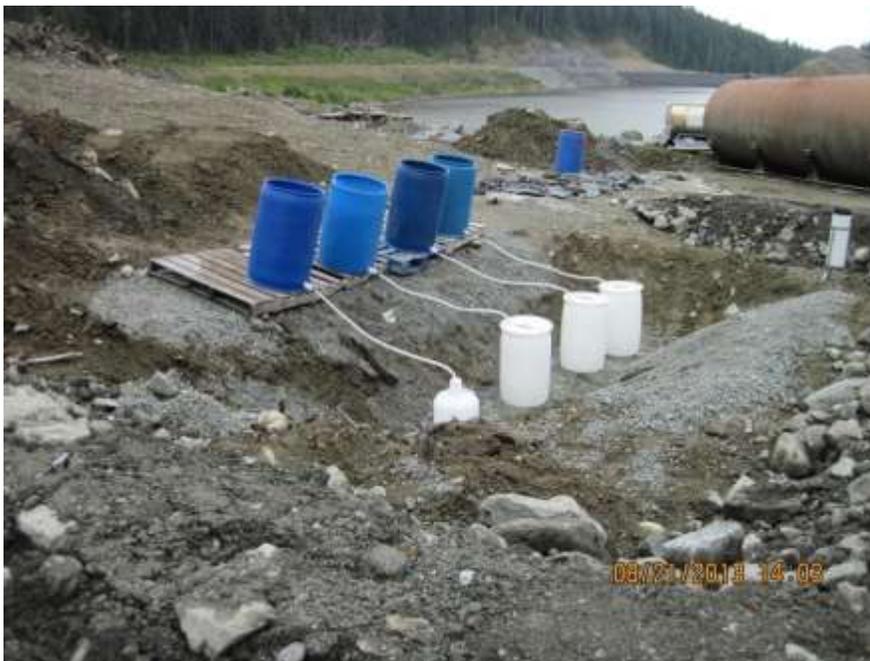
The GP field test cells have been prepared (photo 09), and Kevin told me that the testing started on August 20. The area has not yet been secured with a fence. The Scope of Work for Construction and Operation of Field Test Cells report states that the site should be in a secure area with limited access that can be fenced off.

Photo 09. The field cell tests started on August 20, but the area needs to be enclosed by a fence.

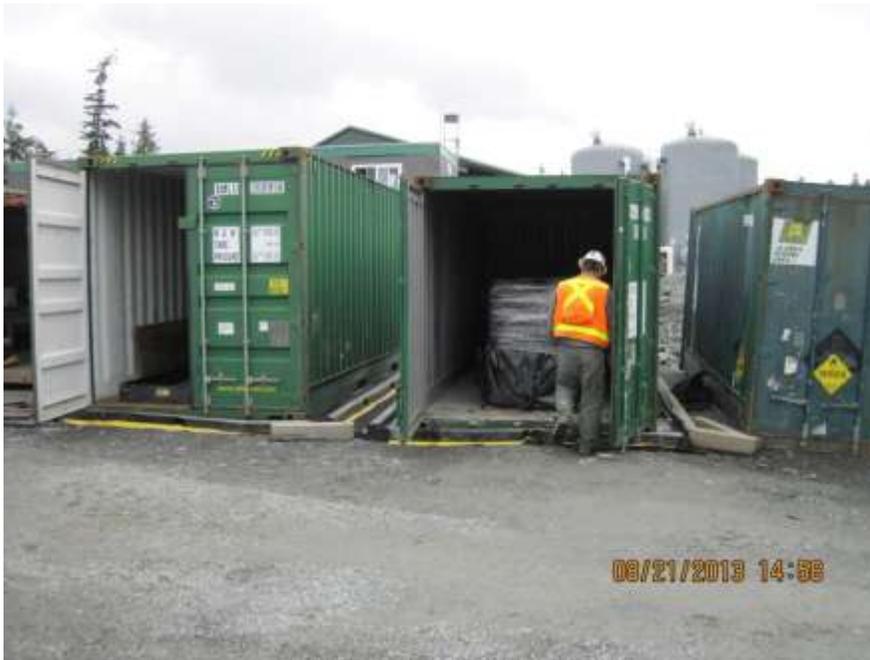
There were several secondary containment violations at the TTF. The inadequate secondary containment of a conex container that I previously reported had not yet been fixed (photo 10). The secondary containment requirement is to store 110% of the largest container (363 gallons). With a level and a tape measure, I measured the slope of the container, and then calculated the capacity to be less than 100 gallons. It is essential to fix the inadequate secondary containment of this conex container. I also found several buckets containing liquids that were outside of secondary containment (photos 11 and 12); Coeur personnel immediately moved the buckets inside the building where there is secondary containment.

Photo 10. The secondary secondary containment of the middle conex container is inadequate. Because it is on a significant slope, its capacity is less than 100 gallons, but it is required to hold 363 gallons.

6. At the TTF Water Treatment Plant, it is essential to store all liquid chemicals and wastes within effective secondary containers.

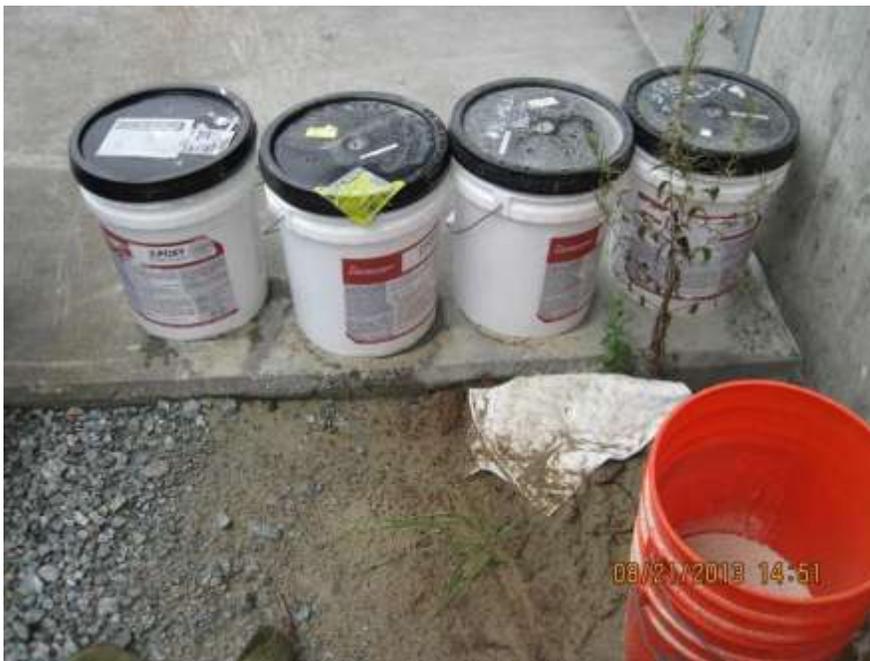
Photo 11. Four 5 gallon buckets of floor sealer were stored outside of secondary containment.

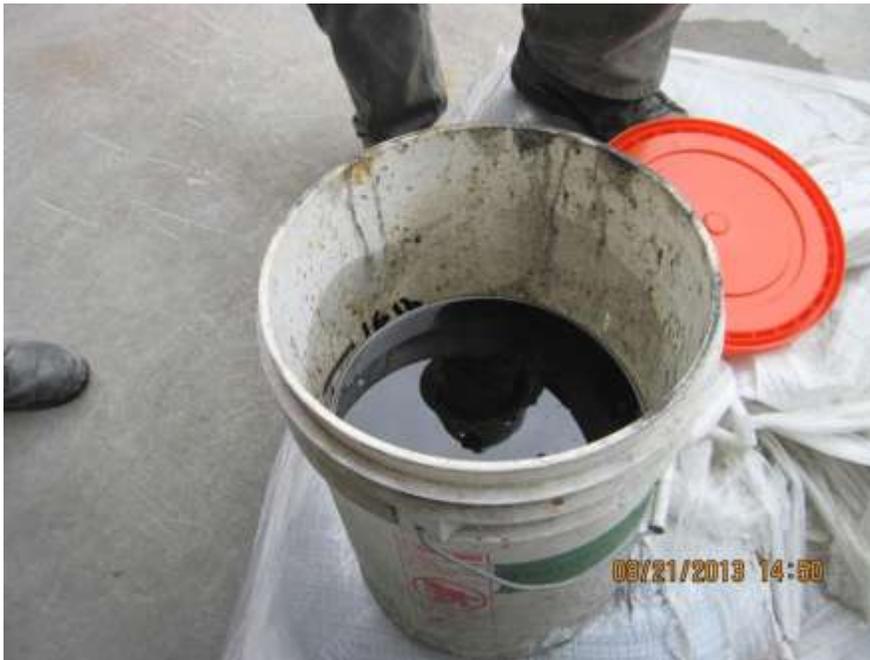
Photo 12. This liquid waste was not in secondary containment, and the bucket did not have a label.

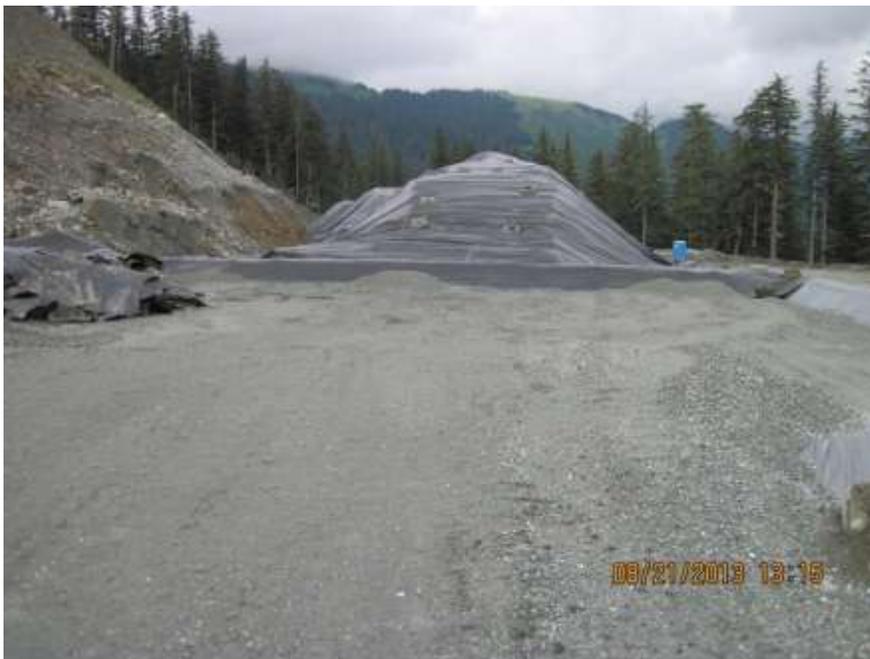
The containment cells for the temporary storage of GP are full and covered (photo 13). According to the approved ARD remediation plan, all of the GP in the temporary containment cells are scheduled to be disposed underground by encapsulation within paste tailings by the end of the third quarter of this year. Kevin stated that Coeur may miss this deadline by several weeks. He gave three reasons for the possible delay. First, the haul trucks that are to be used to move the GP underground need to be modified before they can operate underground. Second, there is presently not enough space available underground for permanent disposal of all the GP. Third, Coeur wants to temporarily store some of the GP underground, but they don't want to do this before they have the necessary approval. On August 26, DEC gave Coeur approval to temporarily store the GP underground.

Photo 13. The graphitic phyllite temporarily stored at Pit 7 is now covered.
