Field Monitoring Report -- Pebble Copper/Gold Exploration Project --

| Personnel: Jeanette Alas (ADF&G) | Inspection Date: July 23, 2013 |
| | APMA #: A136118 |

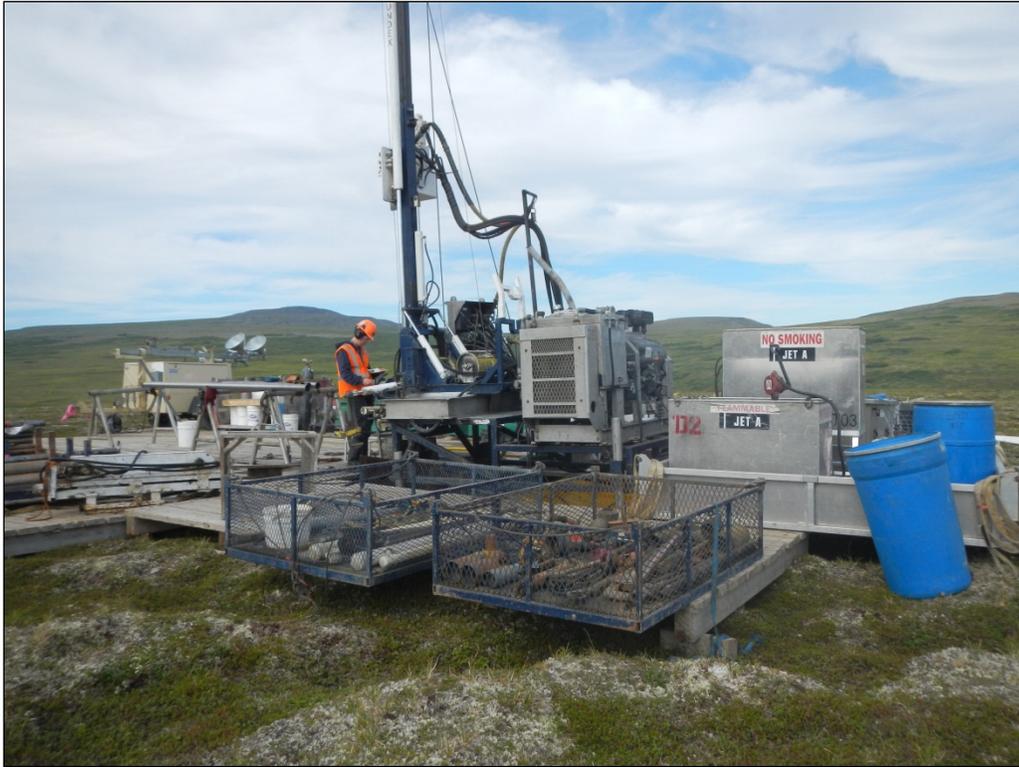
Photograph 1: Tundra mat and drill rig # 4 (GH 13-371).

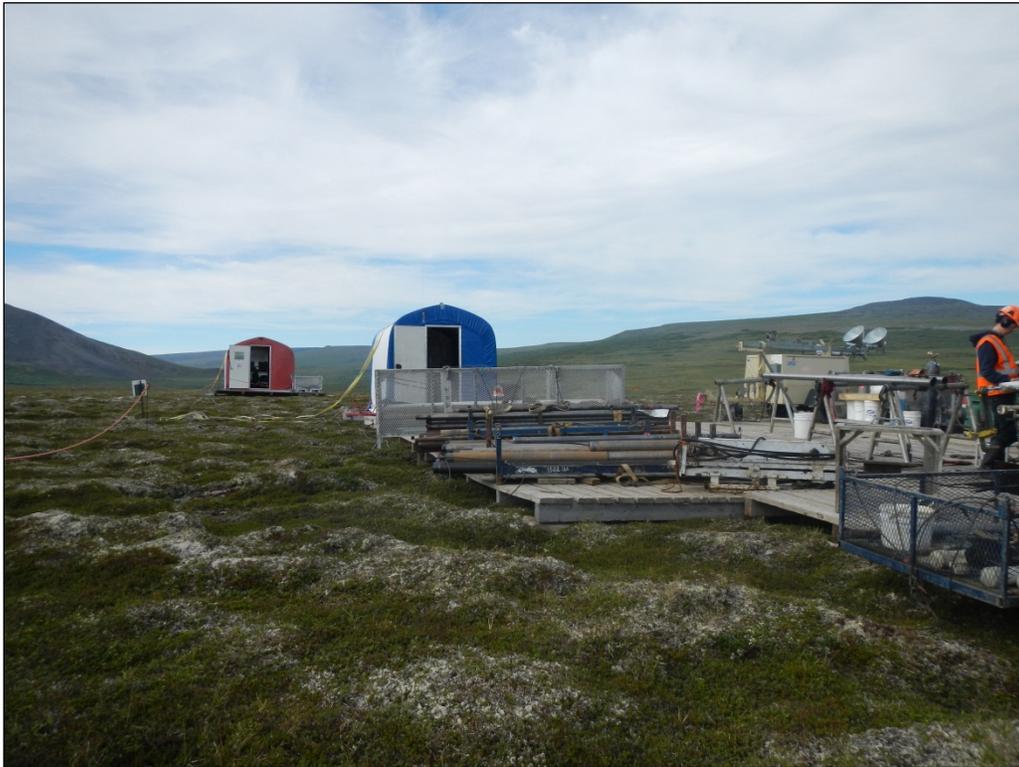
Photograph 2: Drill rig # 4 site; rig on right just out of view (GH 13-371).

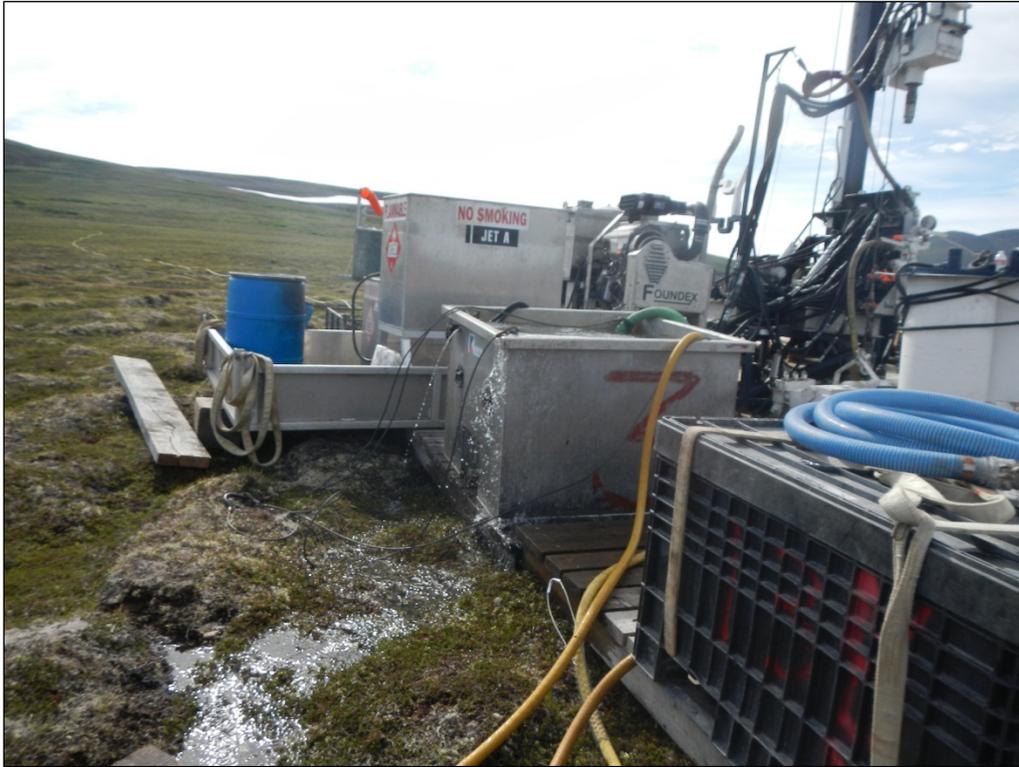
Photograph 3: Water over flowing the top of recirculation tank (GH 13-371).

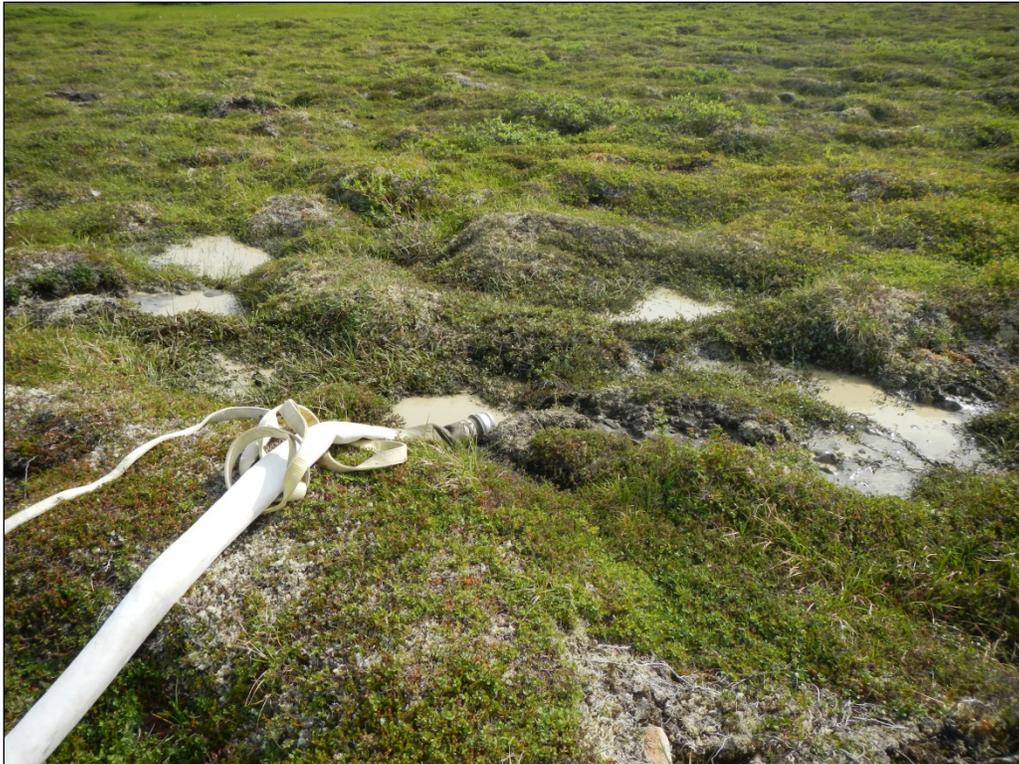
Photograph 4: Discharge hose location and conditions (GH 13-371).

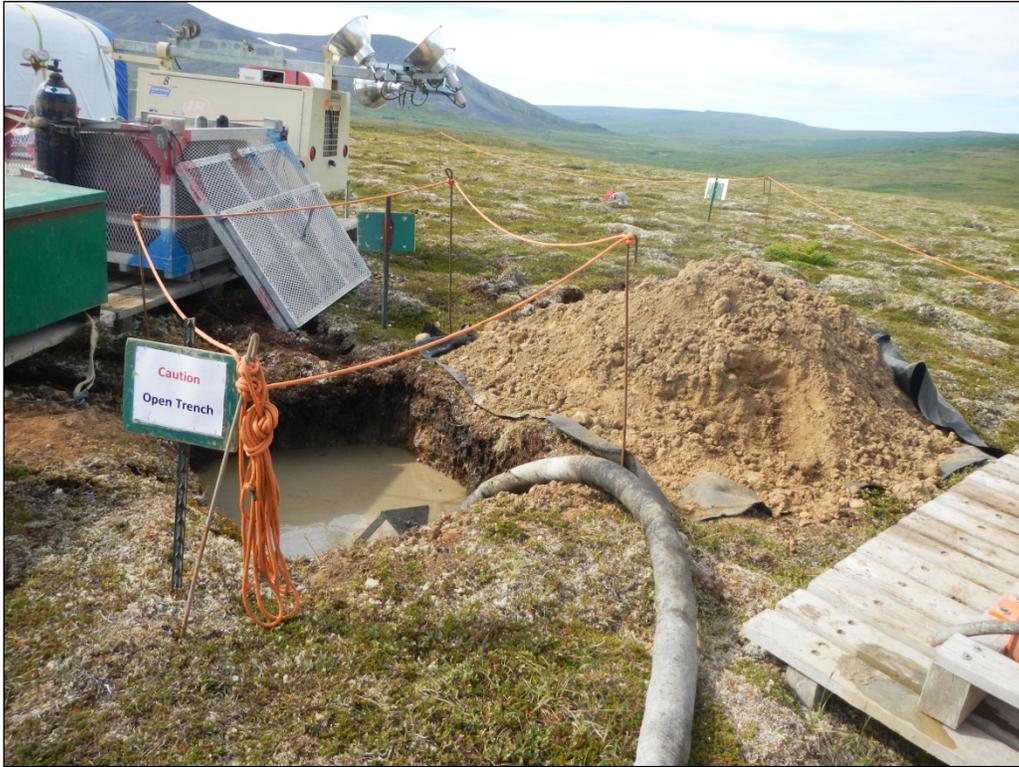
Photograph 5: Sump pit adjacent to rig and tundra mat (GH 13-371); topsoil pile on right.

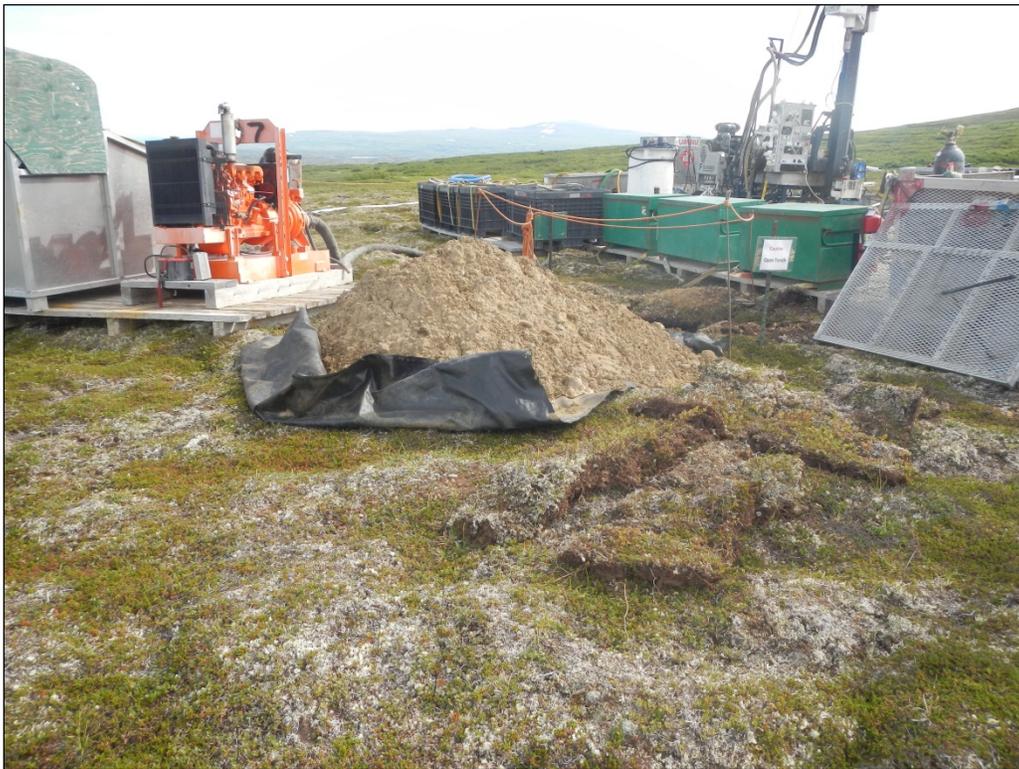
Photograph 6: Topsoil and tundra stockpile; sump pit adjacent to rig behind topsoil (GH 13-371).

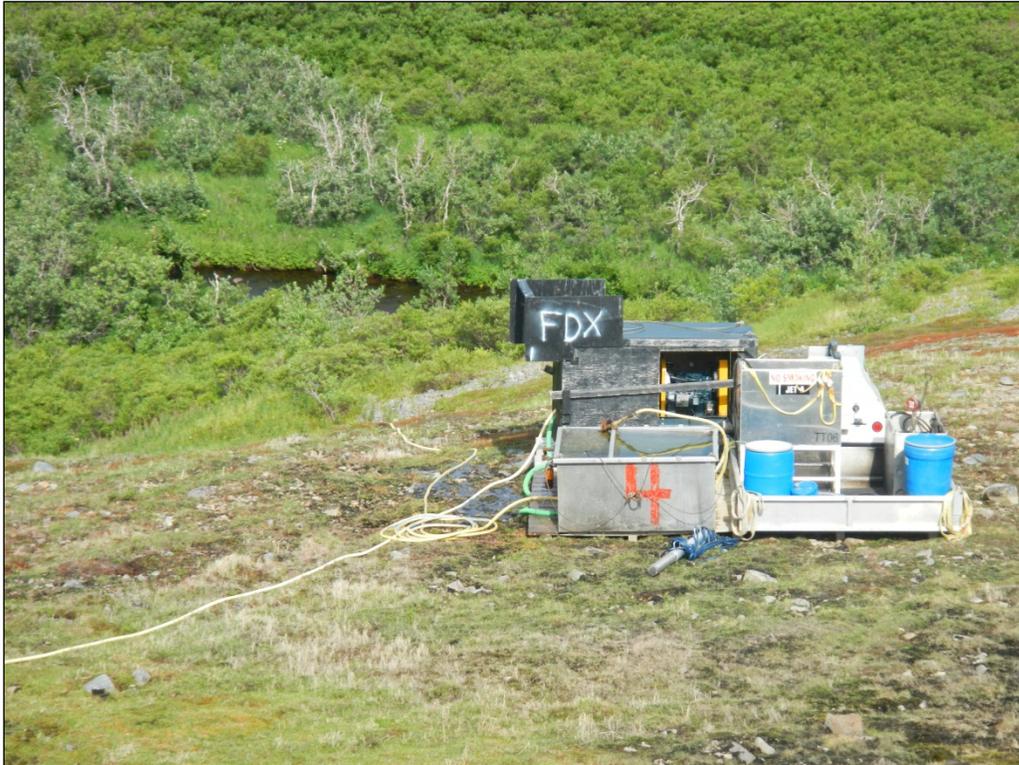
Photograph 7: Fuel and equipment for water intake; water source in background (GH 13-371).

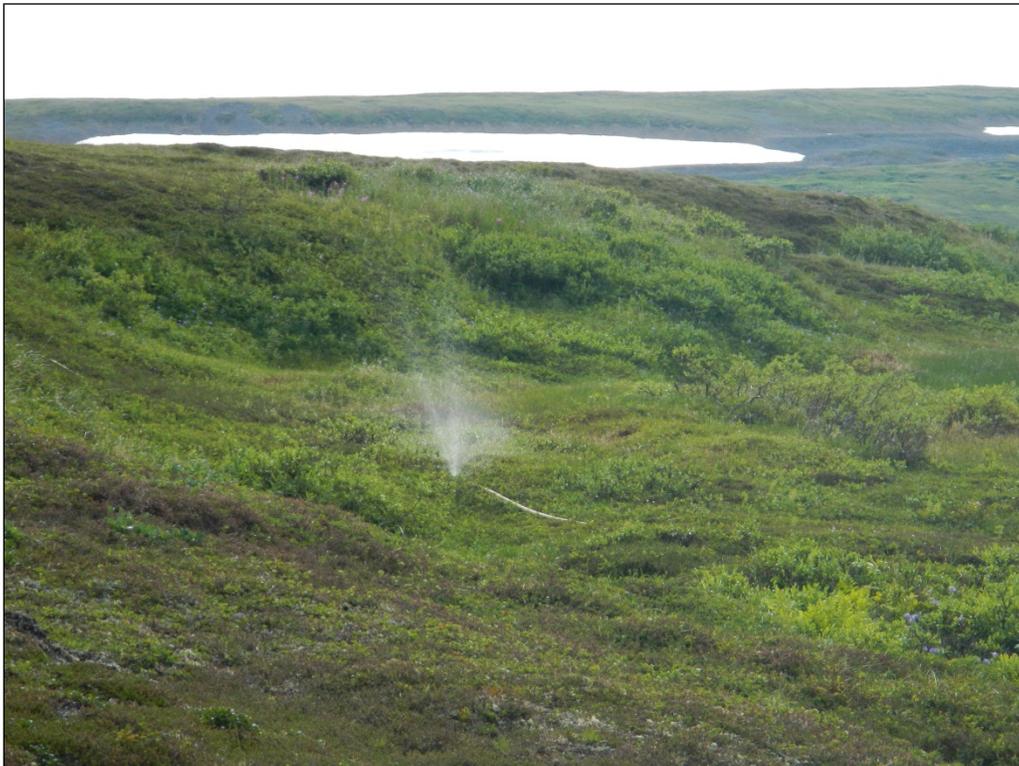
| <ul style="list-style-type: none"> ■ Comments: GH 13-371 - We could not walk to the water source due to standing water in the way, but we did walk to the fuel/generator location source (Photograph 7). There was a hole in the water supply hose between the rig location and the water supply fuel/generator location (see Photograph 8). J. Norberg said he would notify the crew to repair the hose to prevent wasting water. We flew over the water intake in the helicopter (Photograph 9). I could see a sign marking the intake source and that the pump was submerged (barely visible behind the sign in Photograph 9); the structure appeared clear of debris, but I could not be certain from this distance. ■ DDH 09462 – This site was originally reclaimed after artesian flow was stopped on June 11, 2012. A bear disturbed parts of this site sometime after snowmelt this year, and the site was reclaimed again on July 10, 2013. There is some iron (red) staining on the tundra adjacent to the revegetated sump pits. J. Norberg said he will bring the reclamation crew back to work on this site. | |

Photograph 8: Hole in water supply hose (GH 13-371).

| <ul style="list-style-type: none"> ■ Recommendations: GH 13-371 - Repair hole in supply hose. ■ DDH 09462 – Remove/minimize the iron staining on tundra. | |

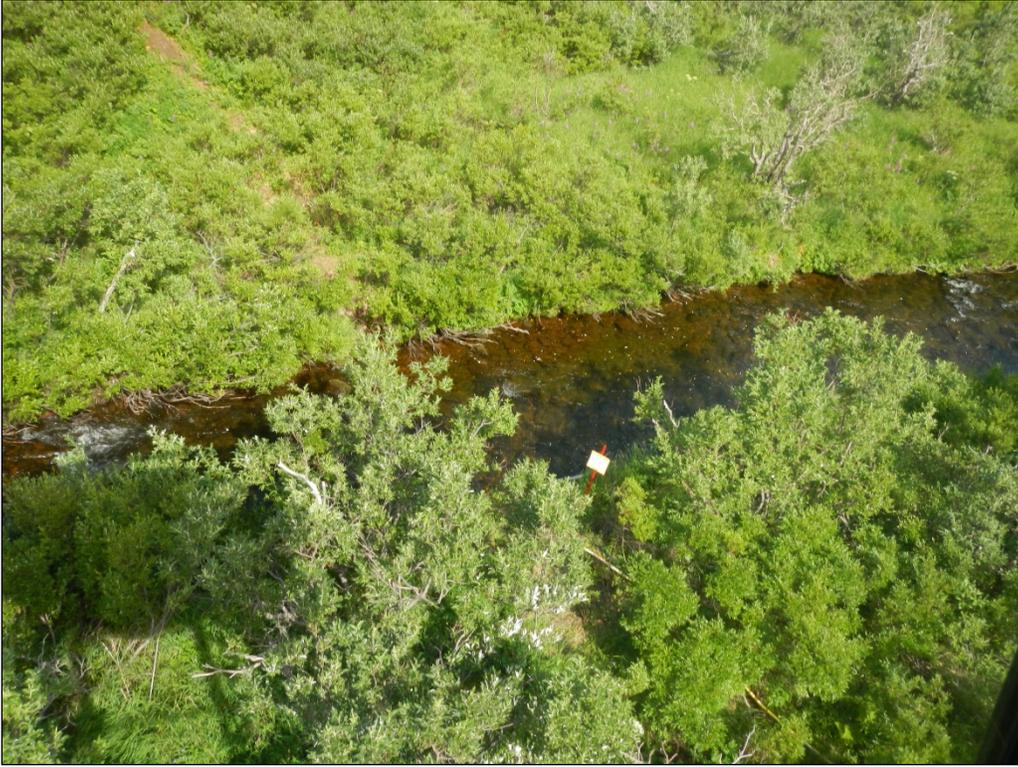
Photograph 9: Water source with signage and intake structure (GH 13-371).

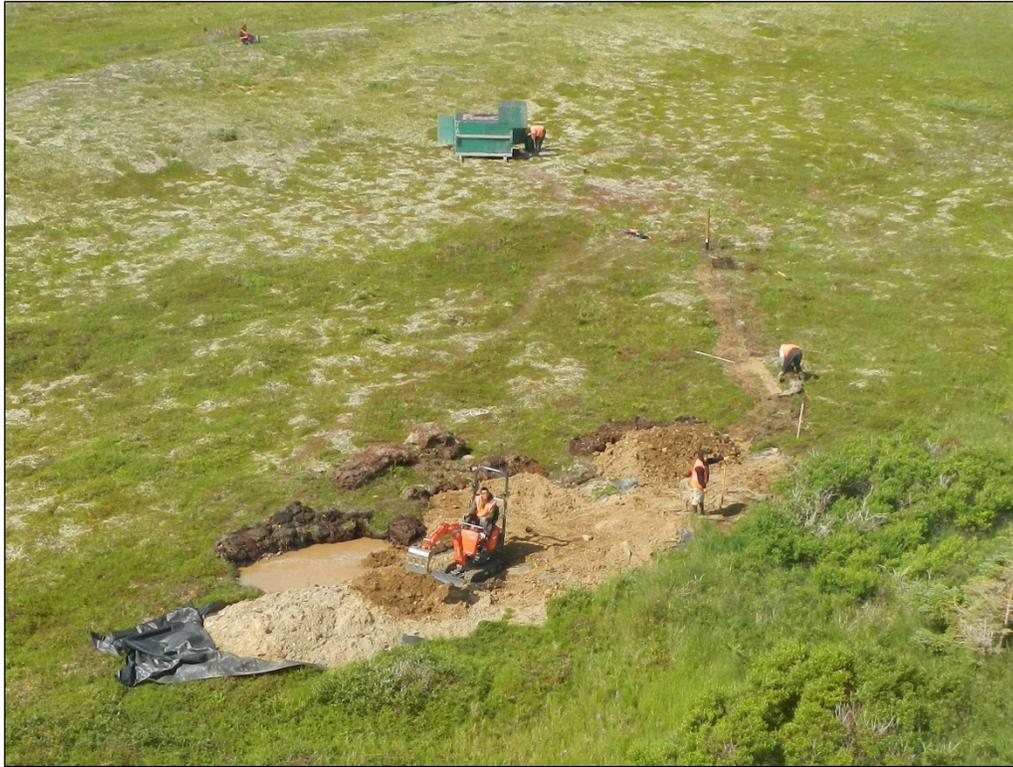
| ■ Sump pit filled in: In the process of being filled (see Photographs 10 and 11). | |
| ■ Water discharge trench filled in: Trench was in the process of being filled (see Photographs 10 and 11). | |
| ■ Site revegetated: Trench was in the process of being revegetated (see Photographs 10 and 11). | |

Photograph 10: Reclamation work on DDH 12556 (aerial view).

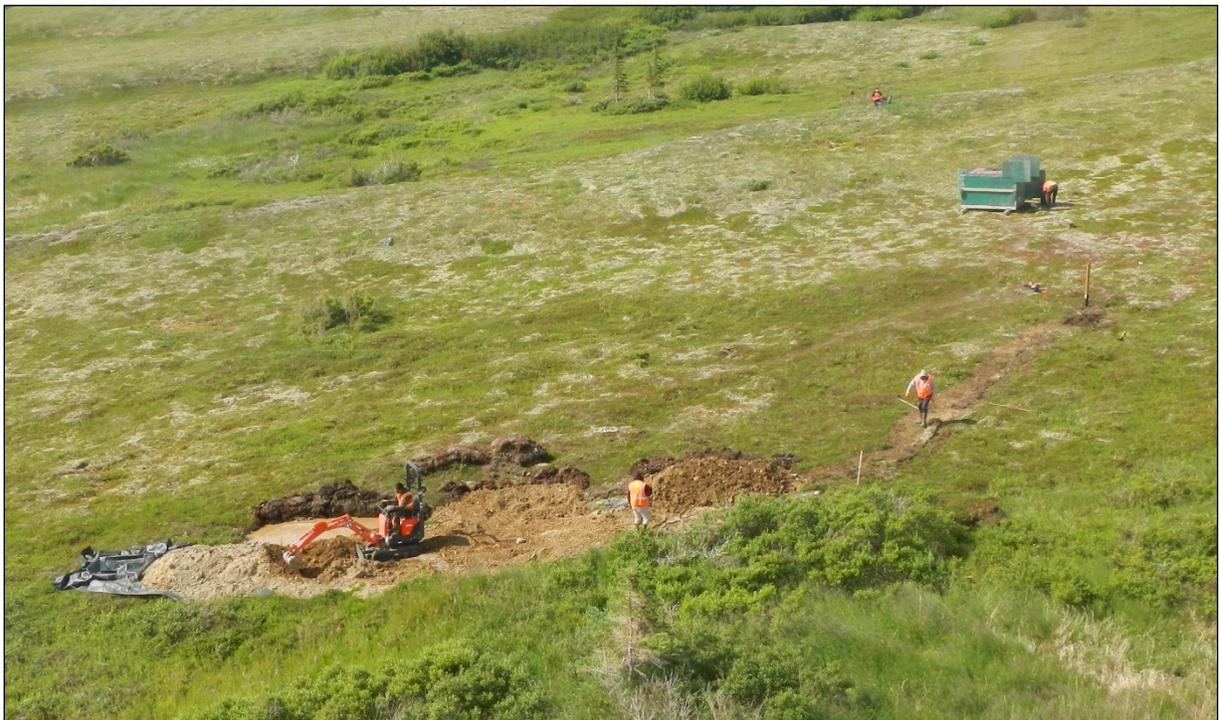
| ■ Comments/General impression: We flew over reclamation site DDH 12556 while it was currently being reclaimed, but did not stop for an inspection due to time constraints and helicopter logistics. See Photographs 10 and 11 for documentation of reclamation activity. | |

Photograph 11: Overview of reclamation work on DDH 12556 (aerial view).

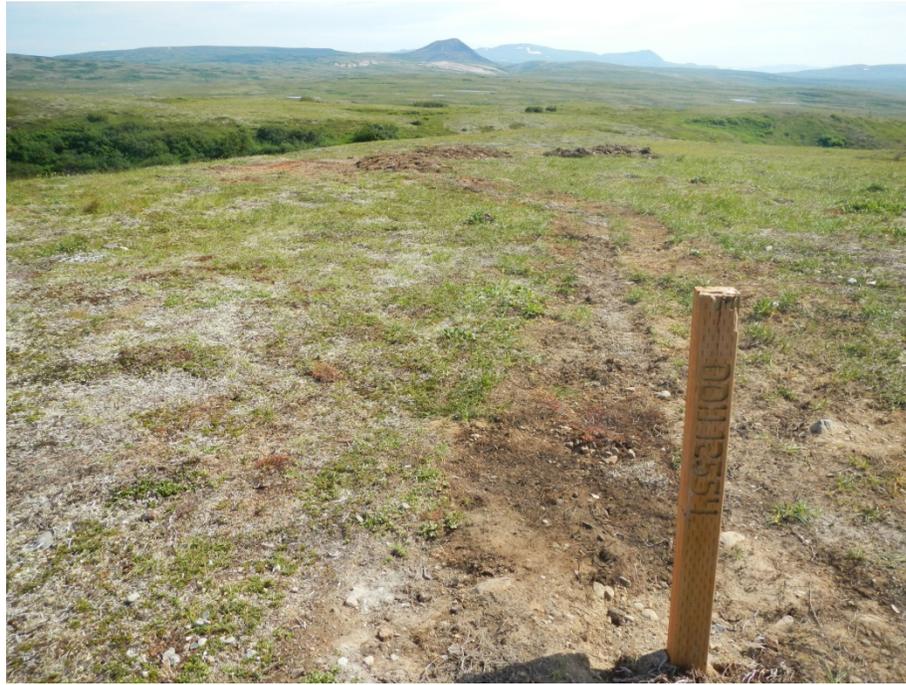
| ■ Standing pipe: Monument marker only (see Photograph 12). | |

Photograph 12: Monument marker for DDH 12554 with revegetated trench and sump pits in background.

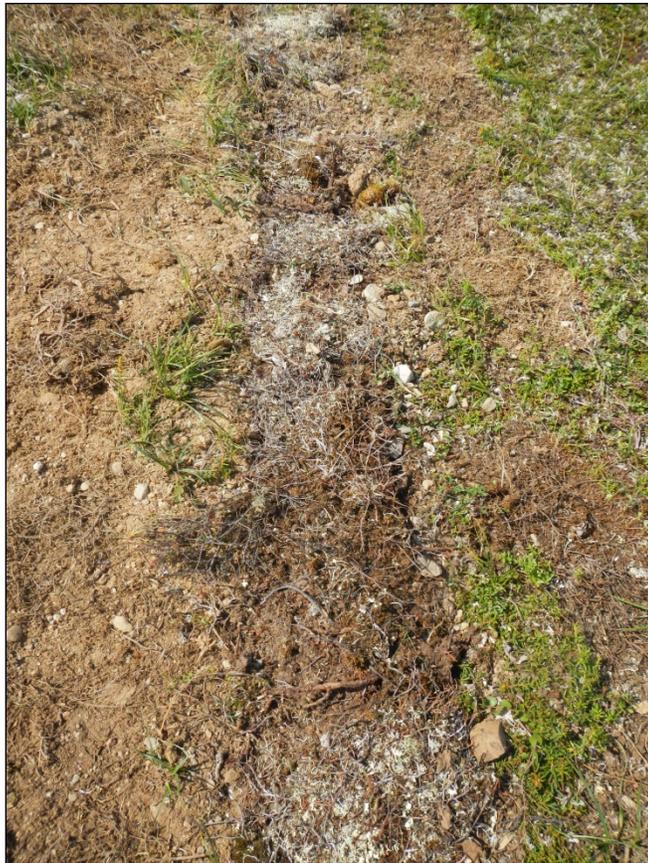
| ■ Water discharge trench filled in: Yes (see Photograph 13) | |

Photograph 13: Refilled and revegetated trench (DDH 12554).

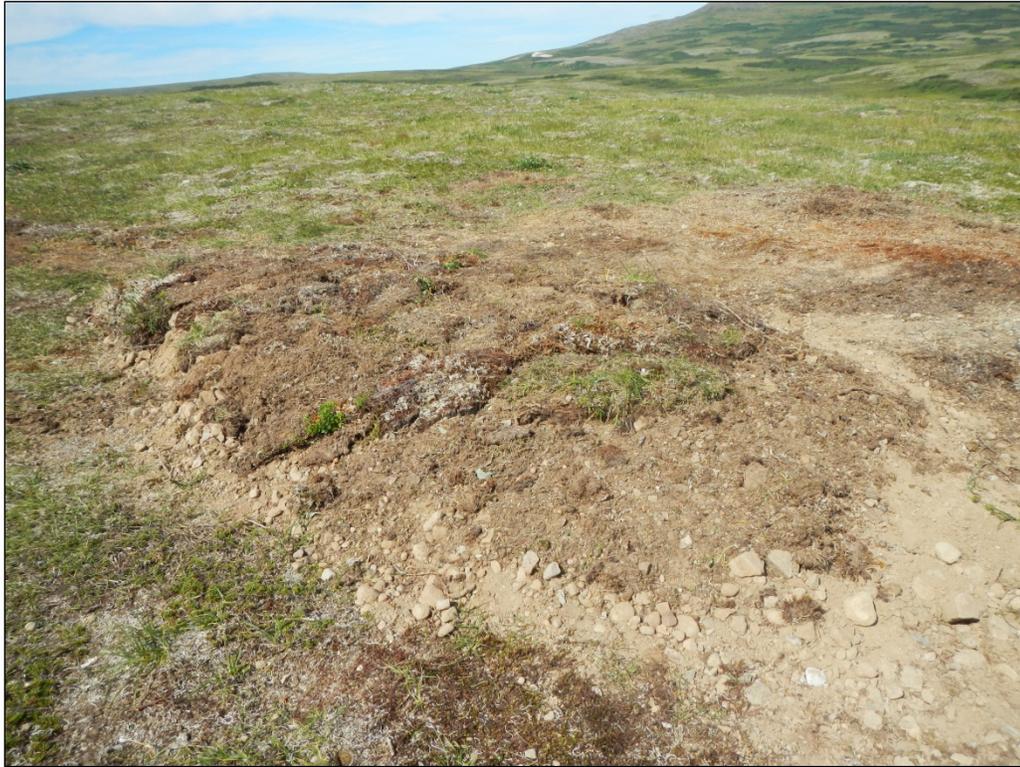
| ■ Site revegetated: Yes (Photographs 14 and 15) | |

Photograph 14: Refilled and revegetated sump pit (DDH 12554).

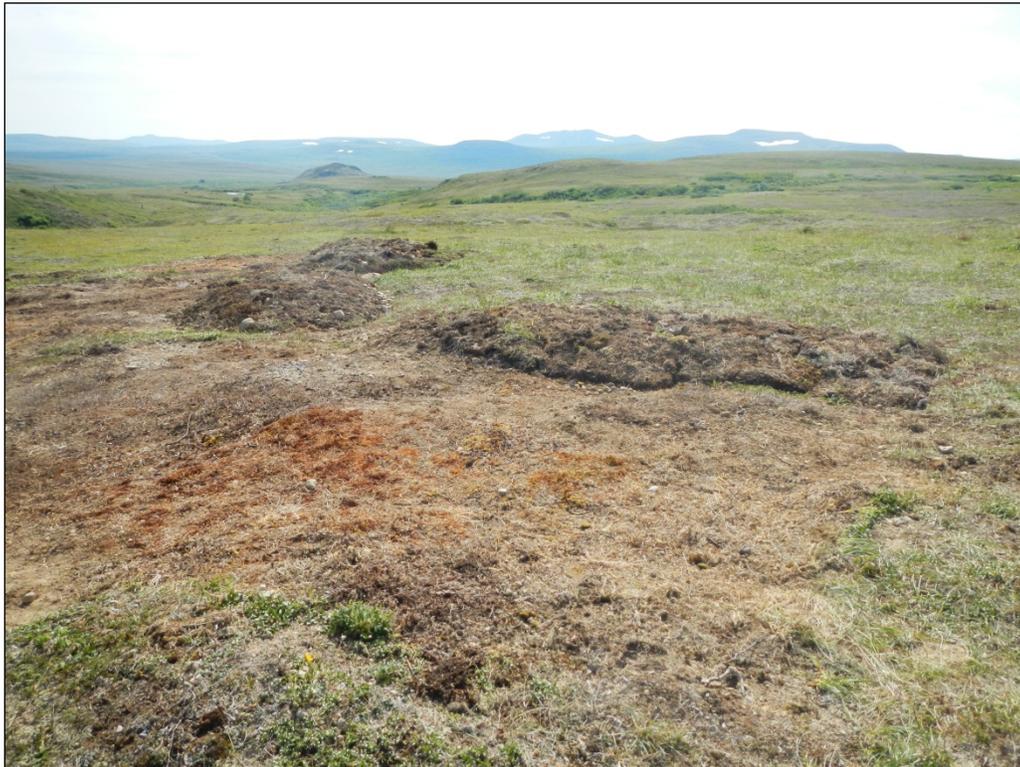
| ■ Comments/General impression: Reclamation work for this site was completed the previous day. Revegetation of the trench and sump pits looked fine; some of the tundra was green and looked to be doing well. The tundra adjacent to the sump pits was brown where the tarps and topsoil/tundra mats had been placed during drilling (see Photograph 15). The sump pits are mounded to allow for subsidence to occur. | |

Photograph 15: Refilled and revegetated sump pits for DDH 12554. Previous location of tarp and topsoil/tundra mat in foreground (brown tundra).

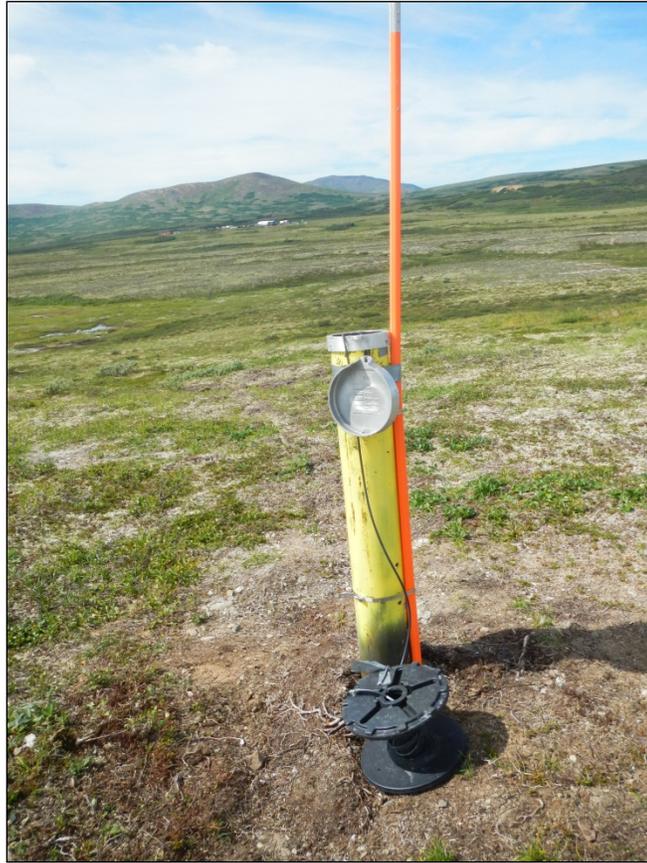
Photograph 16: Standing pipe with filled trench in background (GH 12-322S). Black wire is for transducer currently being used for pump test.

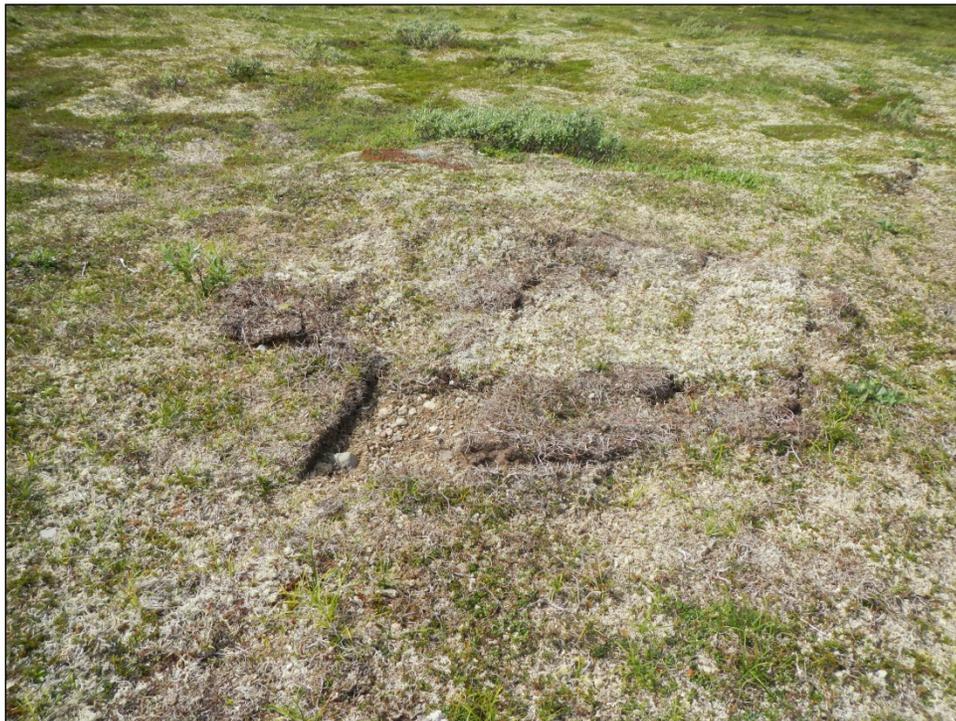
Photograph 17: Revegetated sump pit (GH 12-322S).

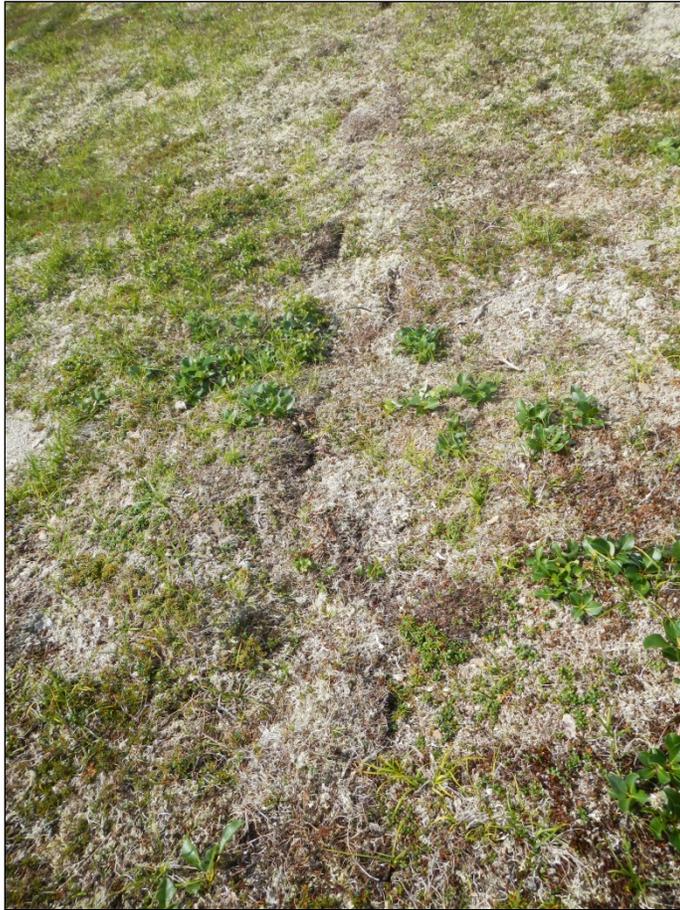
Photograph 18: Revegetated trench (GH 12-322S).

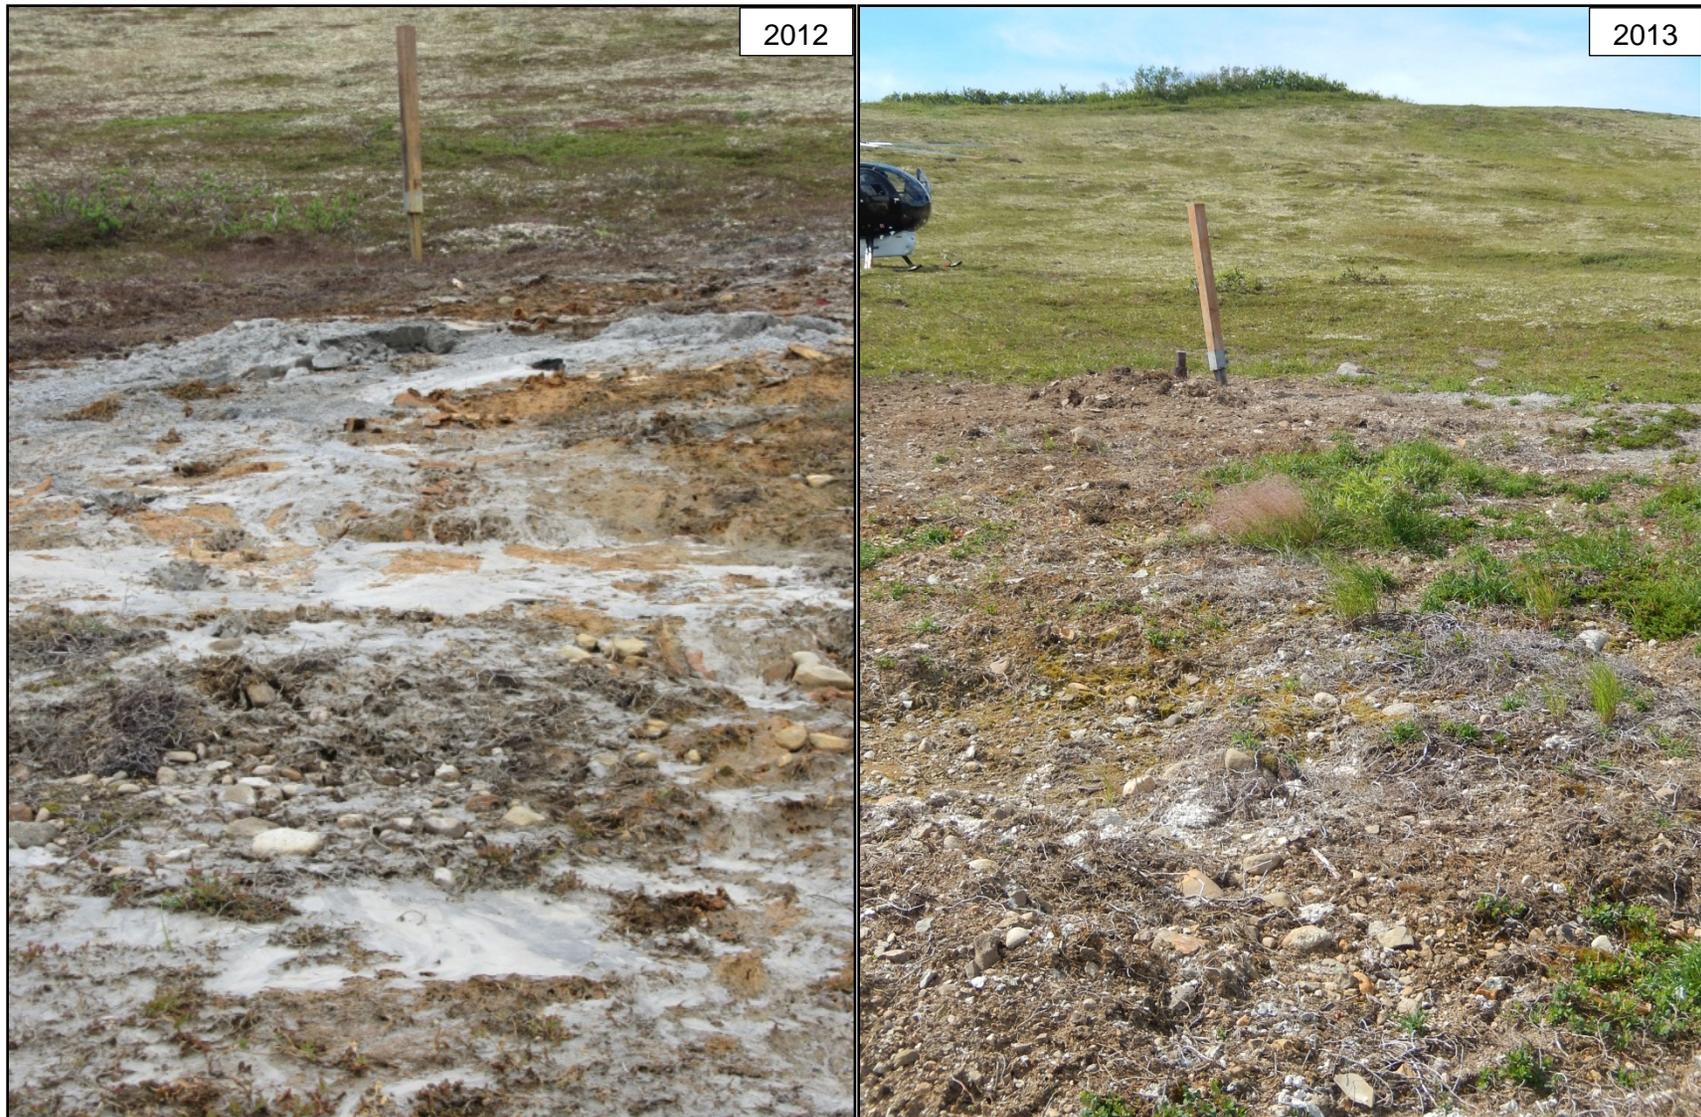
| ■ Any spills or staining: Yes. Iron red staining has been documented in previous site visits conducted on October 20, 2011 and June 19, 2012. Photograph 19 shows a comparison between site visits conducted on June 19, 2012 and July 23, 2013. Artesian flow stopped on June 11, 2012 with the assistance of a grout specialist from Bandimere Grout Consulting Services. No artesian flow was observed during the July 23, 2013 site visit. According to J. Norberg, additional work was completed at this site on July 10, 2013 after a bear had disturbed areas following snowmelt this year (Photograph 20). Iron (red) staining on the tundra was visible near the refilled sump pits during the July 23, 2013 site visit (see Photographs 21 through 23). The sump pits are mounded and revegetated. Although some of the tundra was alive, most of it was not doing well (see Photographs 21 and 22). J. Norberg stated that he will bring the reclamation crew back to work on this site. | |

Photograph 19. Photographs taken on June 19, 2012 (left) and July 23, 2013 (right) showing remnants of discharged fluids and iron staining from previous artesian upwelling (DDH 09462).

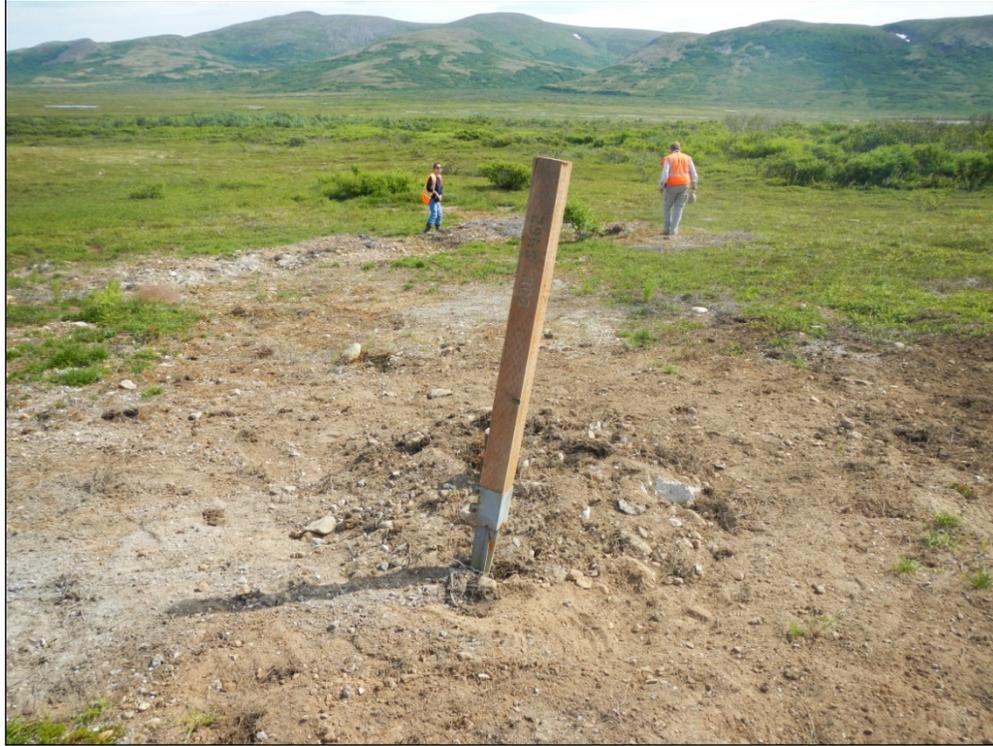
| ■ Standing pipe: yes with monument marker (see Photographs 19 and 20) | |

Photograph 20: Monument marker in foreground with refilled sump pits in background (DDH 09462). Recent work after bear activity in foreground near monument marker.

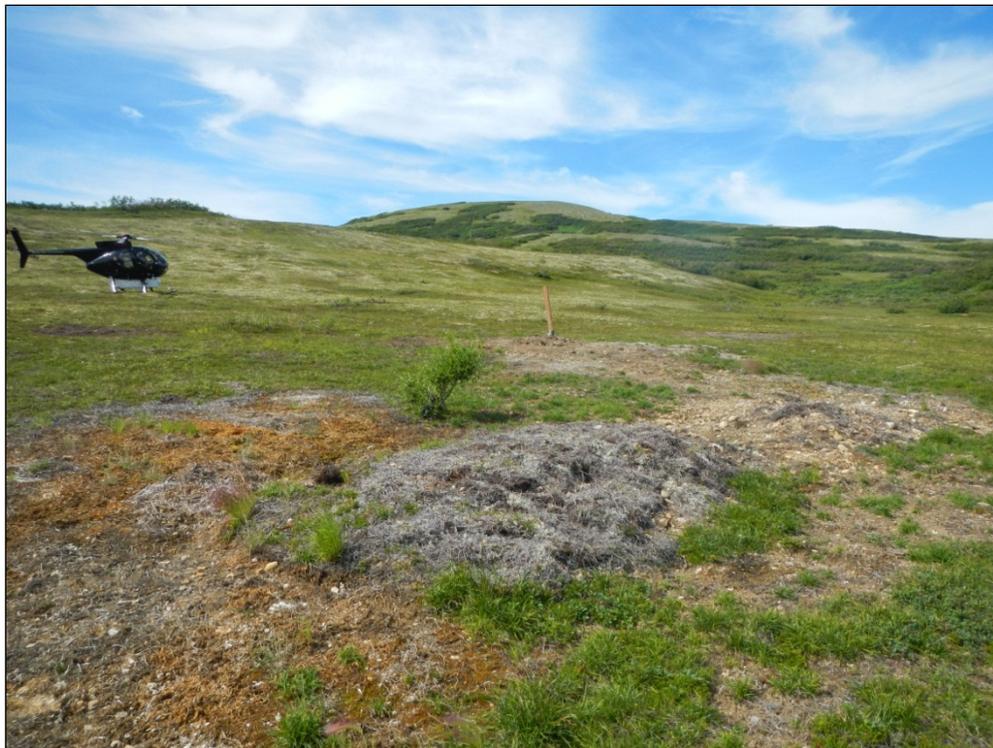
Photograph 21: Refilled and revegetated sump pits (DDH 09462). Some red staining noticeable left of sump pit.

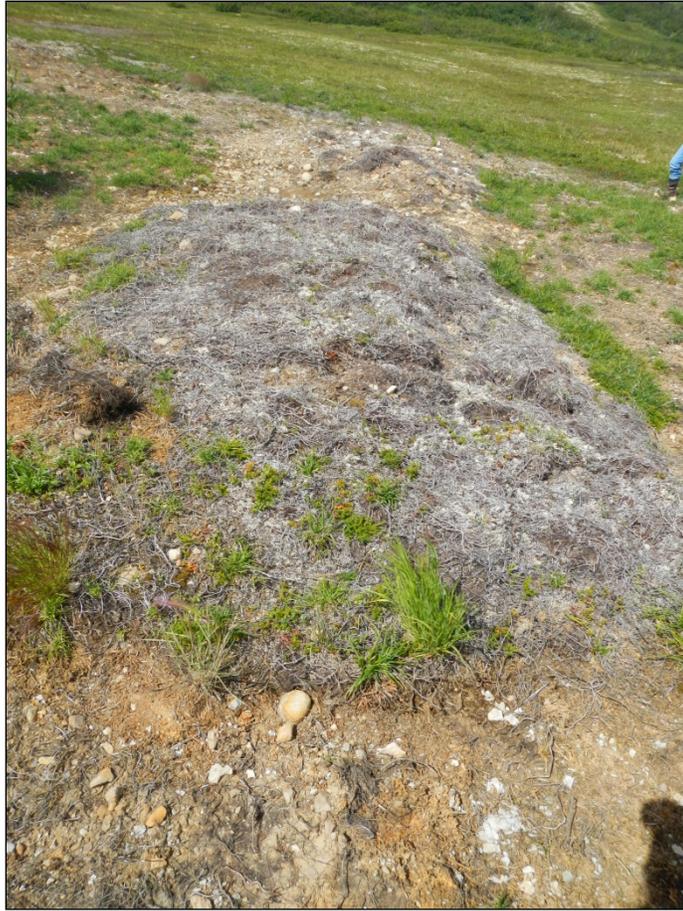
Photograph 22: Tundra on sump pit rejuvenating slowly (DDH 09462).

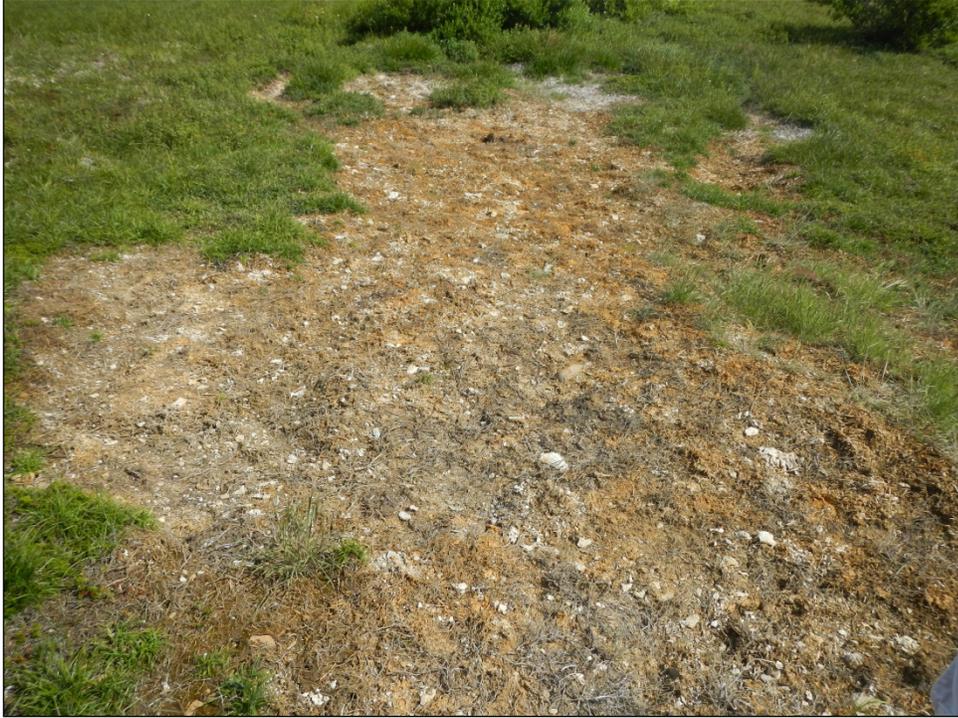
Photograph 23: Iron (red) staining adjacent to filled sump pit (DDH 09462).

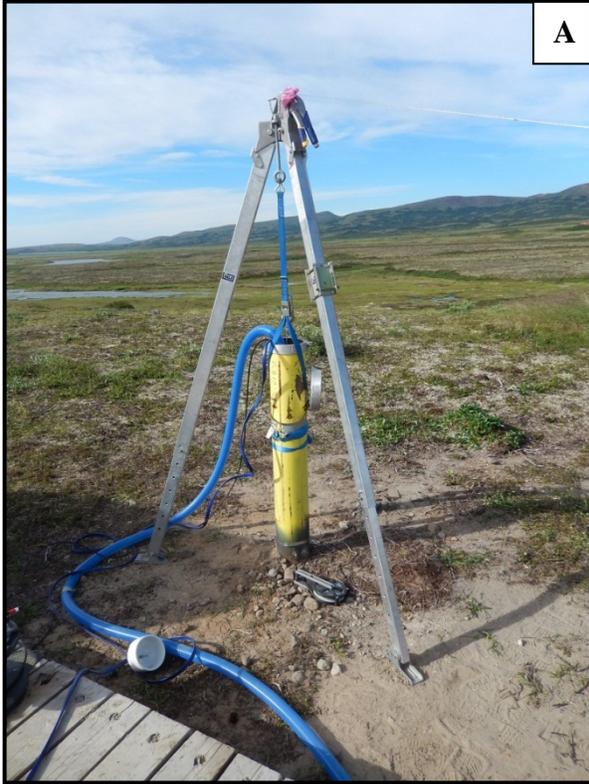
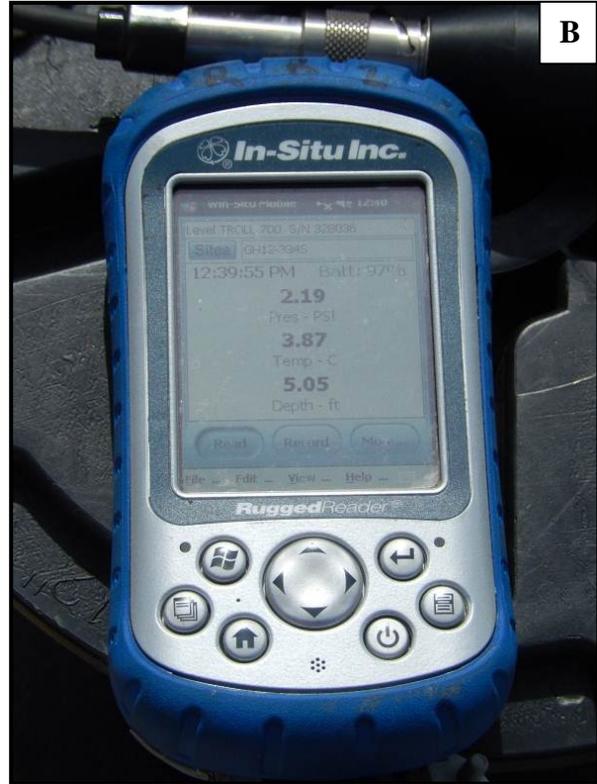
Photograph 24. Pumping well GH12-334S (A). A data reader was used to continuously monitor water levels in the pumping well to avoid drawing air in the pump (B).

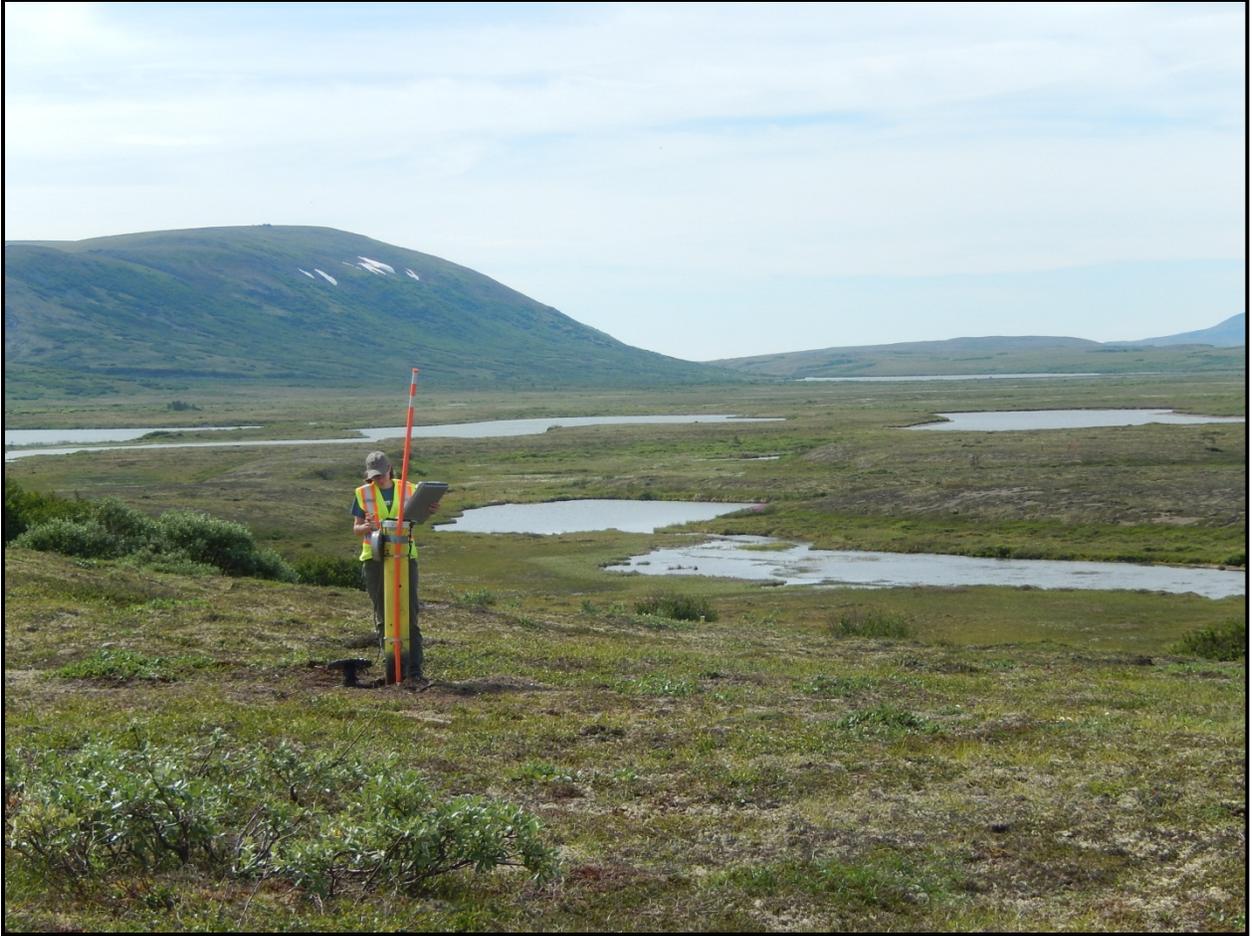
Photograph 25. SLR staff conducting manual verification of depth to water on monitoring well GH12-322S.

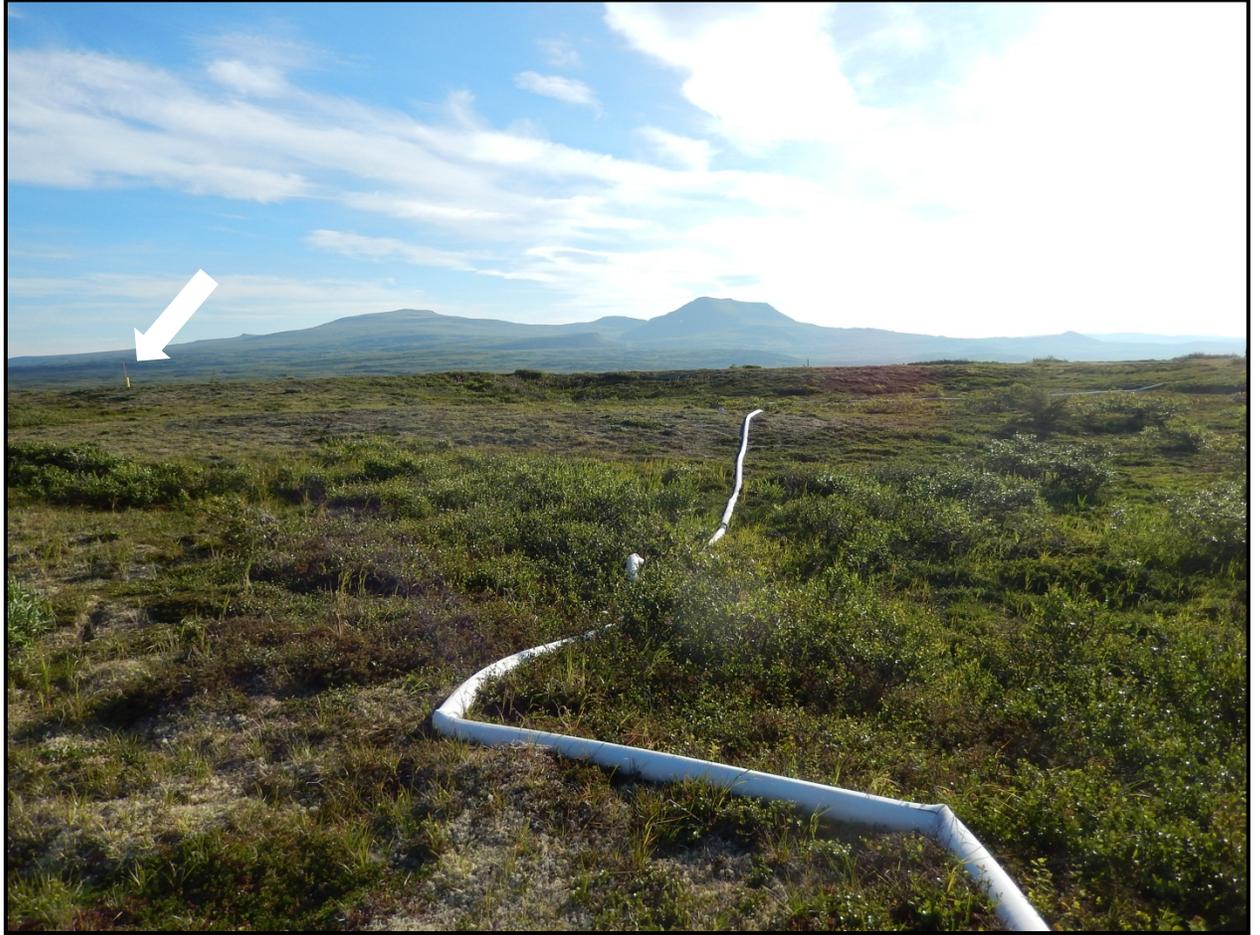
Photograph 26. Four-inch diameter discharge hose and monitoring well GH11-265S (arrow) shown in background.
