Field Monitoring Report -- Pebble Copper/Gold Exploration Project --

| Personnel: Jeanette Alas (ADF&G) | Inspection Date: July 23, 2013 |
| | APMA #: A136118 |

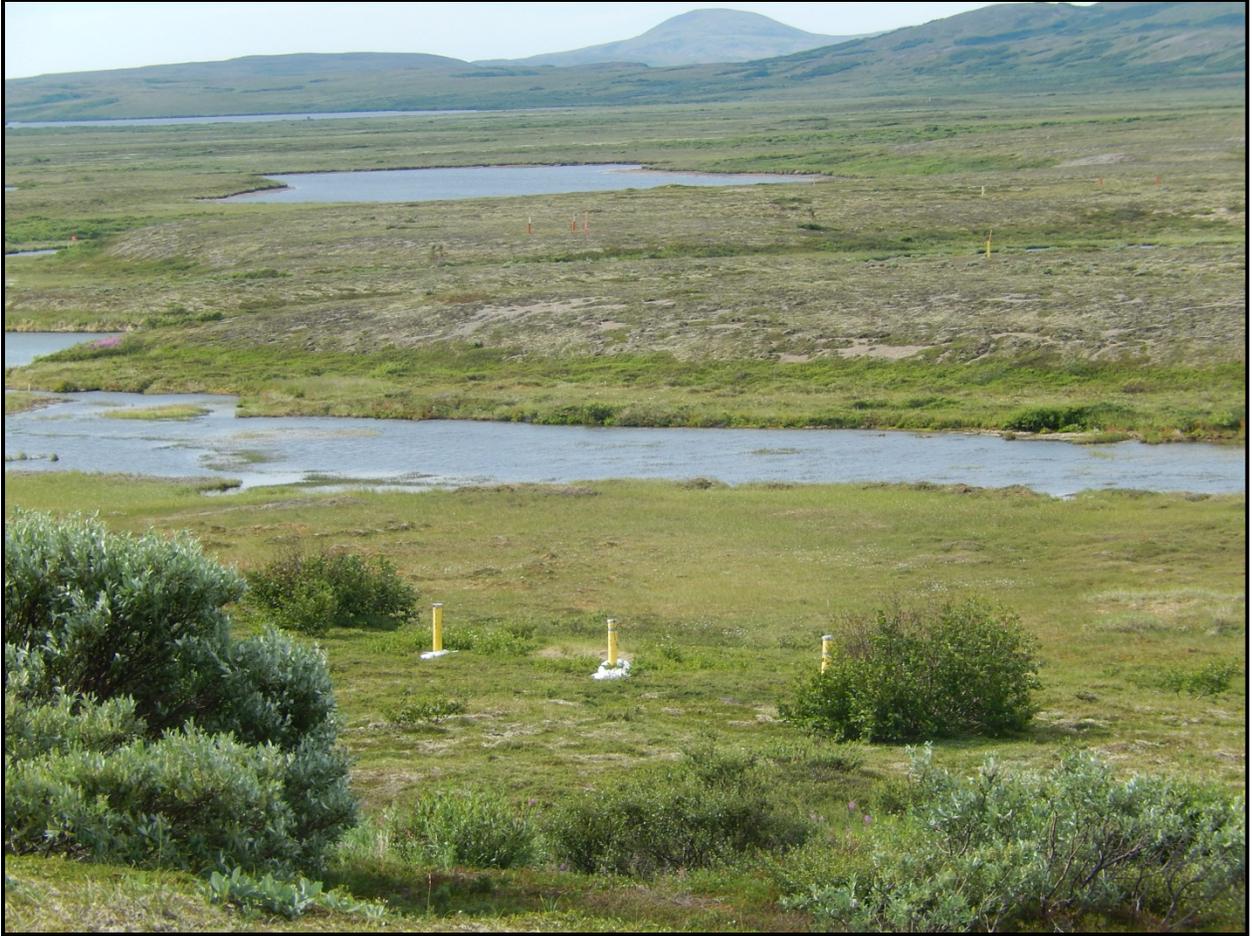
Photograph 27. Nested observation wells P-05-36M, P-05-36D and P-05-36S. P-05-36D was instrumented with a vented pressure transducer. P-05-36S was instrumented with a non-vented vibrating wire and P05-36M was manually monitored using a water level meter.

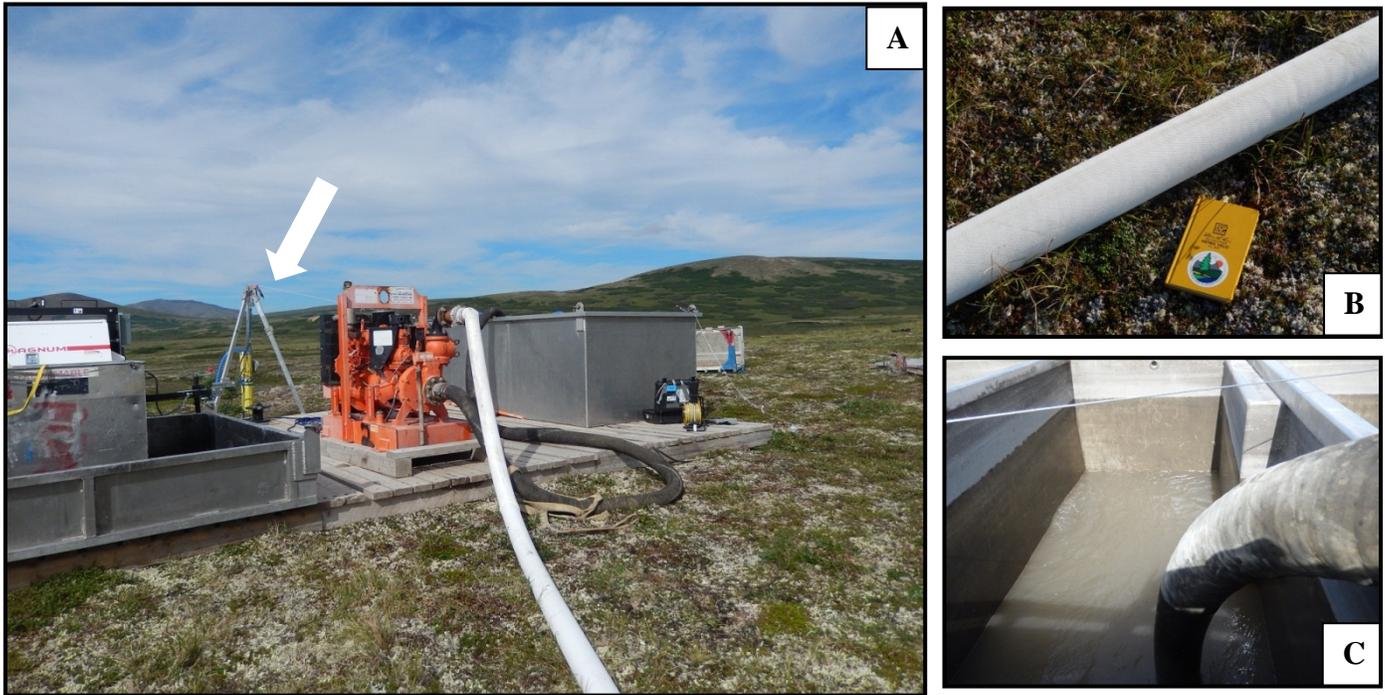
Photograph 28. Storage tank for capturing discharge from pumping well and high capacity pump for discharging water to uplands through hose. Arrow points to pumping well in background (A). White hose (4-inch diameter) with book for scale (B). The entire length of the discharge hose was walked and no leaks were detected. Storage tank filling with groundwater from pumping well (C).

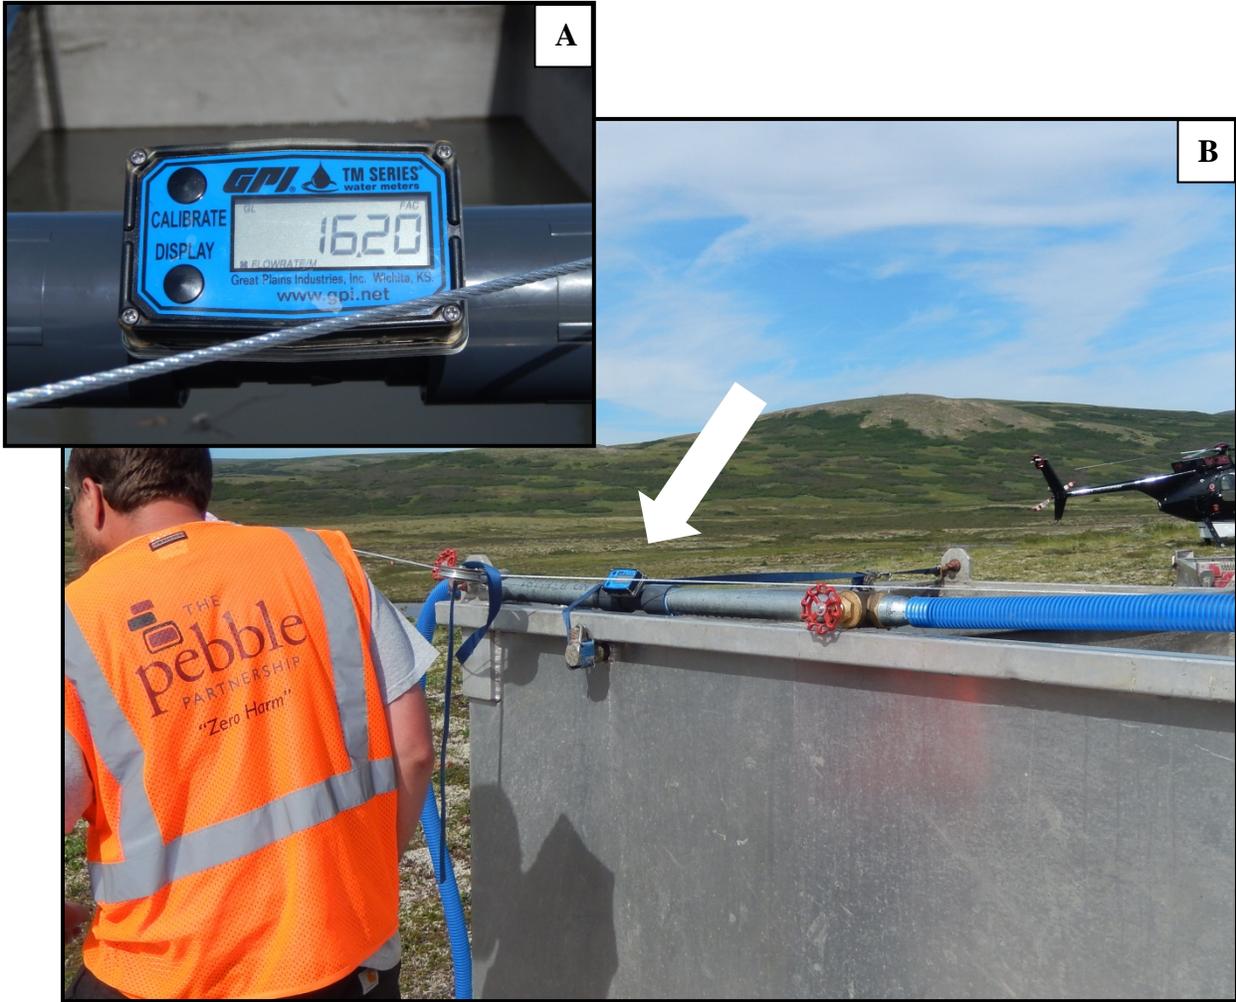
Photograph 29. Close-up of flowmeter (A). Arrow points to in-line flowmeter (B).

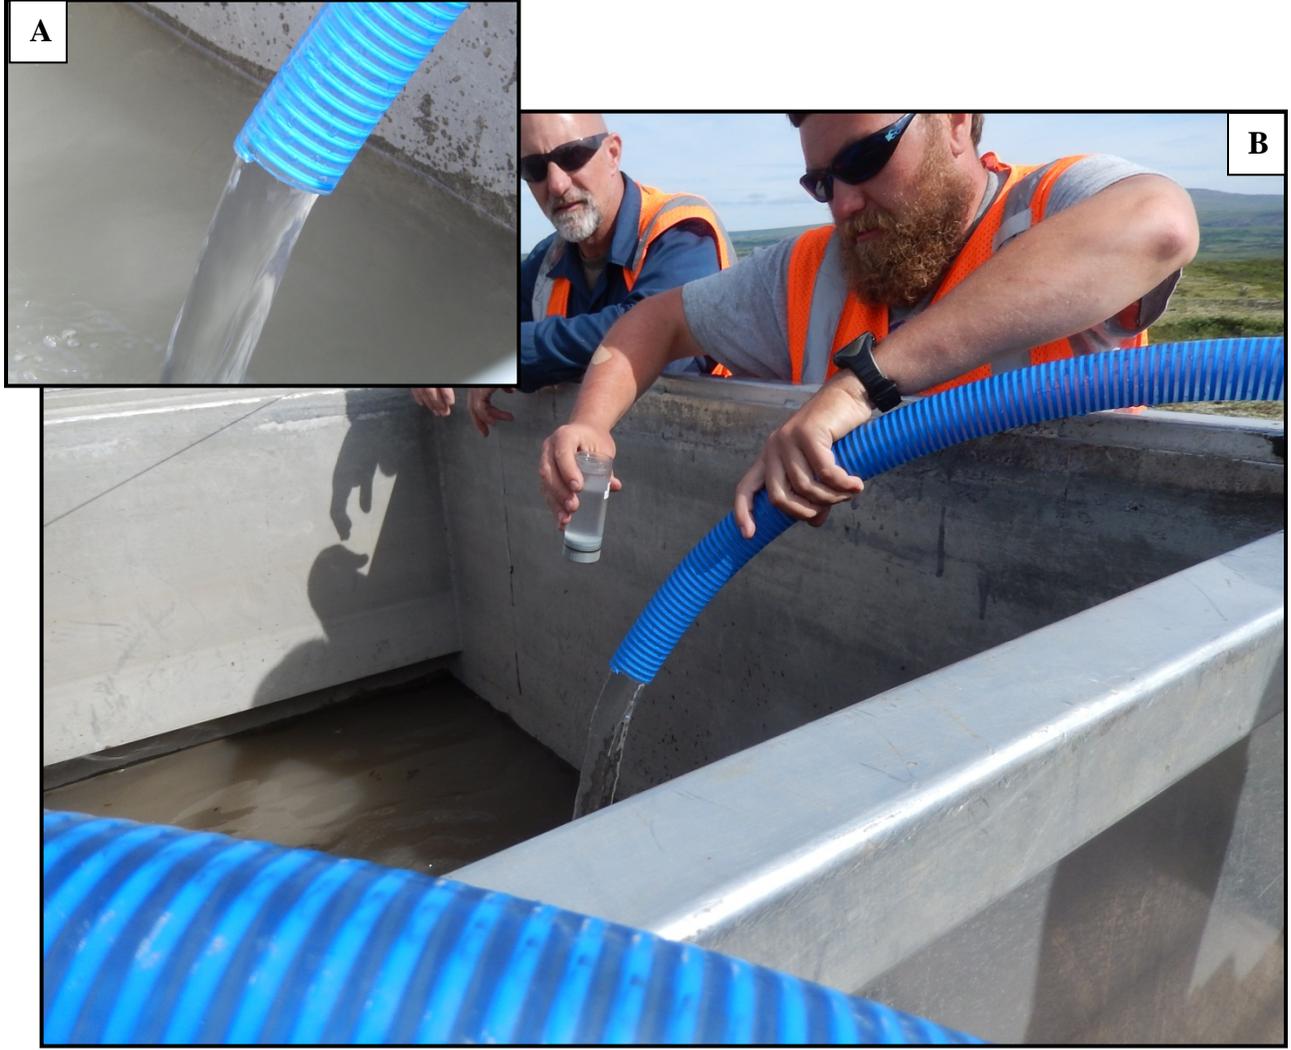
Photograph 30. Close-up of discharge from pumping well (A). SLR staff sampling discharge from pumping well (B). A YSI meter was used to measure water quality.

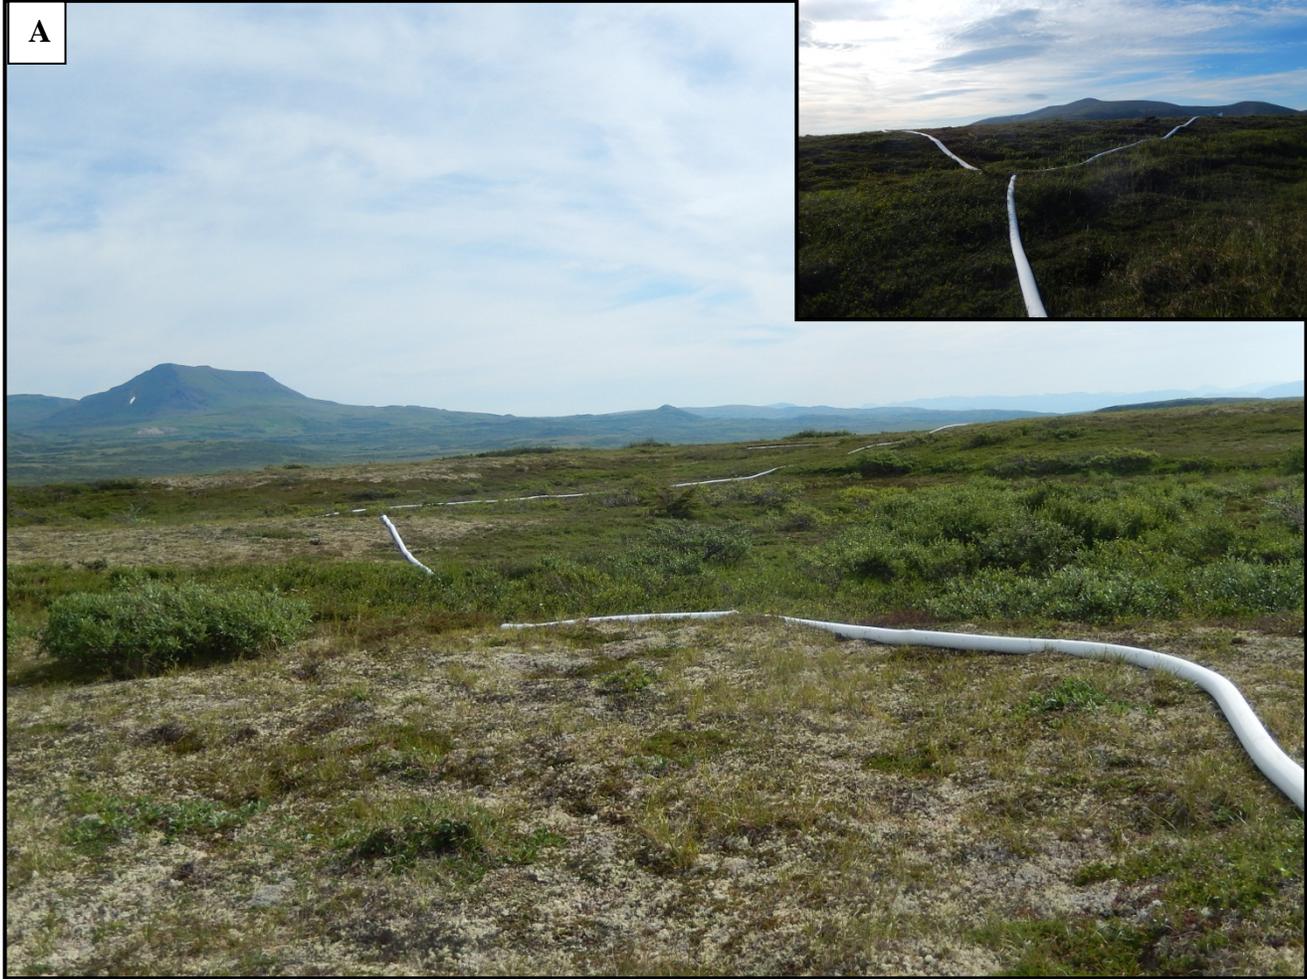
Photograph 31. Discharge hose (A) with junction (B).

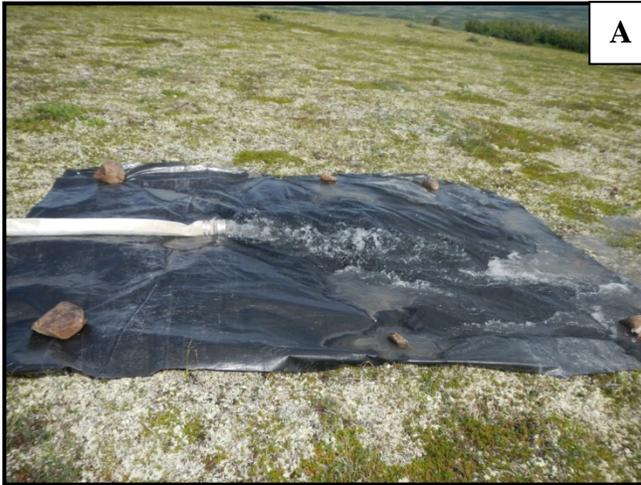
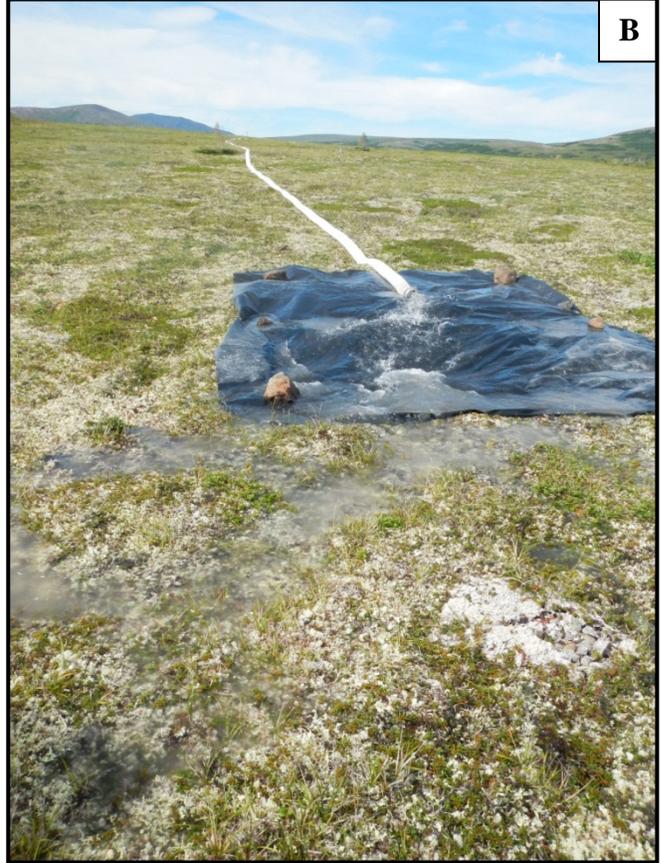
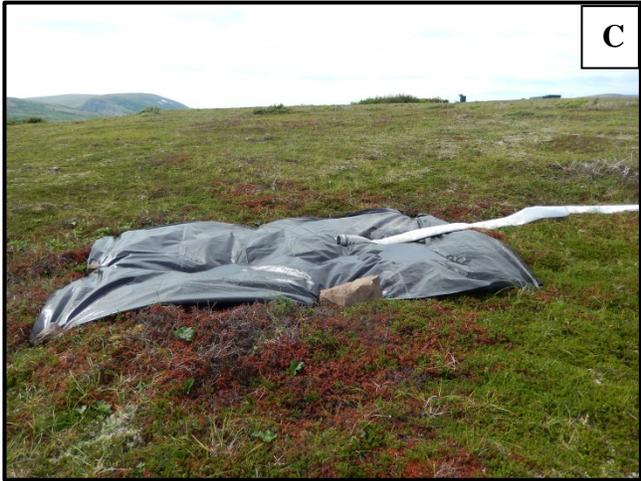
Photograph 32. Discharge onto uplands. Note the presence of the tarps to mitigate erosion and disperse discharge. Tarps were used on both discharge points (A and C). The junction with the highest discharge is documented in photographs A and B.
