Field Inspection Report -Pebble Copper/Gold Exploration Project-

Personnel: Patricia Bettis (ADNR/MLW) and
David Johnson (DEC)
APMA No.: A076118

Inspection Date: October 4, 2007

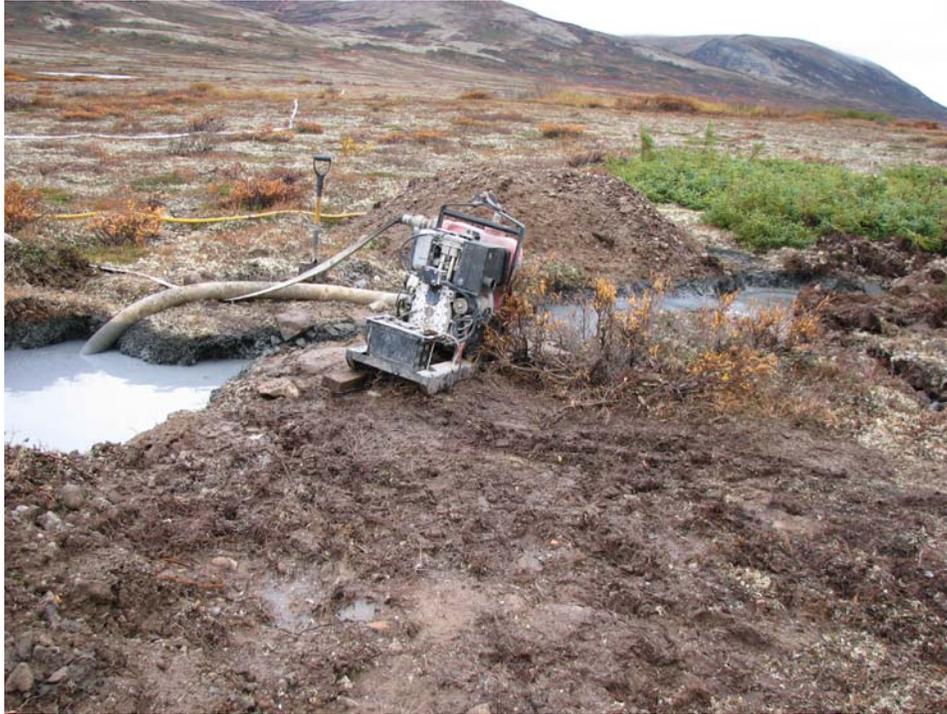
- Distance from water body: **125 ft.**
- Location of fuel storage: **On pad.**
- Sorbent Pads Present or Not: **Yes.**
- Tundra Mat: **Yes.**
- Pipe off Tundra: **Yes.**
- Litter: **None.**
- Spill Indications: **None observed.**
- Activity: **Drilling.**
- Trash Containment: **Yes.**
- Sanitary Facilities: **Yes.**
- Any spills or staining, or 'none' for that matter: **None.**
- General impression of site: **Clean. No disturbance to tundra other than sump pit and trench.**

- Location: **Next to rig.**
- Discharge trench: **Yes. Approx. 6 inches deep and 10 inches wide.**
- Dimension pit: **Approx. 6 feet in depth, 2 to 5 feet in width.**
- In use: **Yes.**
- Level of water in pit: **High.**

Photograph No. 1: Drill Site No.7384 trench and sump pit.

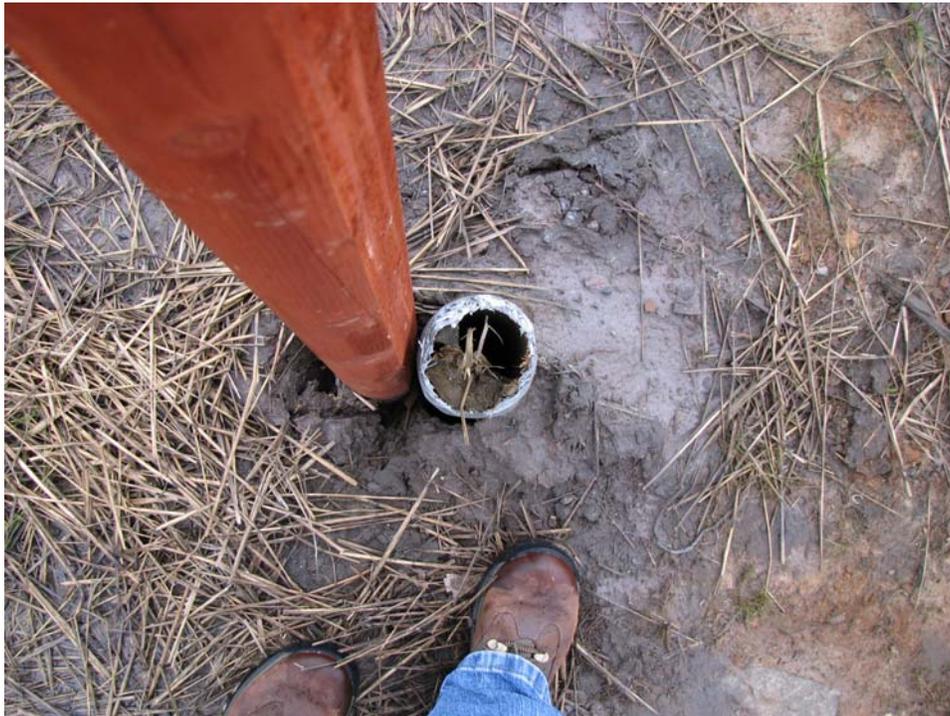
Standing Pipe: **Yes.**

Photograph No. 2: Drill Site 7359 with standing pipe left.

Action Needed: Upper three feet of well casing should be removed to eliminate potential hazard threat.

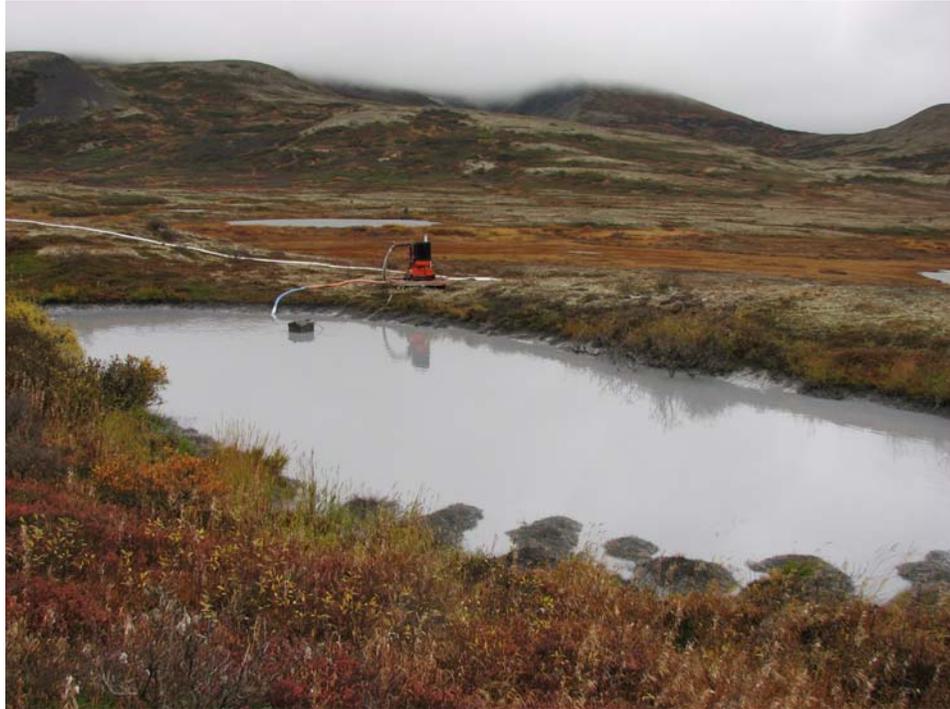
Photograph No. 3: Secondary sump pit (natural hallow) near Drill Site No. 7369.

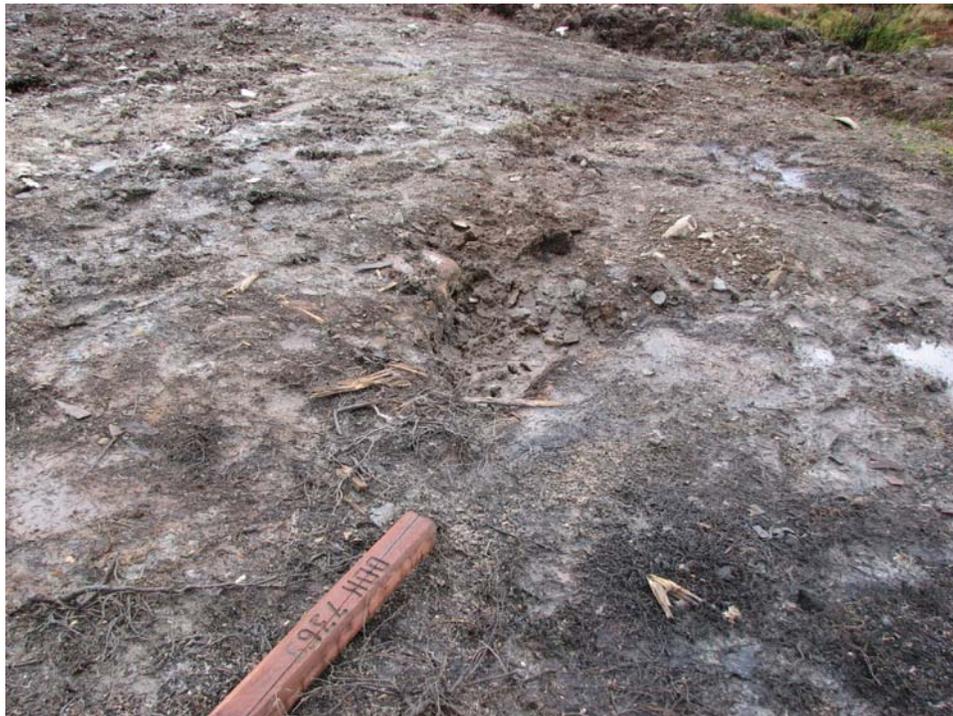
Photograph No. 4: Drill Site No. 7369
Well casing cut off below ground. Reclamation work started.

Action Needed: None. Reclamation of site just started..

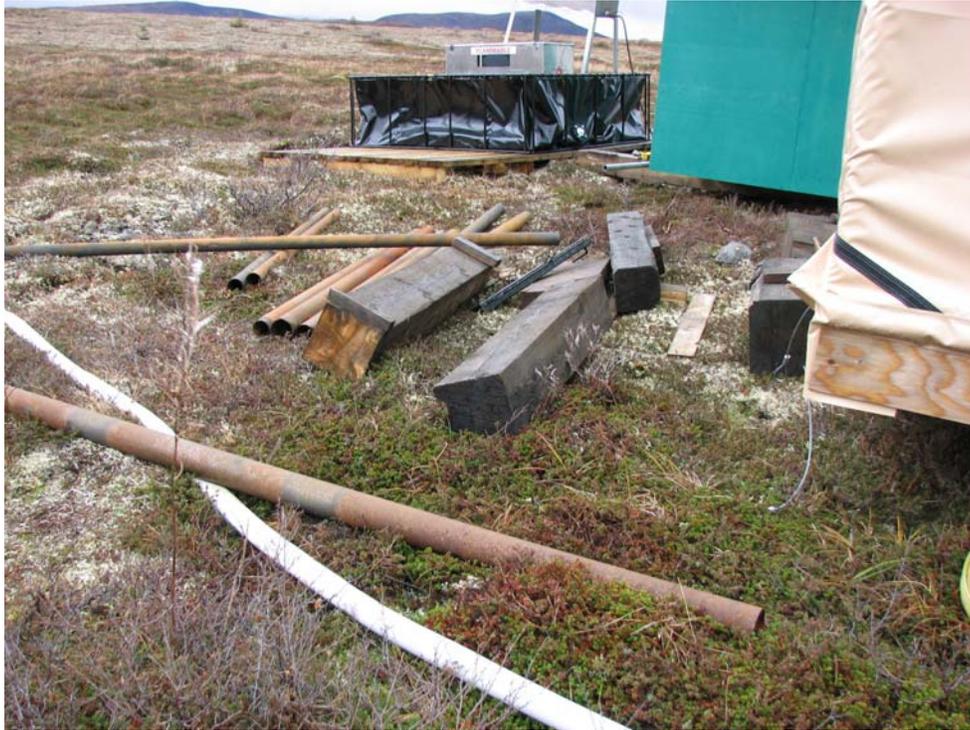
- Distance from water body: **Approx. 230 feet.**
- Location of fuel storage: **On pad.**
- Sorbent Pads Present or Not: **Yes.**
- Tundra Mat: **Yes.**
- Pipe off Tundra: **Discarded pipes on tundra.**
- Litter: **Observed.**
- Spill Indications: **None observed.**
- Activity: **On standby waiting parts.**
- Trash Containment: **Yes.**
- Sanitary Facilities: **Yes.**
- Any spills or staining, or 'none' for that matter: **None.**
- General impression of site: **No disturbance to tundra other than sump pit and trench.**

Photograph No. 5: Drill Site No 7376
Note pipe and debris on tundra.

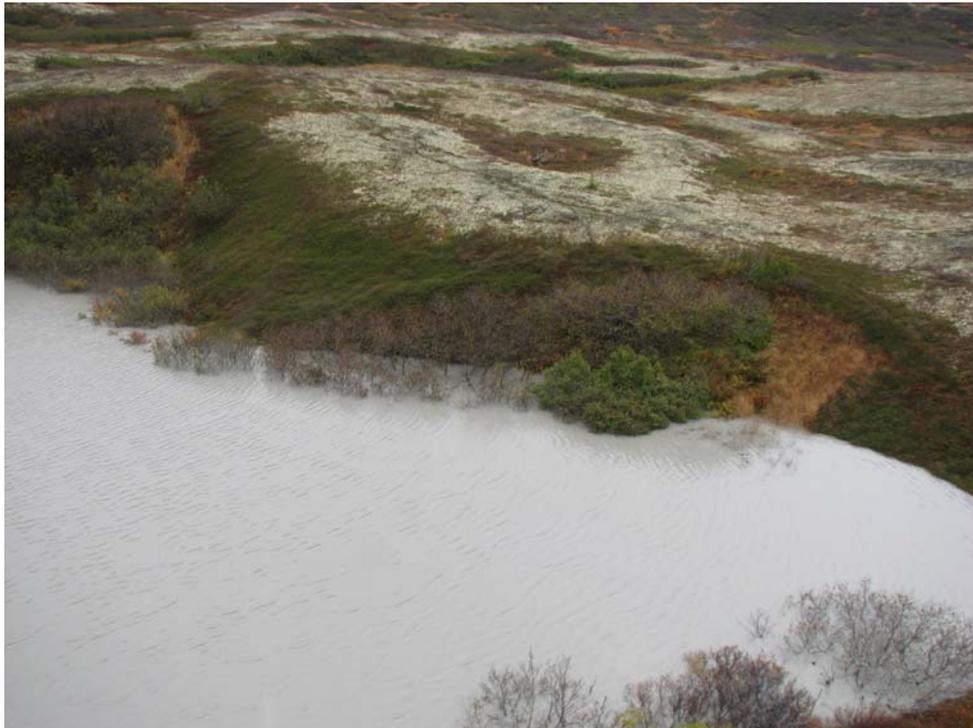
Photograph No. 6: Secondary sump pit (natural hollow) near Drill Site No. 6347
Note water level relative to vegetation.

Action Needed: Wells used as water sources need to be capped when not in use to prevent contamination of groundwater, e.g. Well No. 6347.

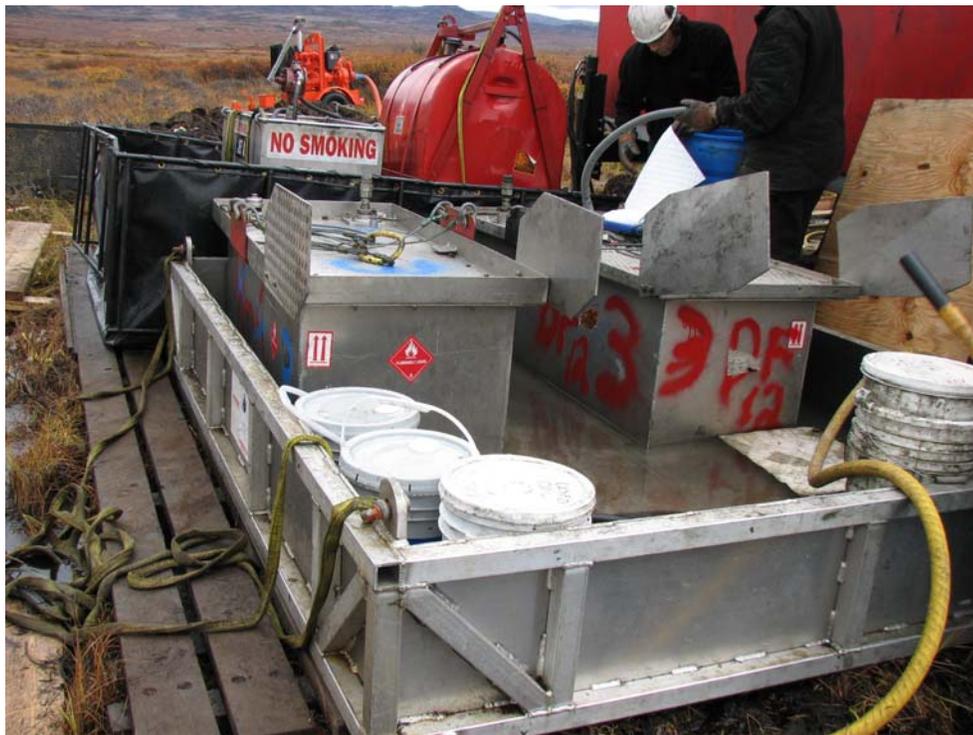
- Distance from water body: **Not measured**
- Location of fuel storage: **On pad.**
- Sorbent Pads Present or Not: **Yes.**
- Tundra Mat: **Yes.**
- Pipe off Tundra: **Pipes observed on tundra.**
- Litter: **None.**
- Spill Indications: **None observed.**
- Activity: **Drilling.**
- Trash Containment: **Yes.**
- Sanitary Facilities: **Yes.**
- Any spills or staining, or 'none' for that matter: **None.**
- General impression of site: **Site is wet, marshy. Not as clean as site no. 7384. Water in fuel containment catch basin.**

Photograph No. 7: Drill Site No 7385
Note standing water in secondary fuel catchment basin.

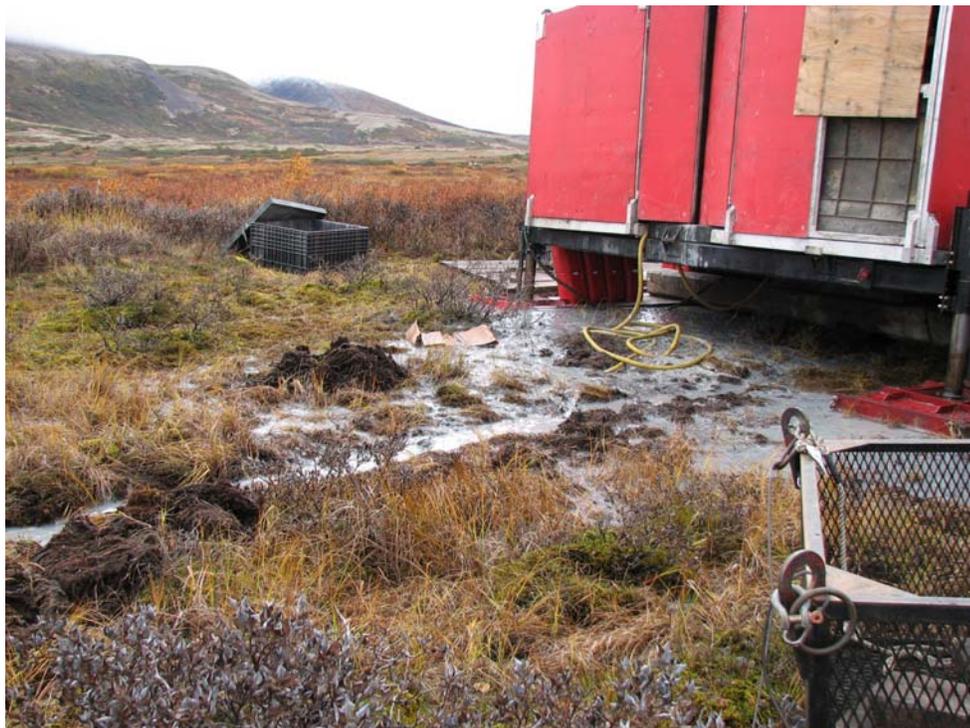
- Location: **Next to rig.**
- Discharge trench: **Yes. Trench was flooded.**
- Dimension pit: **Pit was flooded**
- In use: **Yes.**
- Level of water in pit: **High.**

Photograph No. 8: Drill Site No. 7385
Trench and sump pit system is inadequate owing to marshy conditions.

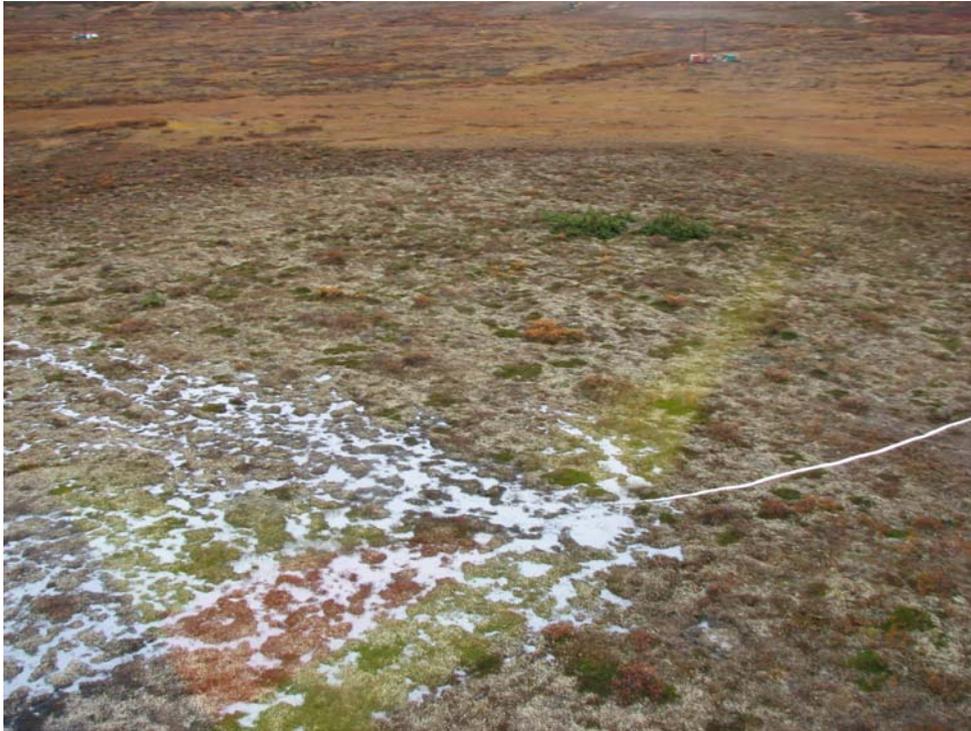
- Topsoil, muck, tundra stockpiled: **Yes.**
- Location and extent of discharged material? **Discharged directly onto the tundra, north of rig, see photograph no. 9.**
- Location of secondary sump pit: **None.**
- Hose color: **White.**

Photograph No. 9: Discharge of drilling water from Drill Site No. 7385 (rig 3) onto tundra.
