APMA A20176118- FIELD SUMMARY REPORT

Inspection Date:	15 Sept 2017 – 17 Sept 2017
Weather:	Overcast, Intermittent Rain Squalls, Variable Wind up to 40 kt, Air Temp. Approx. 48° F
Agency Personnel:	Hollie Chalup (Mining Section), Renee Romsland (Mining Section), Katrina Chambon (Dept. of Environmental Conservation, 15 Sept only)
Operator Contact:	Tim Havey, Env. Manager, Pebble Limited Partnership
Pilot:	Archie, Soloy Helicopters
Inspection Objectives:	Annual Inspection and Follow-Up Compliance Inspection

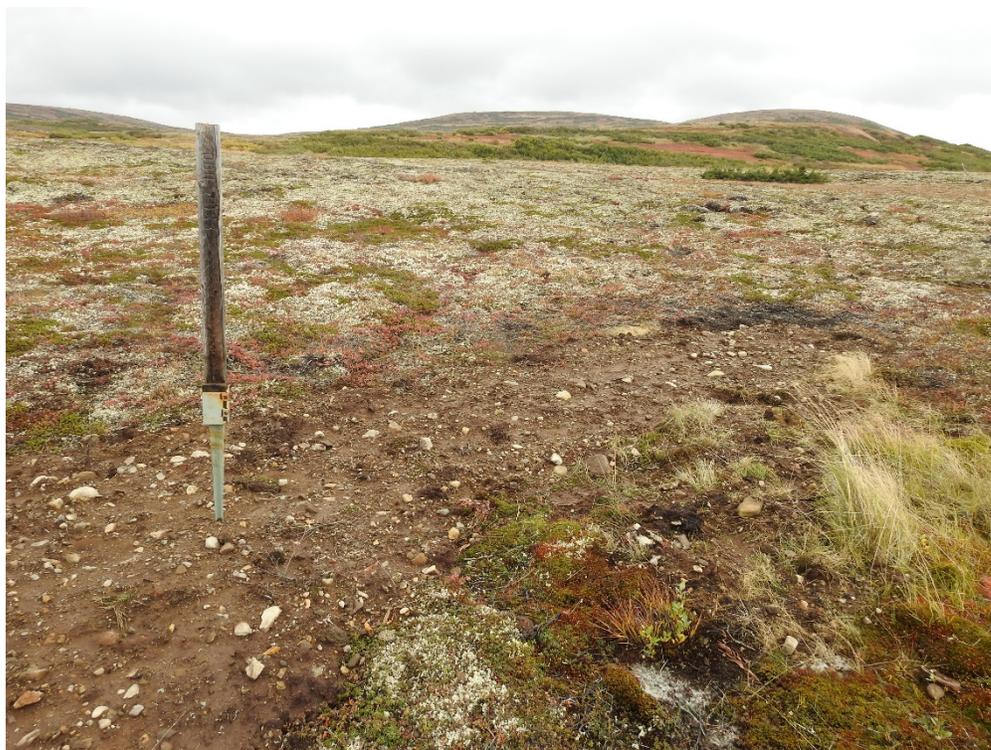
1. Borehole 8433M

1.1 Borehole 8433M (ADL 516874, Figure: 1)

Exploration borehole 8433M exhibited ponded water near the borehole with an unknown source in 2016. Attempts to stop water flow in spring of 2016 were unsuccessful. On August 20, 2017, the operator re-drilled, grouted and reclaimed the site successfully as reported in PLP's 2017 Reclamation Activity Report⁶ submitted November 30, 2017. At the time of inspection, the site was found to be in an acceptable stable condition. DNR recommends seeding this site in spring of 2018 but it is not a requirement under AS 27.19, 11 AAC 97.200 or terms of MLUP A20176118. The borehole rating for this location has been modified to 3-D⁴.

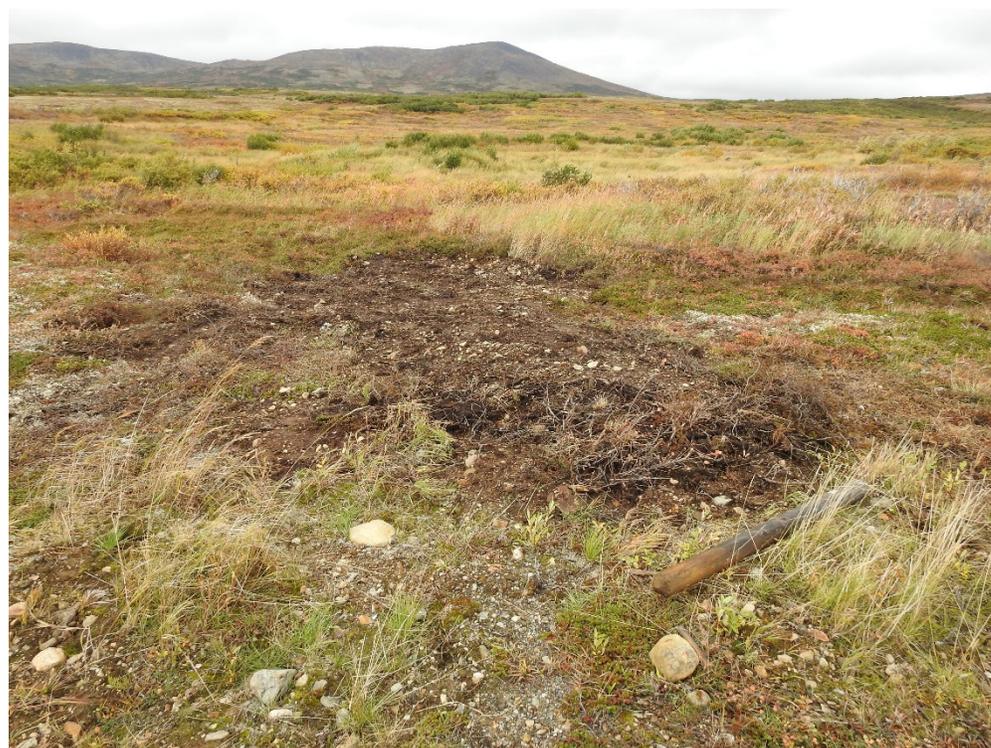
2. Borehole 3132

1.2 Borehole 3132 (ADL 516873, Figure: 2)

Exploration borehole 3132 exhibited a minor weep upon inspection in 2016. Borehole 3131, located in close proximity to borehole 3132, was repaired in 2015 by drilling and regrouting, but the repair was unsuccessful. Borehole 3132 was re-drilled, grouted and reclaimed on August 10th, 2017⁶. It appears that borehole 3131 and 3132 exhibit some influence on one another. Borehole 3132 was not exhibiting instability at the time of inspection and is also grouted and plugged. DNR recommends seeding this site in spring of 2018 but it is not a requirement under AS 27.19, 11 AAC 97.200 or terms of MLUP A20176118. The borehole rating for this location has been modified to 3-D⁴.

Borehole 3131
also pictured (nearest
stake).

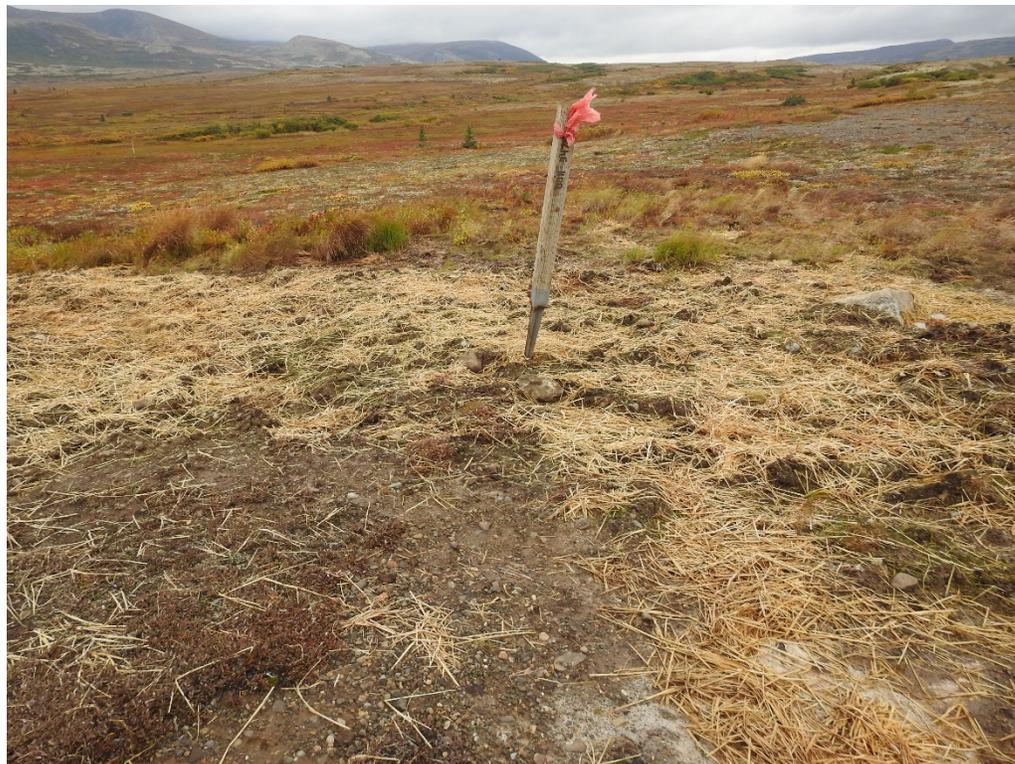
3. Borehole 9475
15 Sept 2017

1.3 Borehole 9475 (ADL 540442, Figure: 3)

Borehole 9475 was re-drilled, grouted and reclaimed in August 2017⁶ after a history of water production and unsuccessful repair. Reclamation efforts began after closure in August and will continue to be monitored for revegetation in 2018. The borehole rating for this location has been modified to 3-D⁴.

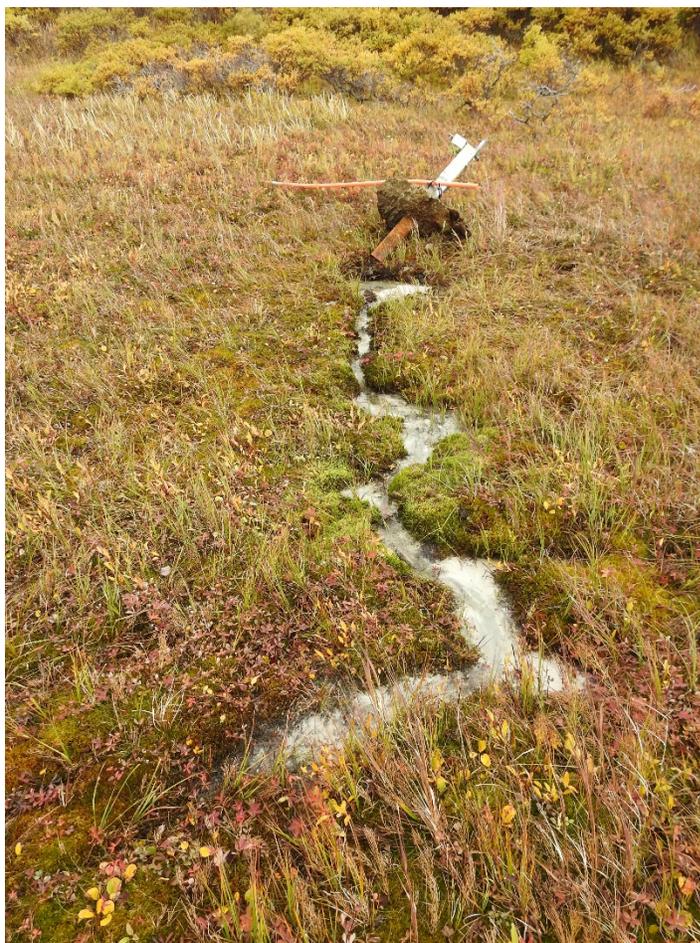
**4. Borehole
GH08-156**
15 Sept 2017

1.4 Borehole GH08-156 (ADL 642443, Figure: 4)

In 2016, DNR requested the operator investigate the origins of a small upwelling at the base of borehole GH08-156. In 2017, the operator determined the water presence was from surface flow originating upgradient from the borehole, collecting at the borehole casing and continuing downgradient in an outflow channel⁶. To confirm this, the operator removed the above ground casing and packed the borehole with bentonite pellets. At the time of inspection, just a short time after the repair was made, an approximate 3" wide by 3" deep and 15' long channel outflow was observed. The outflow channel includes bentonite clay particles suspended after water contact from surface flow. Remediation of the outflow channel is scheduled for the 2018 field season. DNR requests the operator continue monitoring and reclamation efforts as scheduled. The borehole rating for this location has been retained at 1-B⁴.

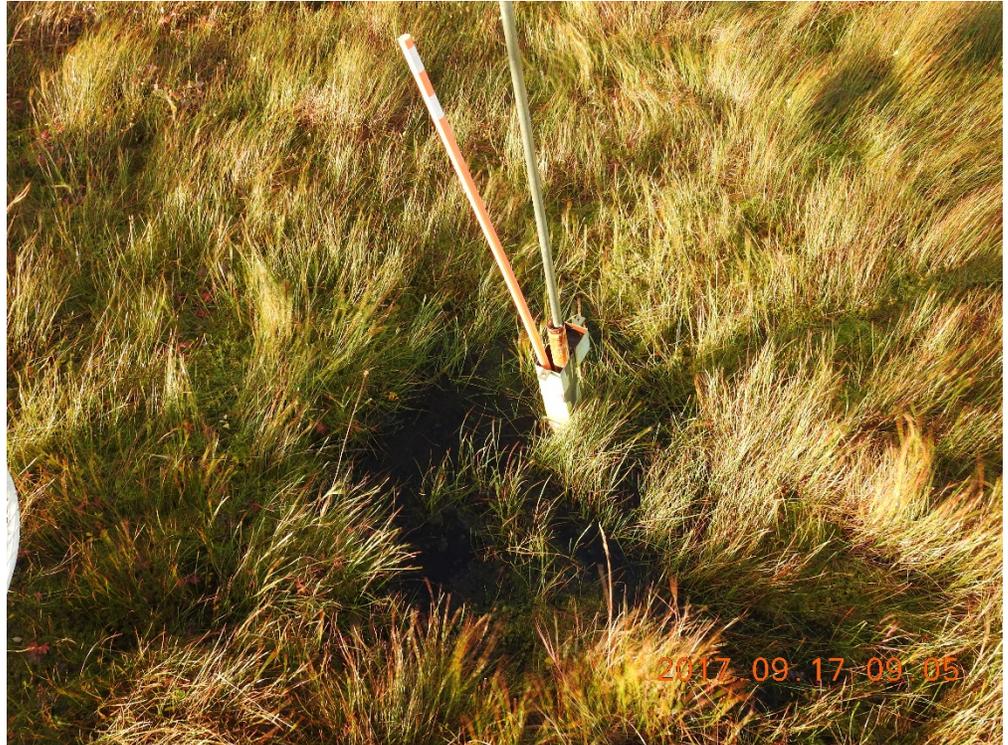
**5. Borehole
GH06-072**
17 Sept 2017

1.5 Borehole GH06-072 (ADL 524808, Figure: 5)

Borehole GH06-072 was observed producing a small amount of water inside the casing in 2017. The Margo plug installed at the time was rusted and likely the cause of the condition. In 2016, DNR requested the operator install a new Margo plug and determine if that repair adequately stopped water flow. The installation of a new Margo plug and the cessation of flow was observed during inspection in 2017. The borehole rating for this location has been revised to 1-D⁴.

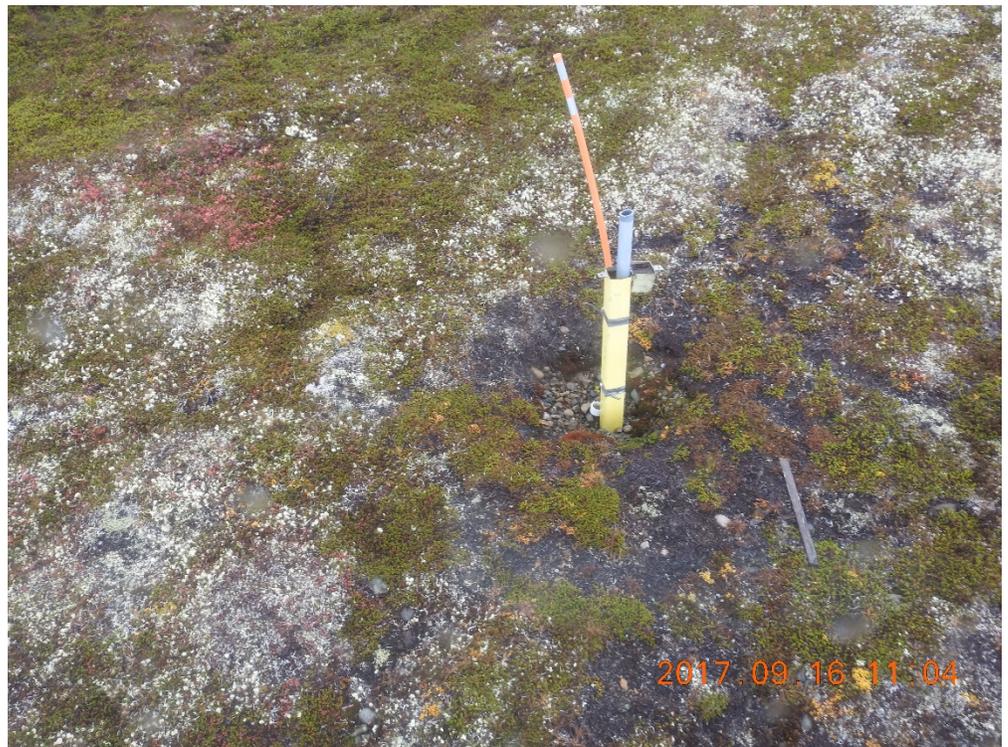
**6. Borehole
GH11-236**
17 Sept 2017

1.6 Borehole GH11-236 (ADL 531455, Figure: 6)

In 2016, DNR observed a depression surrounding the casing of this monitoring well. DNR requested the operator observe and measure the depression to determine if the site was experiencing subsidence. Upon inspection, the site appears to be in similar condition with no notable change in depression dimensions. If no subsidence has been measured, the operator should fill the depression and complete reclamation. The borehole rating for this location has been retained at 1-D⁴.

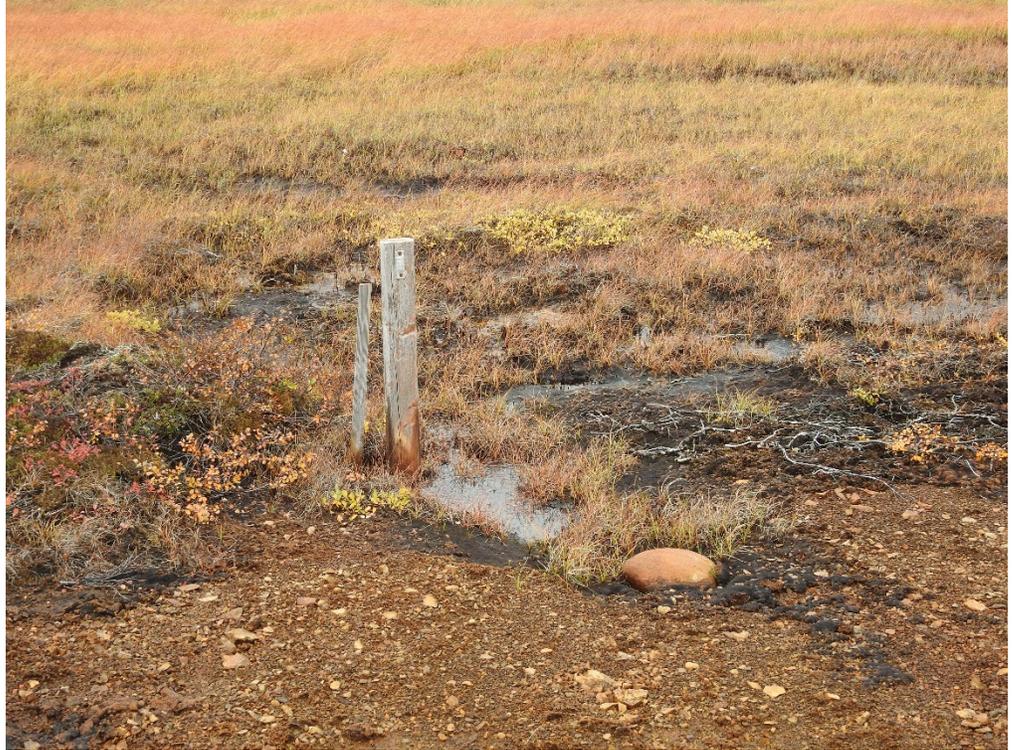
7. Borehole 4279
15 Sept 2017

1.7 Borehole 4279 (ADL 516818, Figure: 7)

Borehole 4279 has been documented with ponded water near the borehole since 2015. In 2016, DNR requested the operator confirm the standing water was not produced from the borehole location. The operator has made multiple inspections and determined the ponded water is not a result of influence from the borehole. In 2017, DNR observed standing water across the surrounding low lying, flat area and noted no substantial change from years past. The borehole rating for this location has been retained at 3-D⁴ and no additional action is requested at this time.

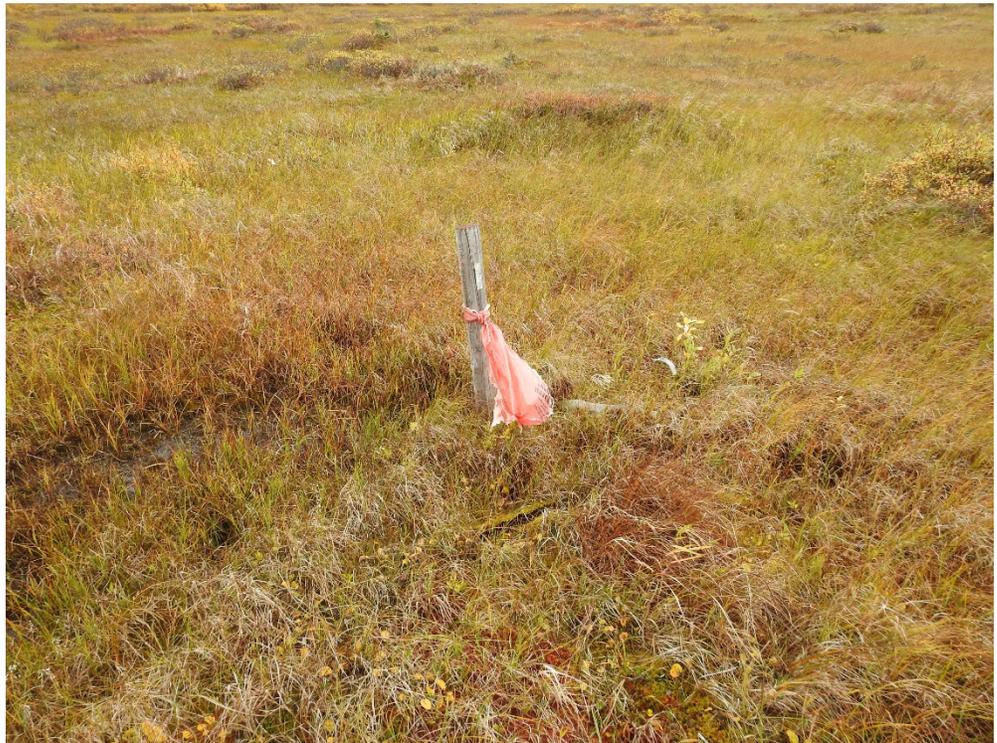
8. Borehole 5332
15 Sept 2017

1.8 Borehole 5332 (ADL 540426, Figure: 8)

Borehole 5332 was observed with nominal amounts of ponded surface water. Surface water appears to flow through the surrounding low-lying area and past the borehole location. The ponded water was observed clear and without a sheen or smell. The borehole has been plugged, reclaimed and abandoned. The borehole rating for this location has been retained at 3-D⁴.

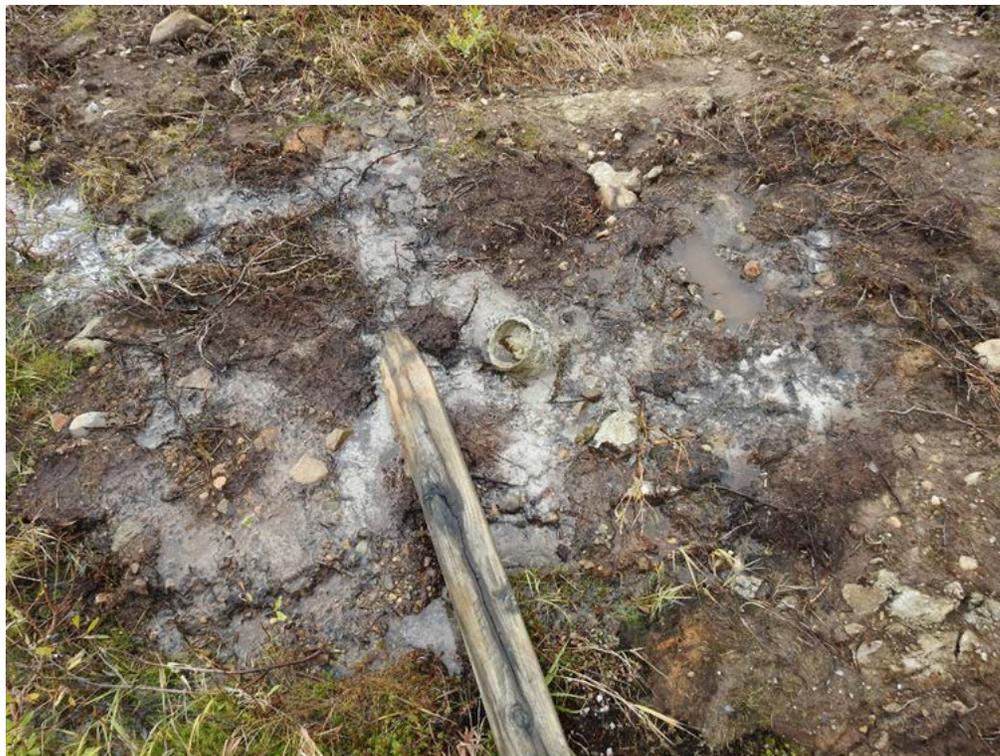
9. Borehole 3127
16 Sept 2017

3.1 Borehole 3127 (ADL 516873, Figure: 9)

This borehole exhibited minor water production despite efforts to re-drill and grout to stop water flow in August 2017. Water produced from this borehole dissipated in a disseminated fashion to surrounding

vegetation several feet from the borehole. The operator indicated the need for a more specialized drill to successfully complete repairs. Repairs are scheduled for Spring 2018. DNR requests the operator continue monitoring site conditions and report repair activities as soon as practicable. Borehole rating has been modified to 3-B⁴.

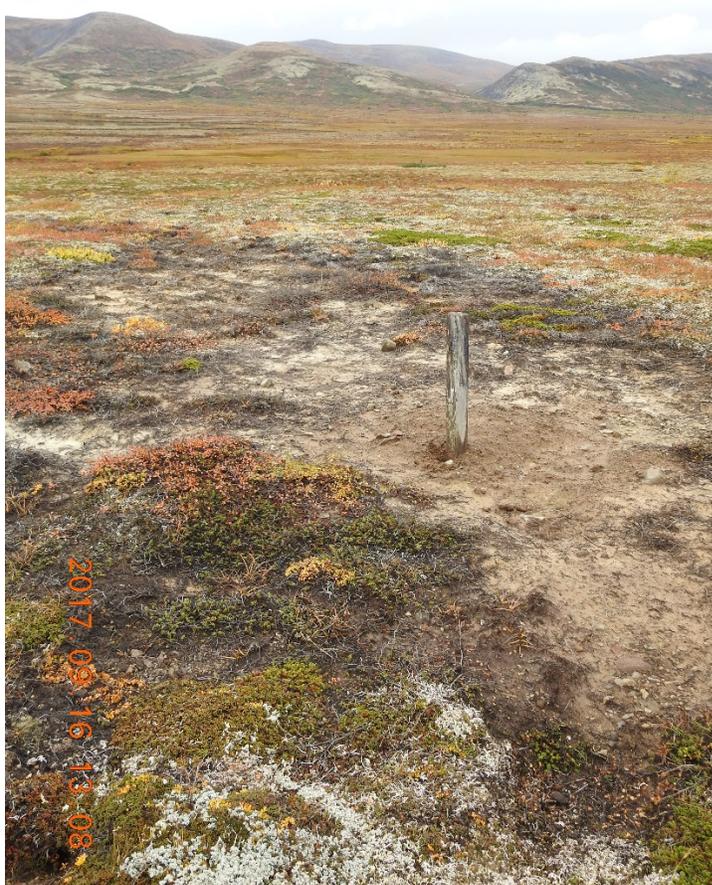
10. Borehole 3134
16 Sept 2017

3.2 Borehole 3134 (ADL 516874, Figure: 10)

Borehole 3134 was abandoned and reclaimed in 2017. Vegetative regrowth since drilling has been slow and may be due to the minimal organic layer naturally occurring in the surrounding area. DNR requests the operator amend the soil and reseed as necessary to encourage regrowth. Borehole rating has been modified to 3-B⁴.

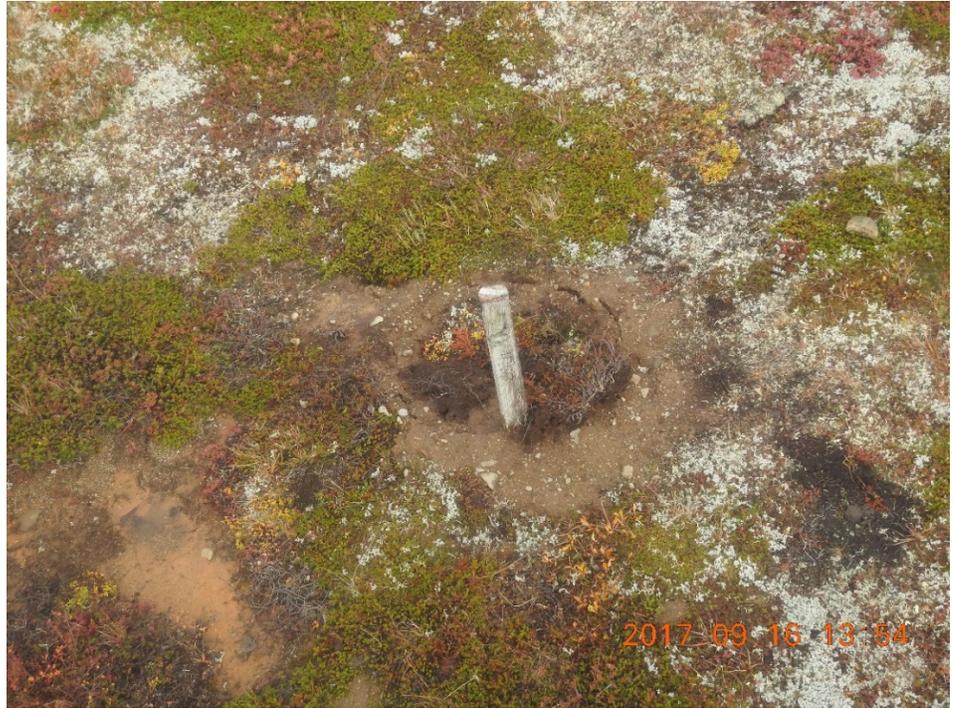
11. Boreholes 4153
16 Sept 2017

3.3 Borehole 4153 (ADL 516810, Figure: 11)

Borehole 4153 appears to be experiencing a small amount of subsidence surrounding the casing. The subsidence is estimated at approximately 4" deep by 3' wide encircling the borehole location. In 2017, the operator removed the casing above ground and may have instigated this condition during reclamation efforts. DNR requests the operator to monitor the site in 2018 for further subsidence or monitor to verify the site is in fact subsiding. If the site is subsiding, complete a repair to prevent further subsidence. The borehole rating for this site has been modified to 3-D⁴.

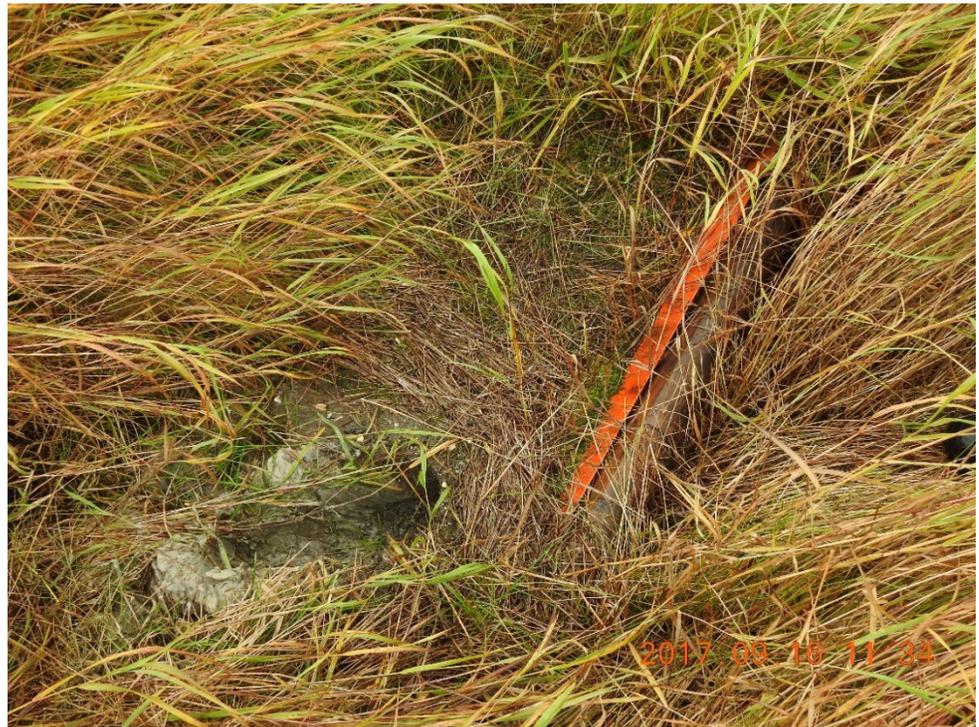
12. Borehole 4224
16 Sept 2017

3.4 Borehole 4224 (ADL 516829, Figure: 12)

Borehole 4224 had an attempted repair but the repair was not successful. Surface water flow from the hillside appears to be affecting this borehole though water does not run from the borehole itself. DNR requests the operator to complete repairs in the 2018 season and to backhaul the cut casing from the field. The borehole rating has been modified to 3-C⁴.

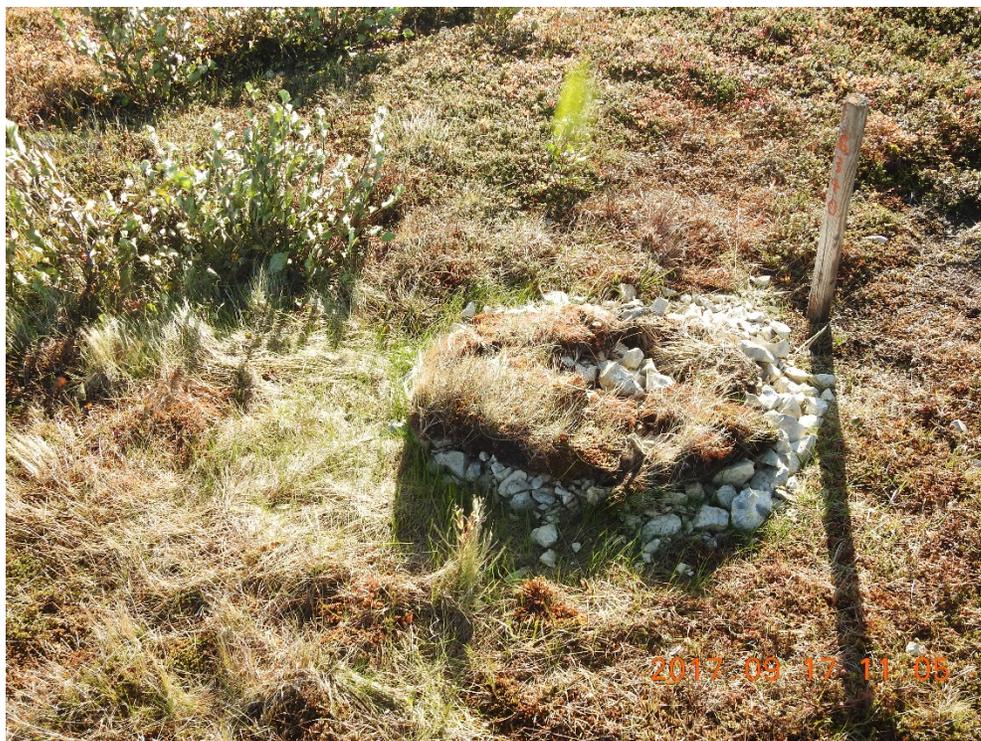
13. Borehole 6340
17 Sept 2017

3.5 Borehole 6340 (ADL 642364, Figure: 13)

Borehole 6340 has a pile of mounded rock at the borehole location. This borehole was abandoned by cutting off the casing structure in 2017. DNR requests the operator place additional organic cover to promote revegetation. The borehole rating has been modified to 3-D⁴.

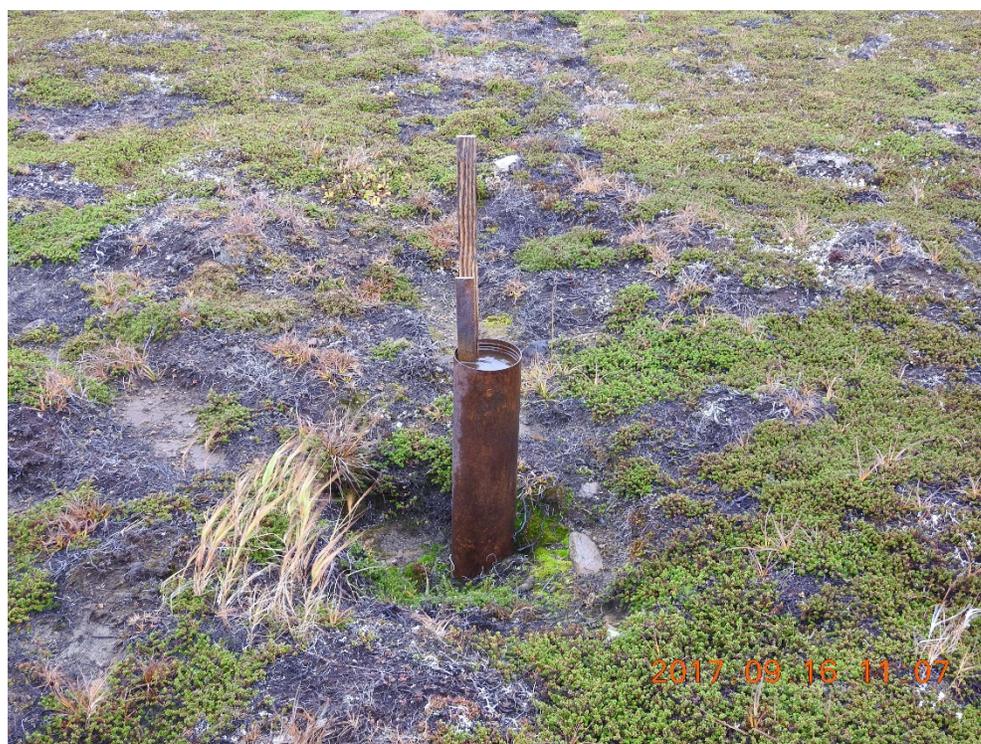
**14. Borehole
GH11-247**
16 Sept 2017

3.6 Borehole GH11-247 (ADL 531454, Figure: 14)

This borehole has been grouted, plugged and reclaimed but not abandoned (an above ground casing remains). DNR inquired as to why the borehole casing was not capped and was informed there is a PVC pipe structure within the borehole casing which is properly capped. The rating for this borehole has been modified to 2-D⁴.

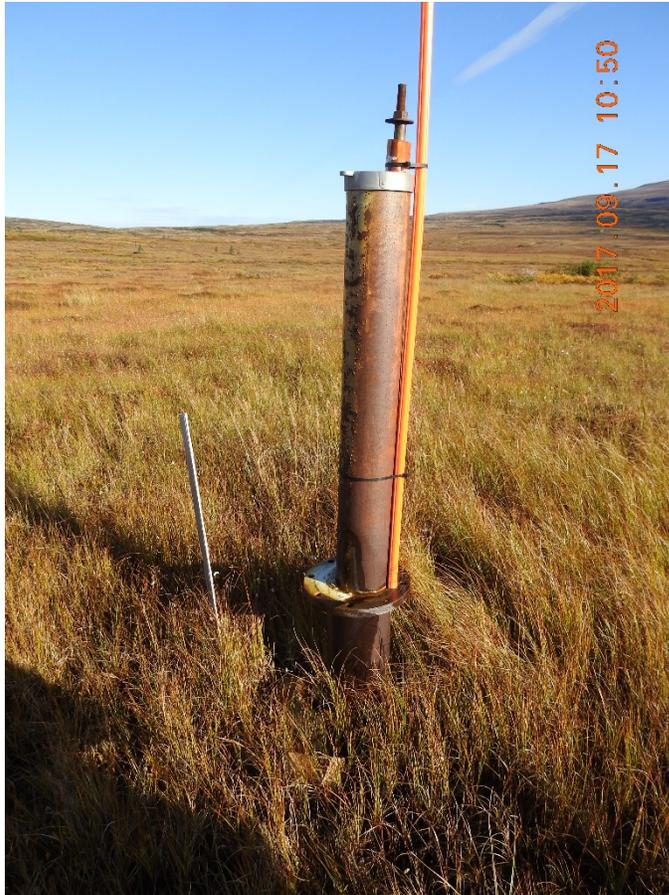
15. Borehole GH11-272S
17 Sept 2017

3.7 Borehole GH11-272S (ADL 824714, Figure: 15)

This monitoring well has a pin hole in the casing approximately 6" above the lower casing collar. A very small amount of rainwater is dripping and running outside the casing. A small amount of algae growth was observed. This well has a Margo plug installed which prevents capping. This notification is a matter of courtesy only as the condition does not pose a compliance risk or environmental degradation. DNR advises the operator to repair at the operator's convenience.

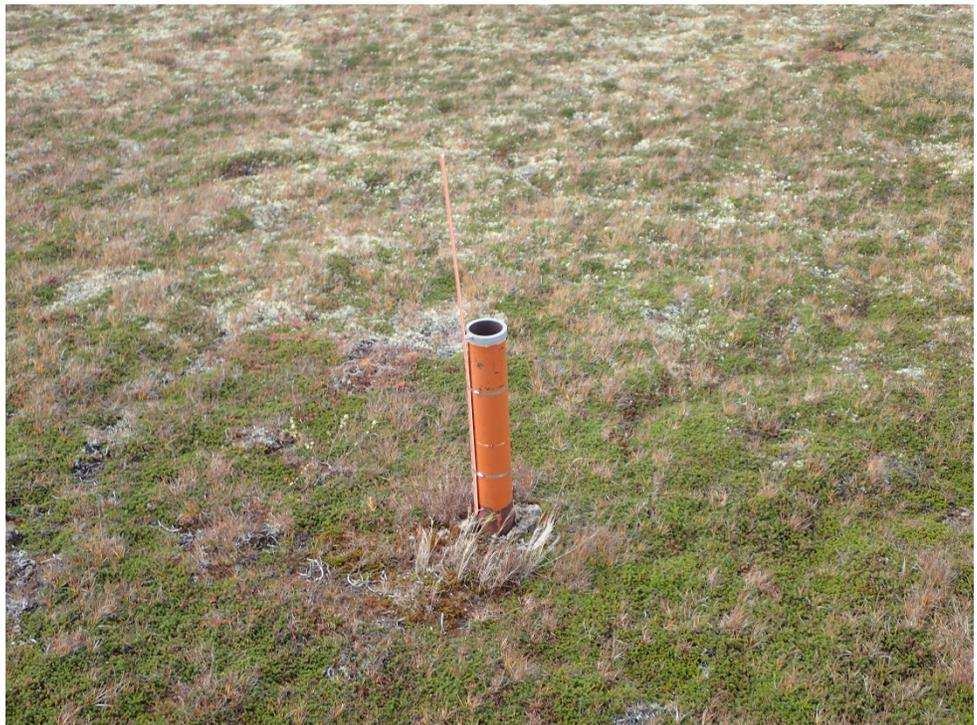
16. Borehole P-04-02M
16 Sept. 2017

3.8 Borehole P-04-02M (ADL 516868, Figure: 16)

Site P-04-02M was observed to be lacking a cap on the monitoring well. The cap was observed onsite but was not affixed. It does not appear the condition of this monitoring well would prevent capping. The operator notified DNR that the casing was successfully capped on October 6th, 2017. The rating for this location has been modified to 1-E⁴.

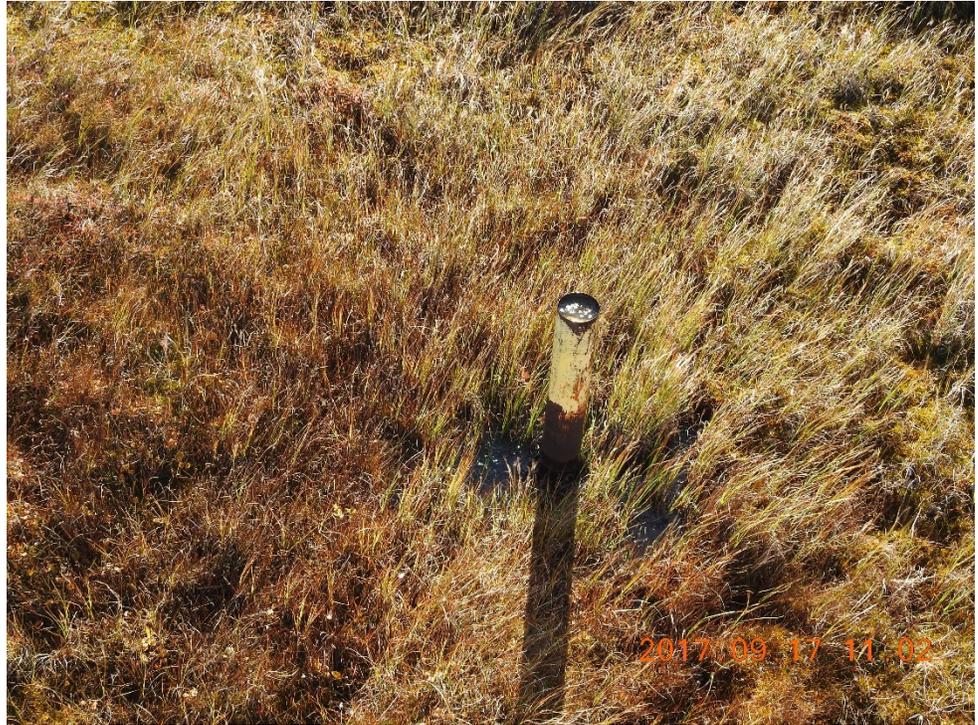
17. Borehole GH06-078
17 Sept 2017

3.9 Borehole GH06-078 (ADL 524714, Figure: 17)

Site GH06-078 was observed to be lacking a cap on the casing. There was no cap observed onsite at the time of inspection and no structures were identified that would reasonable prevent capping. This monitoring well has been grouted and plugged. The operator subsequently reported successful capping at borehole GH06-078 on October 5th, 2017. The rating for this location has been modified to 2-E⁴.

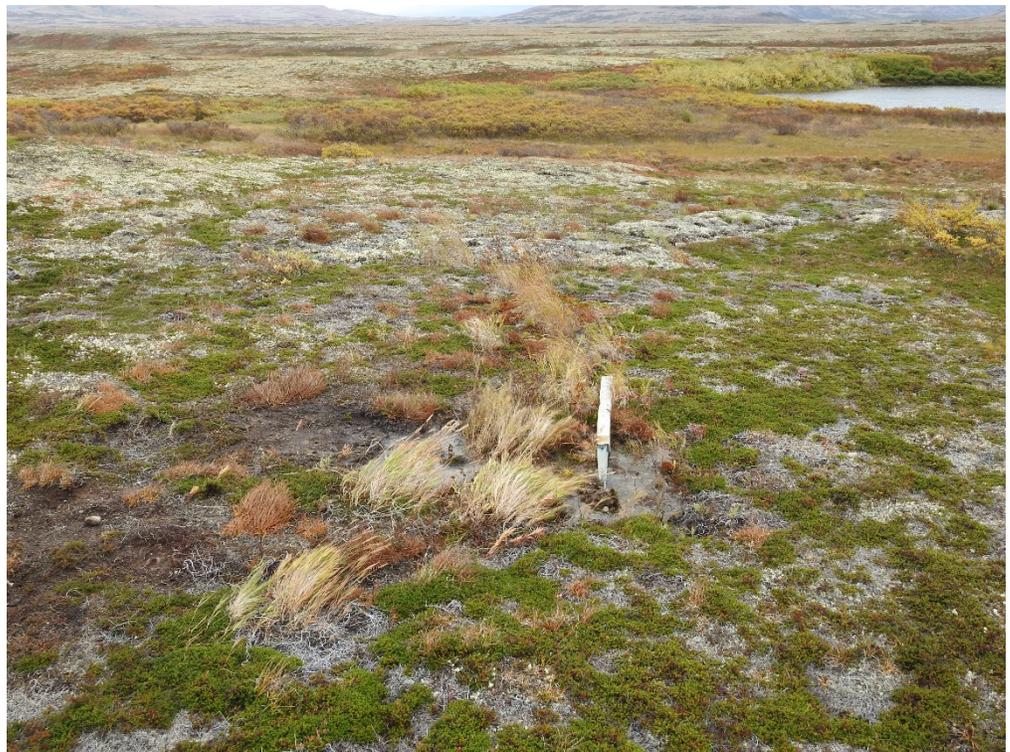
18. Borehole 11538
15 Sept 2017

3.10 Borehole 11538 (ADL 643907, Figure: 18)

Borehole 11538 exhibits pooled surface water at the borehole location. The site is located on a dry bench above a small kettle pond and does not appear to be under the direct influence of a surface water source. The outflow channel observed in previous inspections was not observed in 2017. The operator informed DNR that a drilling contractor investigated the site and determined water was precipitation resurfacing after rain events or snow melt. The drill contractor did not advise re-drilling. DNR requests the operator to continue monitoring at this site. The rating for this location has been modified to 3-C⁴.

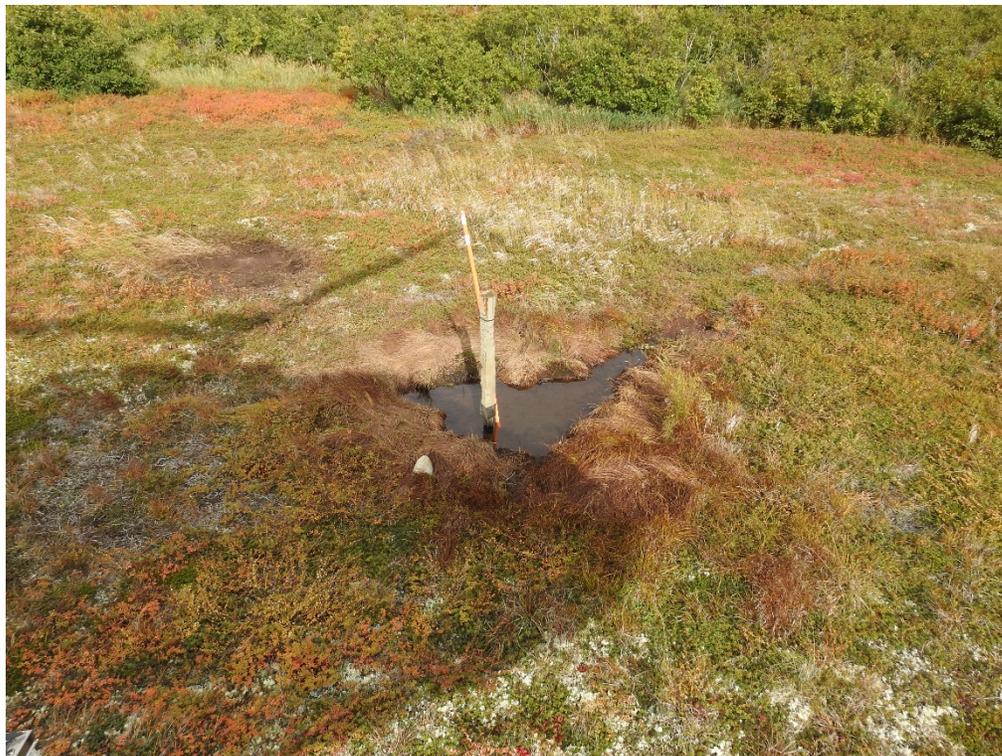
19. Borehole 12550
15 Sept 2017

3.11 Borehole 12550 (ADL 552914, Figure: 19)

Borehole 12550 exhibits continued pooling of water at the casing. The standing water is clear and approximately 6-8" deep in a triangular shape (approximately 4' wide by 6' long) surrounding the borehole. Vegetative growth surrounding the pool of water suggests its continued presence. The outflow channel downgradient from the borehole observed in previous years was dry at the time of inspection. DNR requests the operator continue to monitor this site and conduct any repairs as necessary. The borehole rating for this location is retained at 3-C⁴.

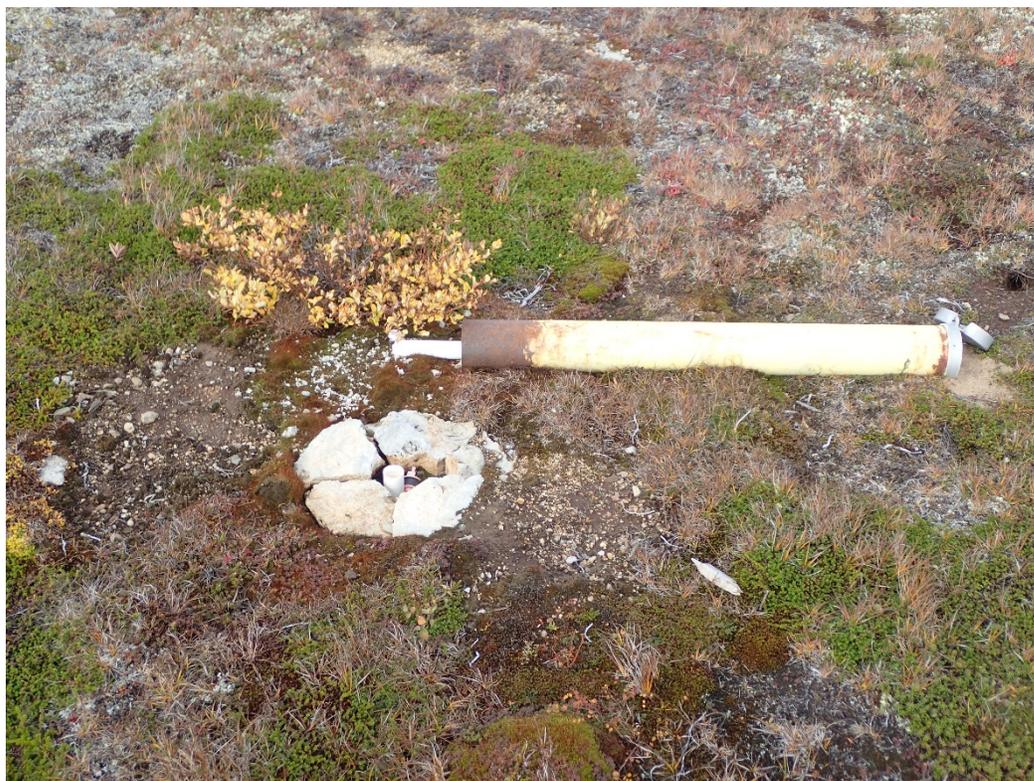
20. Borehole P-04-03
16 Sept 2017

3.12 Borehole P-04-03 (ADL 516874, Figure: 20)

Borehole P-04-03 was observed with the casing and a PVC pipe structure removed from the main PVC pipe stem. The borehole stem is a PVC structure and appears to have been capped at one time. The PVC pipe was not observed with a cap at the time of inspection as is required under MLUP A20176118. DNR requests the operator place a cap as soon as practicable. The borehole rating for this location has been established as 1-C.

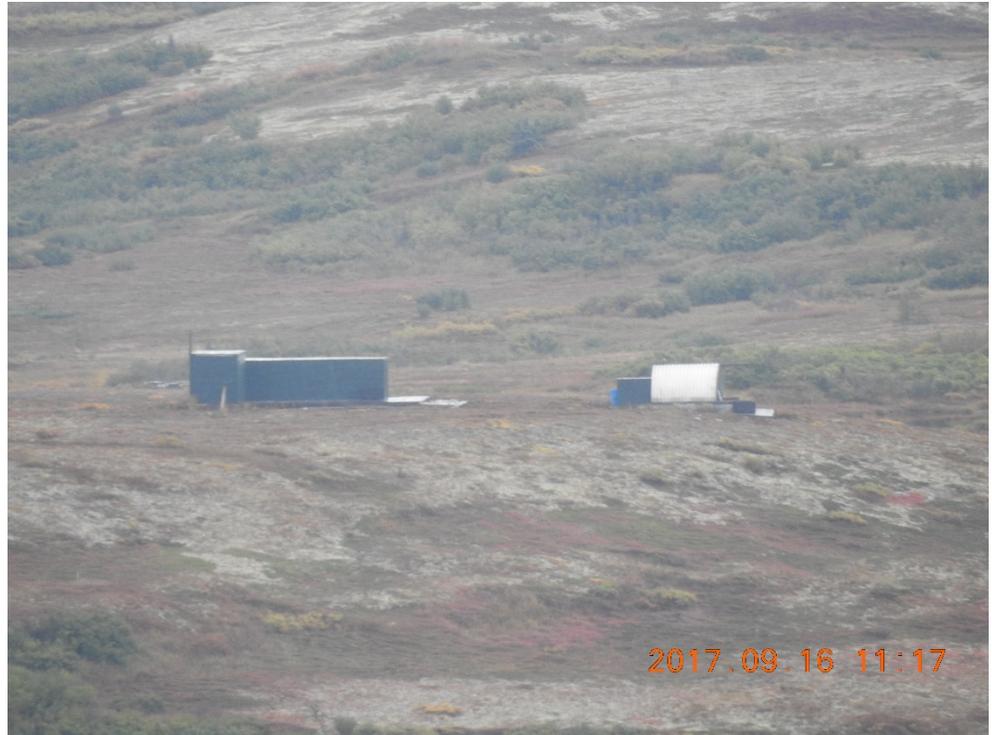
23. Watershed
16 Sept 2017

4.2 Watershed (ADL 524712, Figure: 23)

The Watershed site is in good condition and houses remediation and emergency response supplies. A fuel tank with aluminum containment is present. The fuel container was empty at time of inspection. Secondary containment rainwater collection should be decanted regularly if the tank is put into operation.

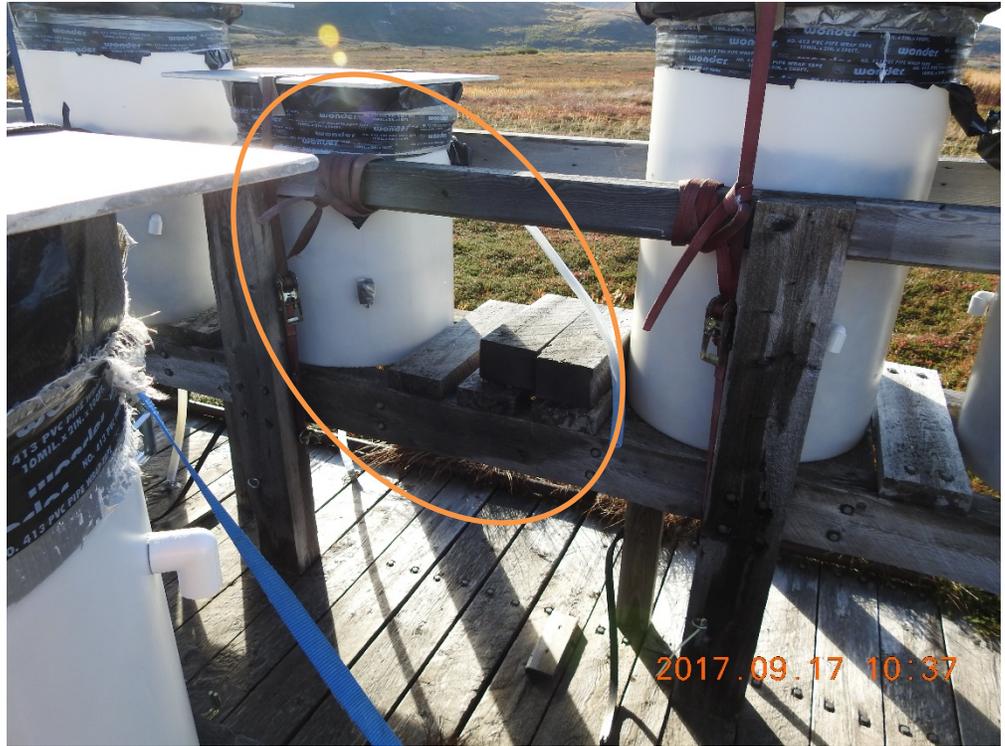
The ARD Test Site is comprised of twelve poly drums containing rock material. All inlets and outlets to the drums are adequately sealed with exception of one hose outlet (middle drum, most southeasterly row). The hose inlet is approximately 6" above rock level with no water observed in the container. Notification was given to PLP during the inspection to reseal the outlet. PLP described having trouble with avian wildlife disrupting the tops of the barrels in the 2016 inspection. PLP replaced all lids with substantial metal lids appropriately affixed to the barrels. All drums are located on a tundra pad and no water was present onsite. No discoloration or other indicators of leakage were present. ADNR requests PLP continue to monitor regularly. Any repairs or modifications should be detailed in the annual reclamation report.

25. ARD Test Site
17 Sept 2017

Orange colored circle identifies hose without outlet plug. See Section 4.3.

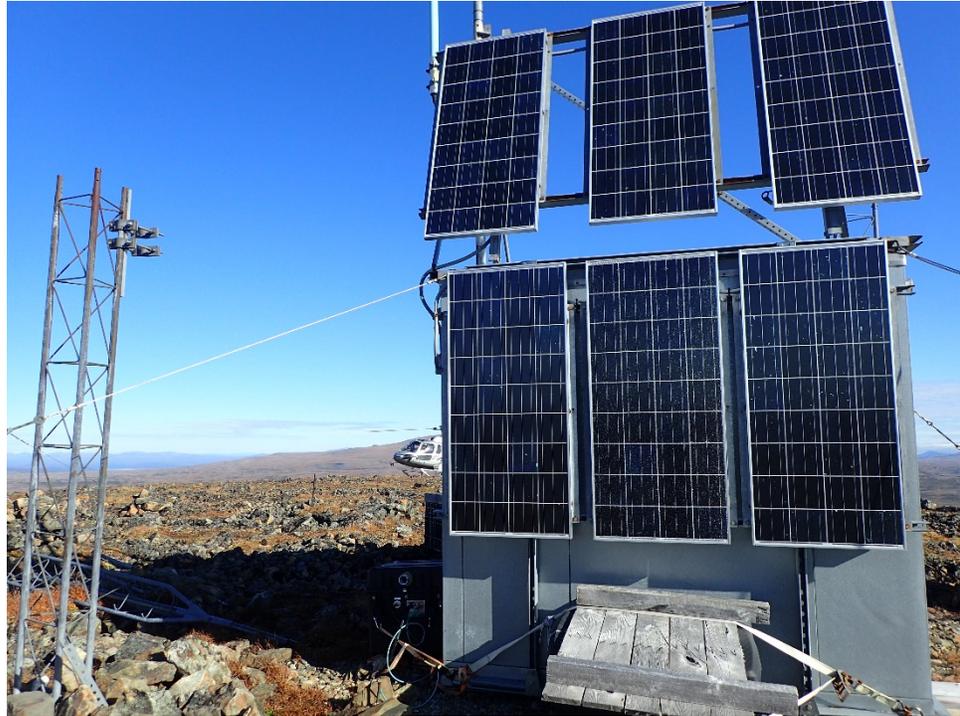
**31. Kaktuli
Mountain Radio
Repeater
Damage**
17 July 2017

ADNR visited the Koktuli Mountain Repeater Station and found facilities to be in acceptable condition. PLP noted vandalism to solar panel and tower equipment in the winter of 2016-2017. The operator subsequently reported cable and tower replacement in the 2017 field season⁷.
