REVEGETATION WITH ARCTOPHILA FULVA

Final Report 1985 ~ 1989

Prepared for:
ARCO Alaska, Inc.
P.O. Box 100360
Anchorage, Alaska
99510-0360

Prepared by:
Alaska Plant Material Center
Dept. of Natural Resources,
Division of Agriculture
HCO2 ~ Box 7440
Palmer, Alaska 99645

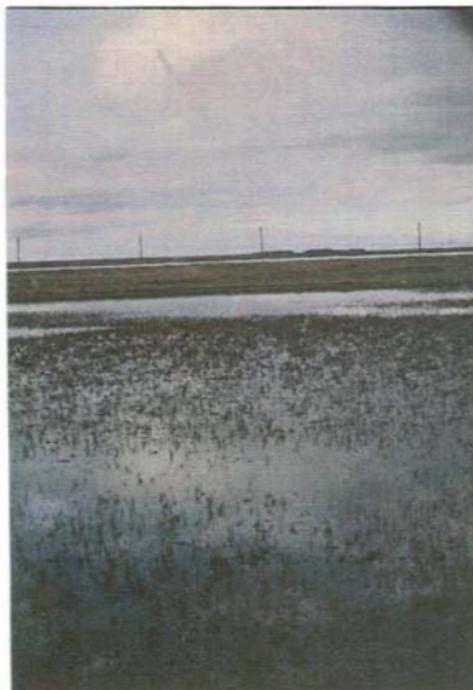
Figure 7. Transect 2 at Nest Lake, July 1, 1985.
Looking from shore towards the intersection with Transect 1.

Figure 8. Transect 2 at Nest Lake, mid-August, 1985.
Notice the increase in plant cover that has occurred in six weeks.

Two transects were established at Nest Lake. Transect 1 began at a point halfway down the eastern shore and ran for 50 meters through a small, sparse *Arctophila* community at the shoreline, across an unvegetated area and finally through an extensive community. Transect 2 ran for 185 meters perpendicular to the shoreline and intersected Transect 1 at the 100 meter point (Figures 7 and 8).

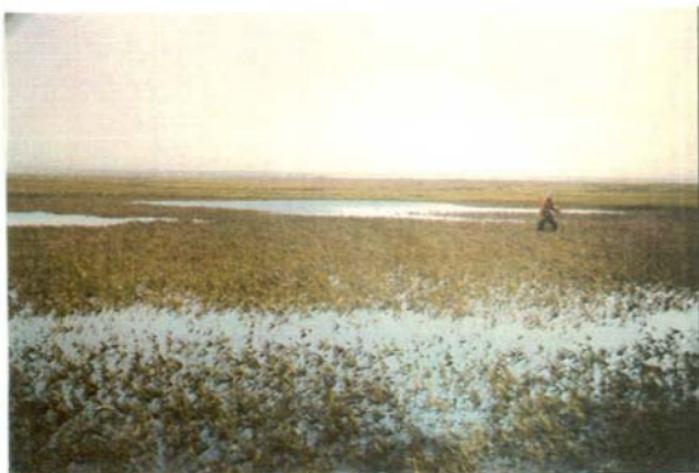
Figure 9

Water depths and species composition at meter intervals on Transect 1 at Nest Lake.

Considerable variation occurred in the substrate profile in this community. Water depths ranged from 14 to 69 centimeters (Figures 9 and 10). These water depths fall within the range of rooting depths for *Arctophila*, so it appears that if conditions are favorable the community could expand into the unvegetated areas.

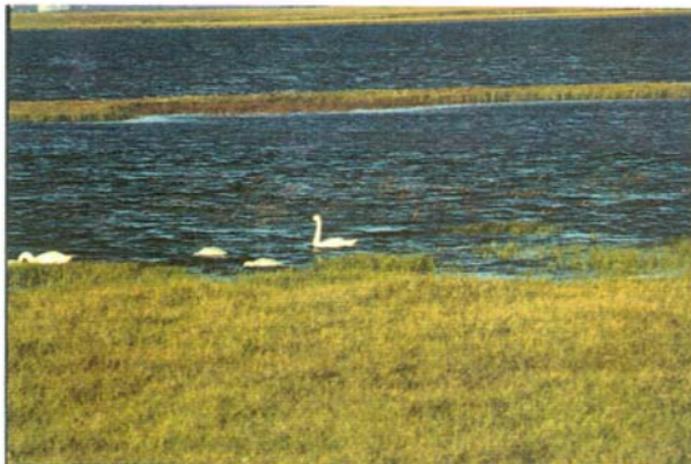
Figure 17. Swans were observed at Swan Lake every year of the study. Three of those years, the swans were rearing young.

Figure 18. *Arctophila* communities in which waterfowl were observed, contained small areas where the new spring *Arctophila* growth was found detached from the plant and floating in the water. It is not understood why this occurred since none of the plants appears to have been eaten. This may be the result of feeding on some other organisms found on the plants.

Swan Lake is a large, elliptically shaped lake with minor variations in the shoreline. The most distinctive feature of the lake is a long, vegetated peninsula parallel with the western shore of the lake (Figure 16). Considerable waterfowl activity was observed in the lake (Figures 17 and 18). Four transects were located in *Arctophila* communities in the southern part of the lake.

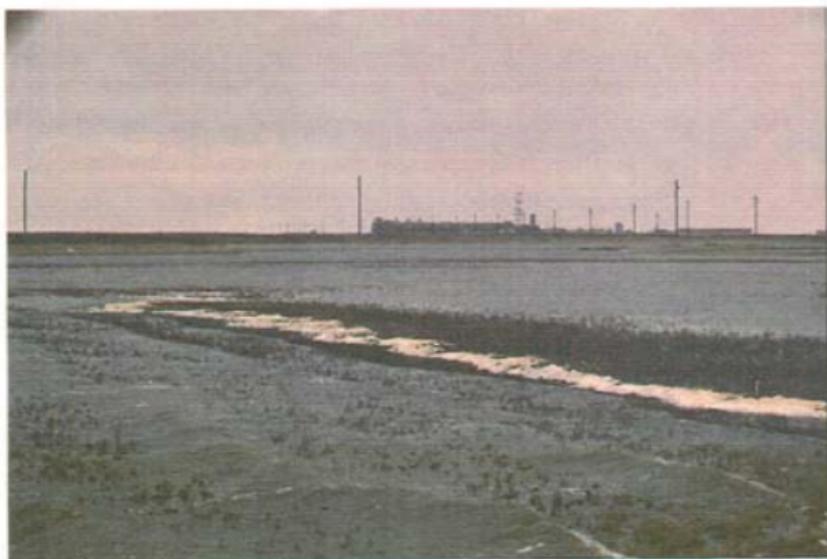
Figure 22. An example of the wave dampening effect of an Arctophila stand.

Swan Lake soil sample 1 from Transect 3, contained more silt and organic matter than other soil samples collected from Swan Lake (Tables 2 and 3). The sample was taken from a shallow part of the community with good vegetative cover. It should be noted that the sample point may have been a site where fine mineral particles and detritus were deposited. Deposits of this type may be common in many *Arctophila* communities. As stated earlier, *Arctophila* plants reduce wave action which then allows suspended particles to settle (Figure 22), a process which may have formed the mud bar.

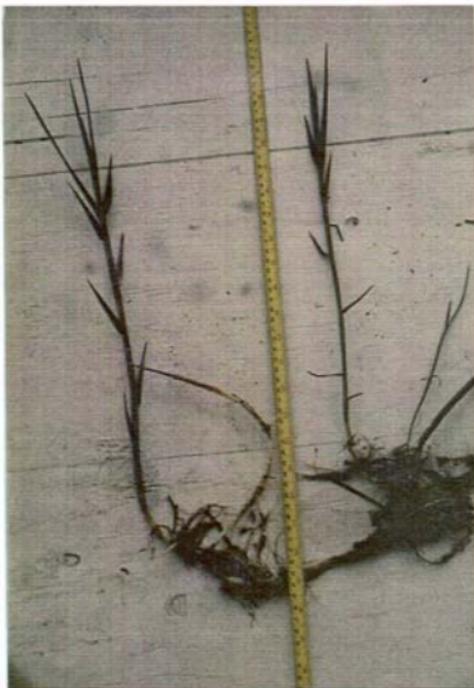
Figure 27. An Arctophila plant. Note rhizome and numerous new shoots. This plant can be separated into at least two Arctophila planting units (APU's).

The planting unit (APU) consisted of a culm and a new shoot (Figures 27 and 28). A potato harvesting fork seemed to be the best tool for harvesting the plants. The fork would rip up an entangled mat of shoots and roots which were then separated into planting units. Preparation of the APUs required twice as much time as the digging process. Therefore, two persons were needed to separate and prepare APUs for each person digging plants. Digging and preparation of 100 planting units took 3/4 of a man-hour.

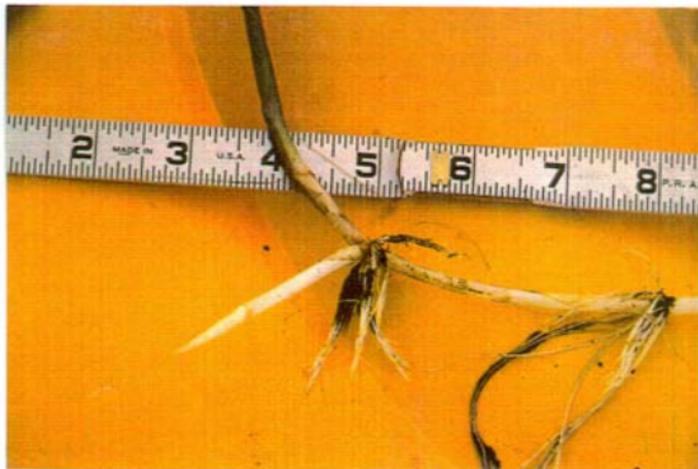
Figure 28. Close up of the rhizome, new shoot and the root system of an Arctophila plant. This is enough plant material to make one APU.

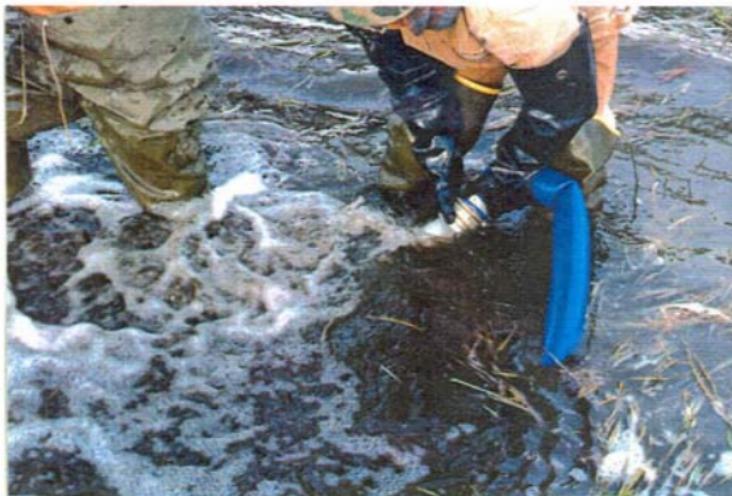
Figure 30. A three-inch water pump was used to flush the substrate from the root system of an *Arctophila* stand.

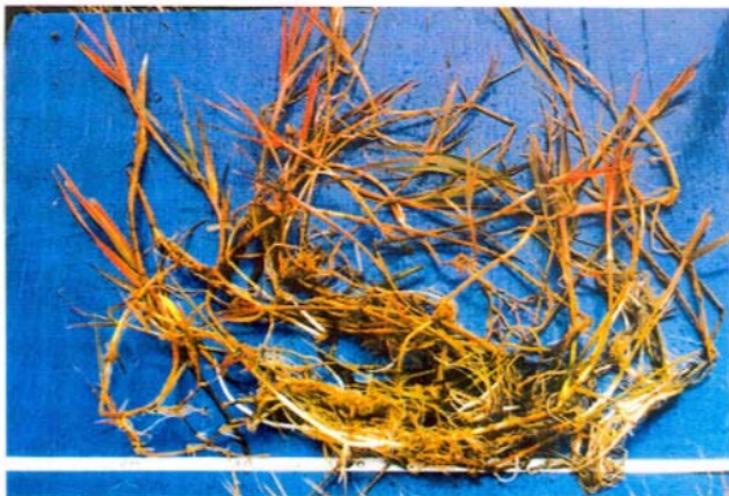
Figure 31. This clump of shoots, roots and rhizomes is ready for planting. The clump should be secured to the substrate with two staples and then fertilized.

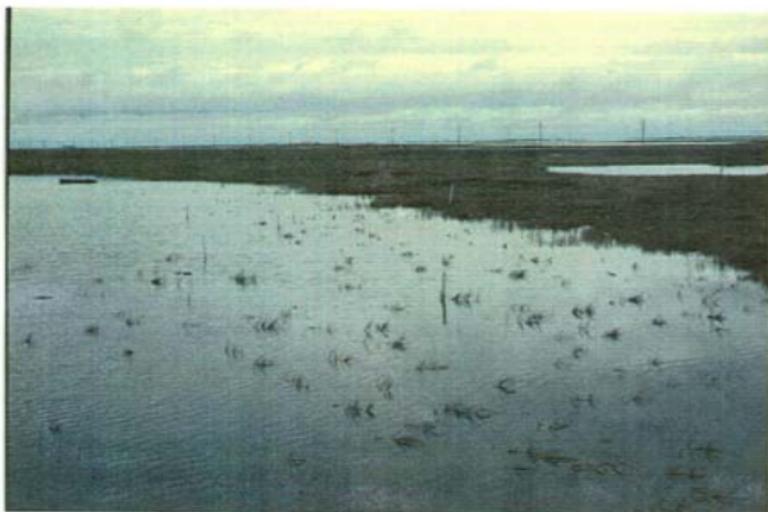
Figure 32. The planting near Drillsite 2D in August, 1988.

The focus of the 1988 plantings was to determine how long it takes a labor crew to harvest and plant *Arctophila*. The plantings were made around the edge of a large pond adjacent to Drill Site 2D. The exact count of the number of clumps planted was not recorded. Evaluation of the survival of the planting was strictly qualitative based on a photo comparison. Only one winter and one growing season passed from the time of planting until the end of this initial study. Figures 32 and 33 indicate that this planting is performing well.

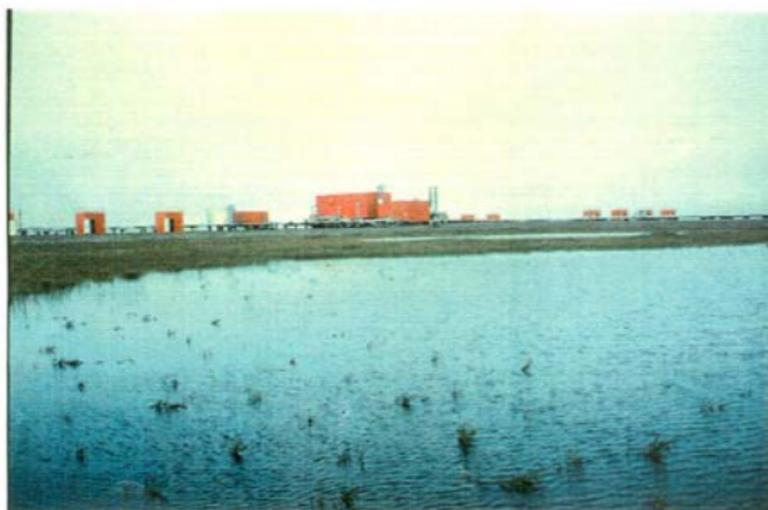
Figure 33. The same planting one year later, August, 1989.
