KENSINGTON MINE ANNUAL MEETING for 2011

KENSINGTON GOLD MINE

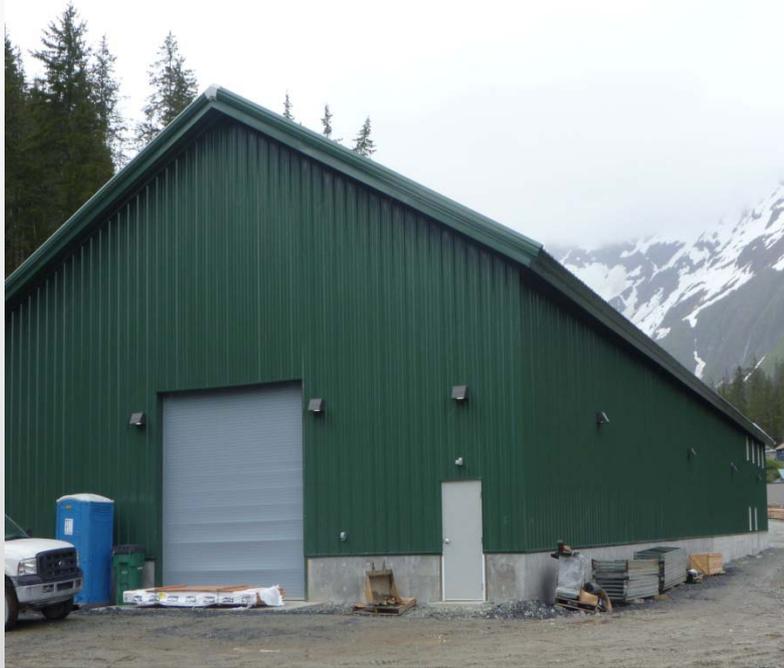
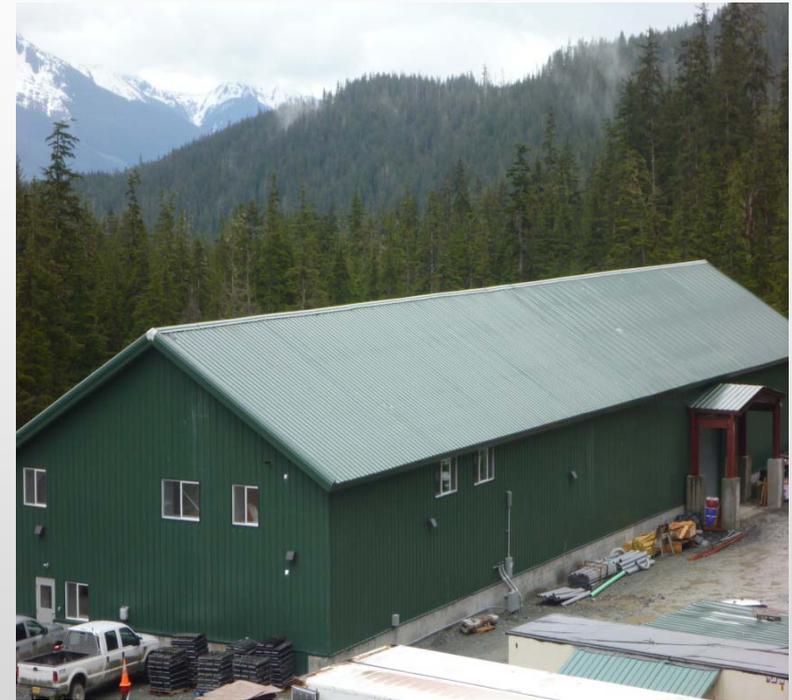
Surface Warehouse Construction

- 10,000 Square Feet Building for Warehouse & Offices
- Planned opening is July 1st, 2012

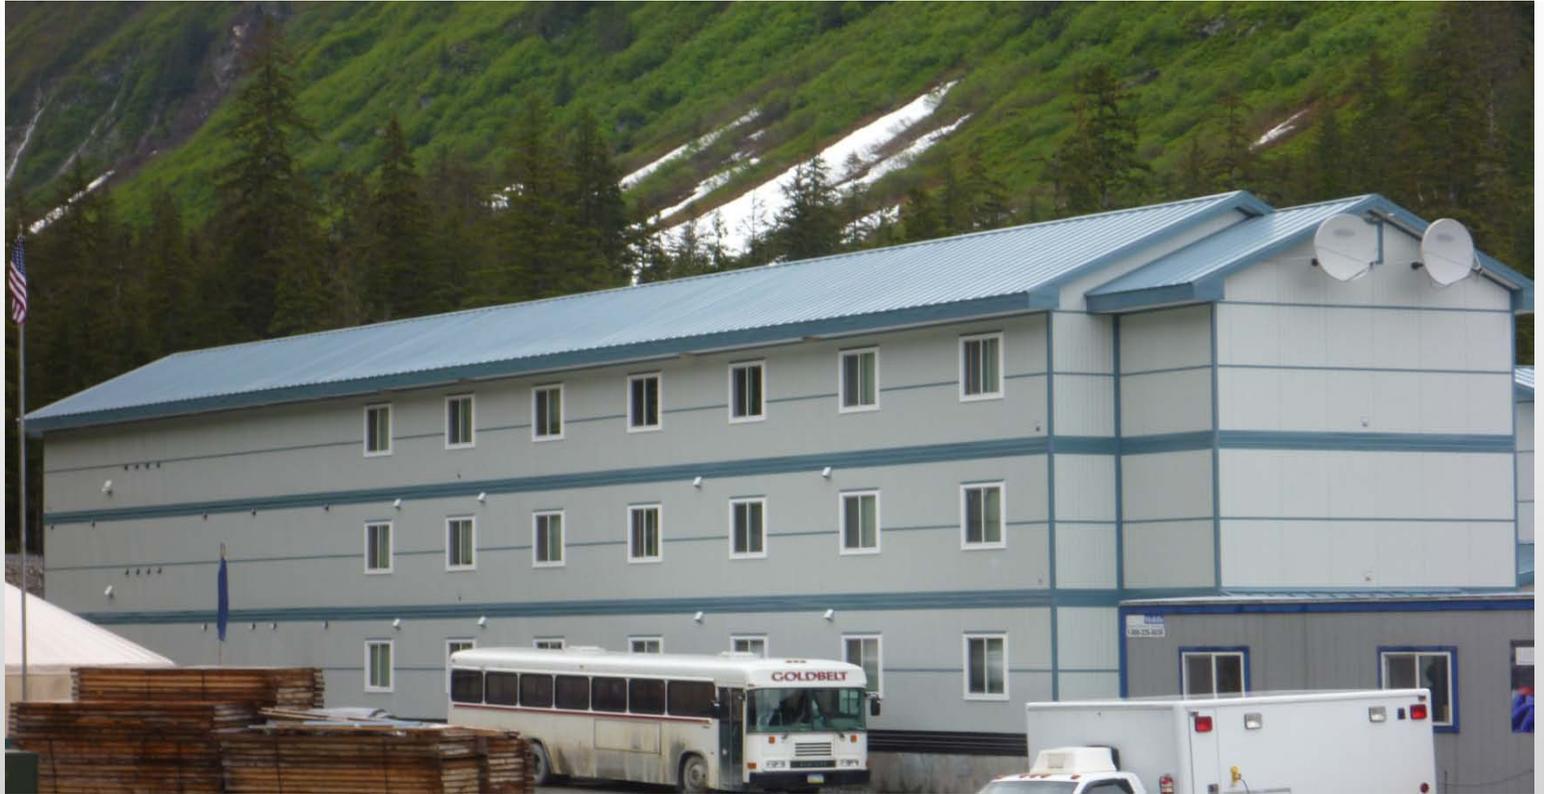
3-Story Dorm Facility

- 96 person dormitory structure
- 12,228 square feet building

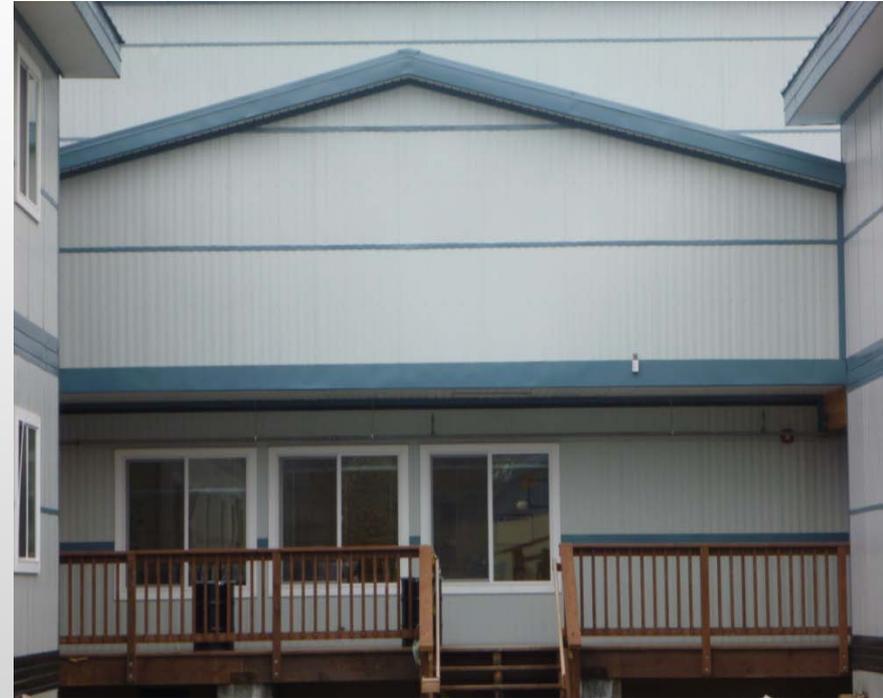
Expansion of Kitchen & Dining Room

- Expanded by 1618 SF; from 3083 SF to 4701 SF
- Constructed Covered Walkways/Stairs

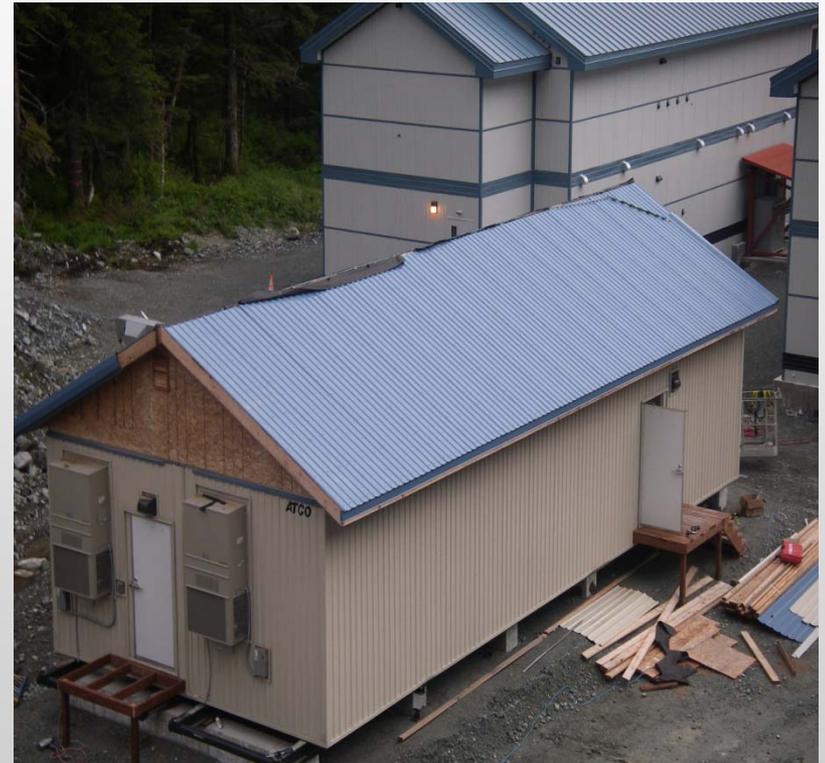
Surface Dry Facility Construction

- 1000 square feet facility
- Worker shower, laundry, locker facility

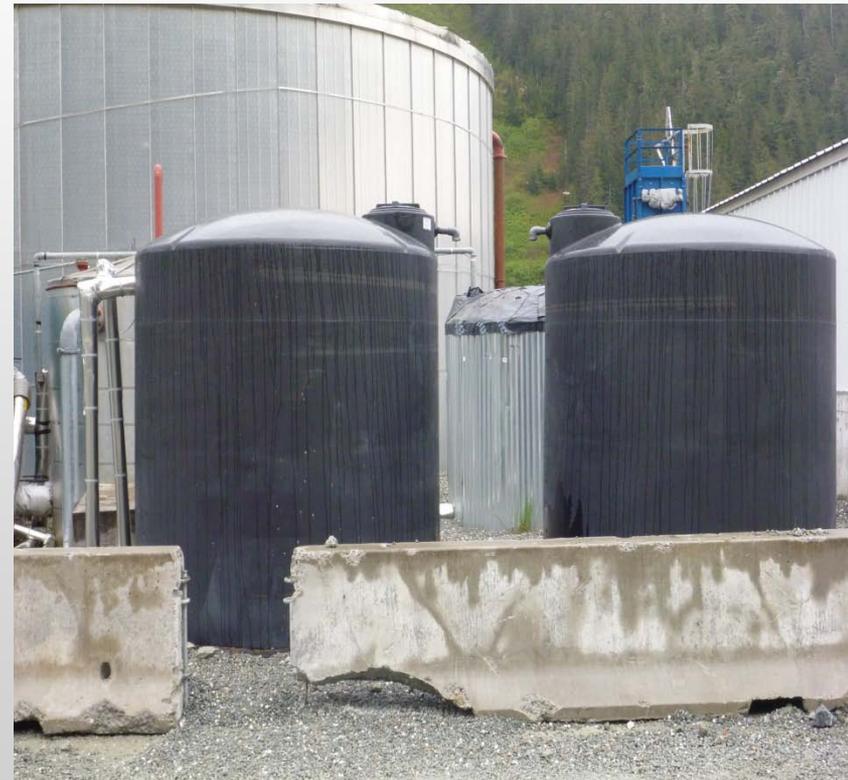
Upgrade of Potable Water System

- Addition of 2 tanks (additional 5000 gallons of storage)
- Installation of larger multi-media tanks
- Increased treatment capacity (6 to 14 gpm)

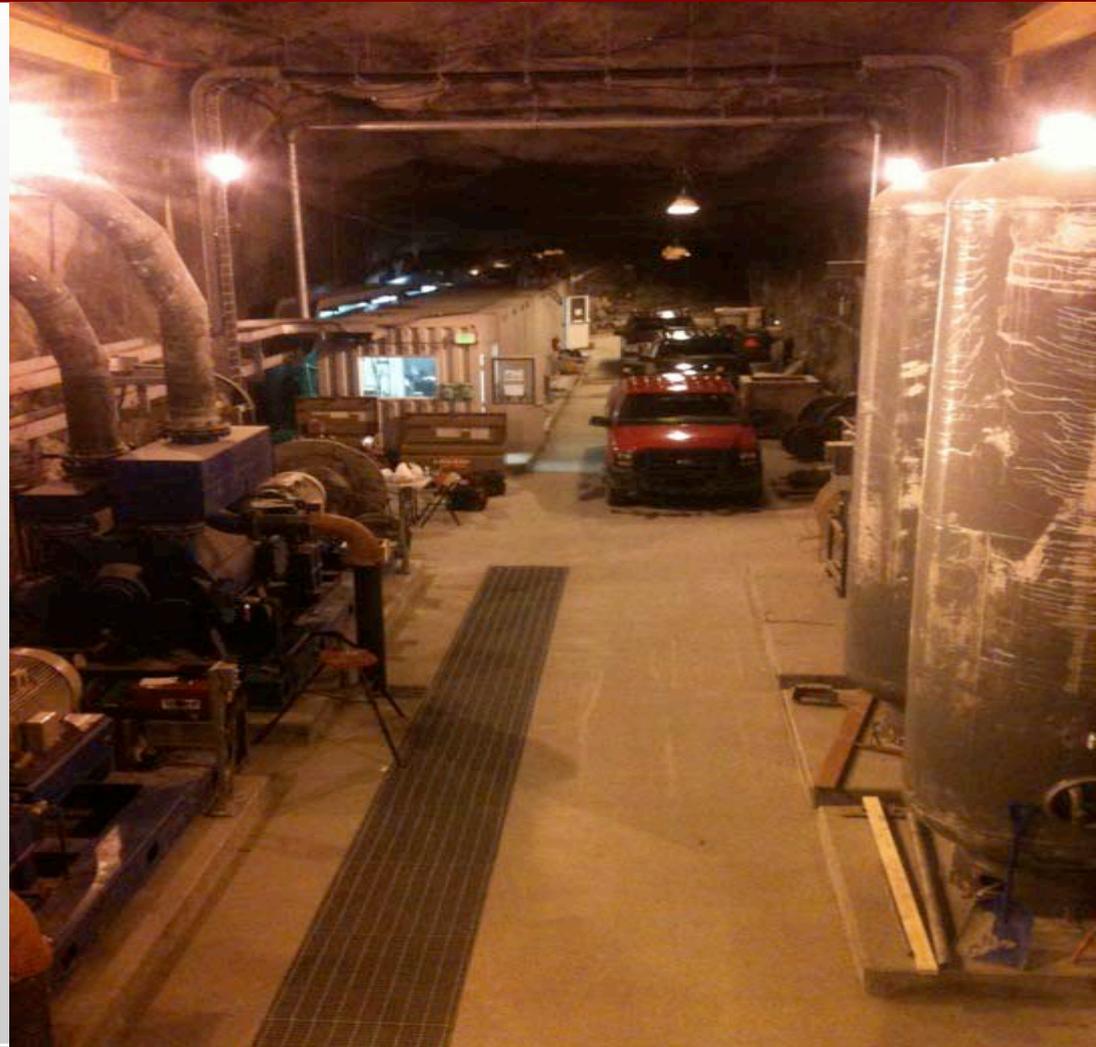
Paste Plant Construction

- Looking North From the 947' Deck, Overlooking the Vacuum Pumps, Air Receiver Tanks, and the Electrical MCC Area

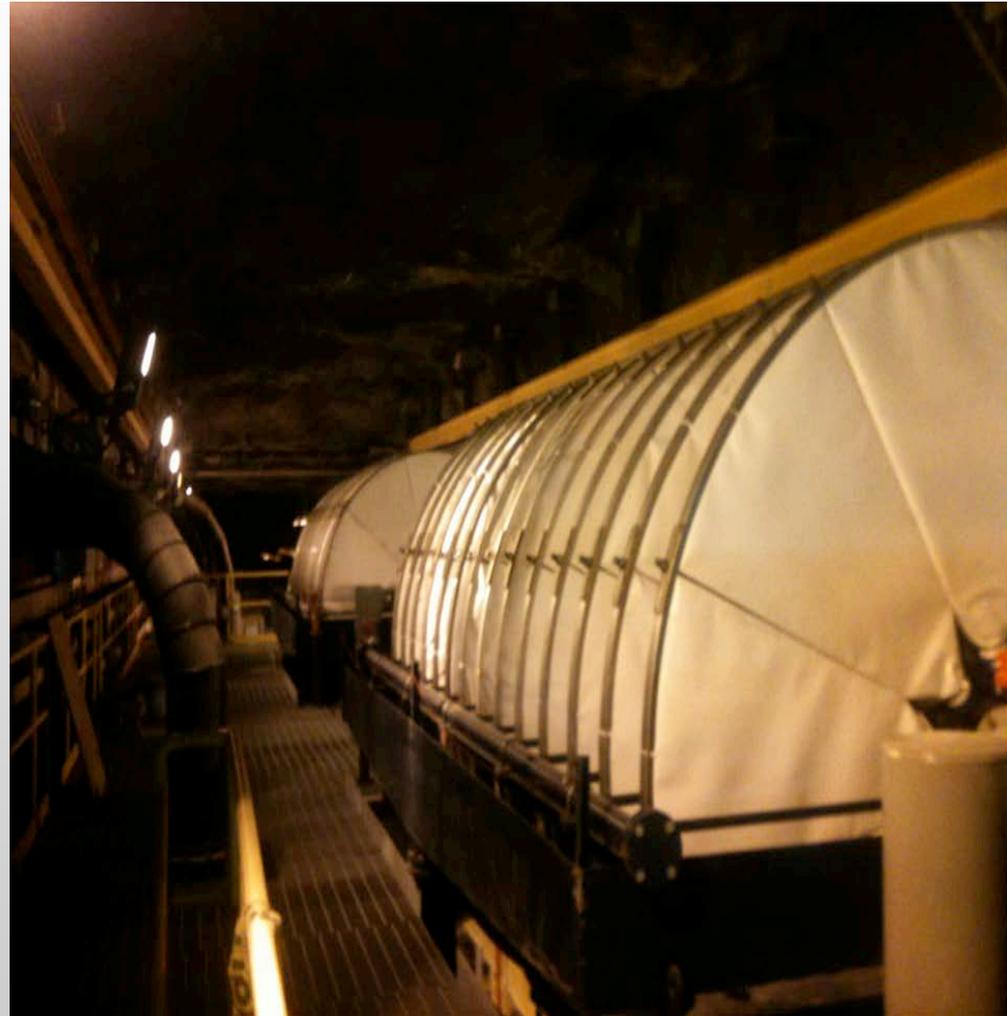
Paste Plant Construction

Looking
North at the
947' Disk
Filter Deck.

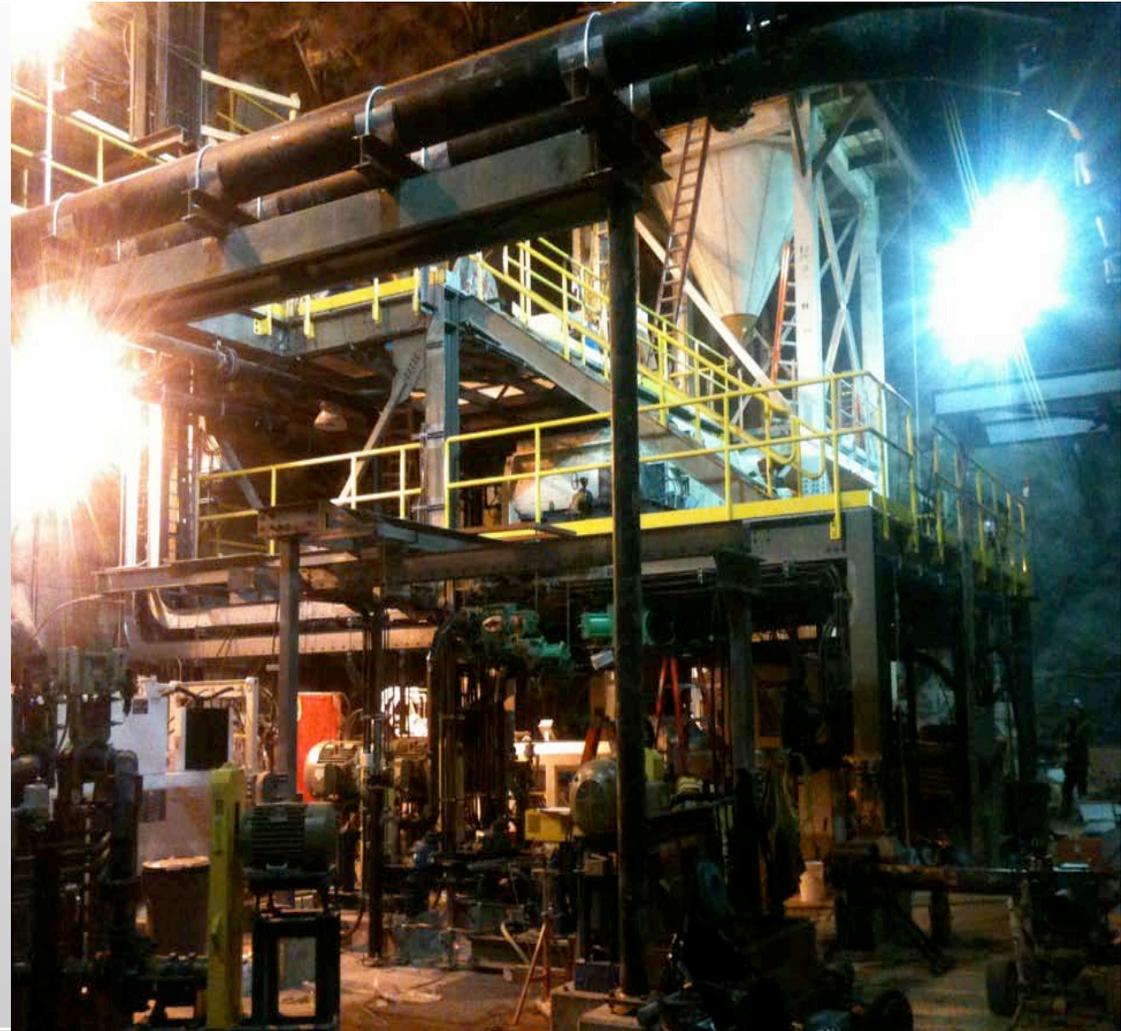
Paste Plant Construction

Looking East
at the Tailings
Pump,
Hydraulic
Unit, Mixer
Deck, with the
Cone of the
Cement Silo in
the
Background

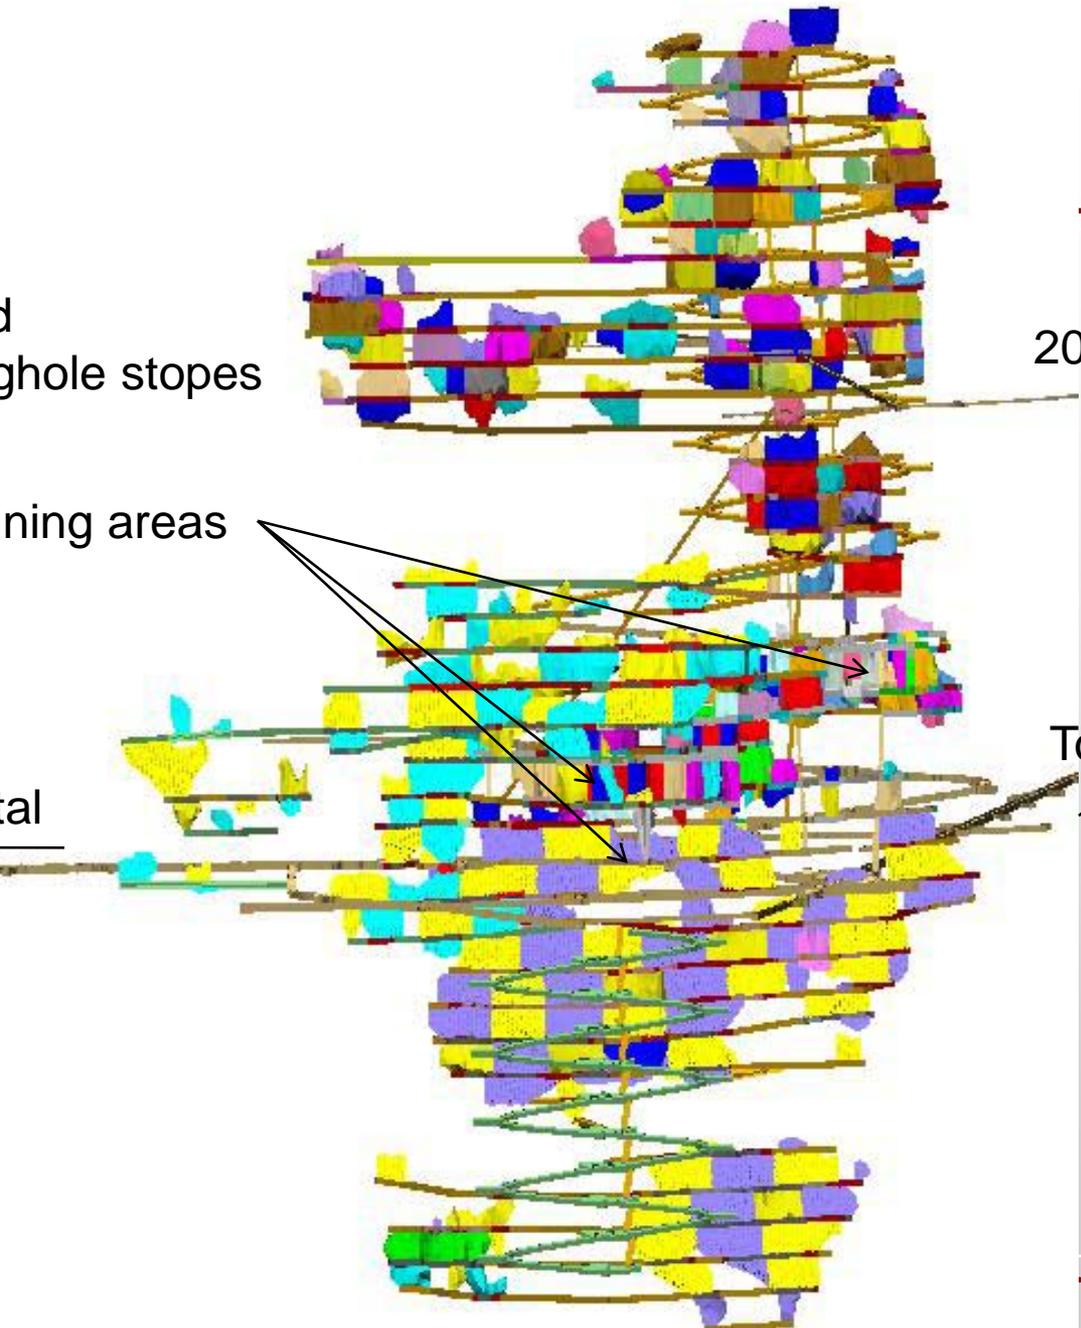
Existing and proposed development with longhole stopes

- Based on the resource model developed by Coeur Alaska geologists.
- Mine plan developed by Coeur Alaska engineers.
- Mining method is mostly transverse longhole stoping with limited drift and fill in large, high grade shear veins.
- Production profile is 1350 tpd through 2023.
- Ore modeling of the Raven deposit near completion, first pass mine planning 2nd half, 2012.

Current mining areas

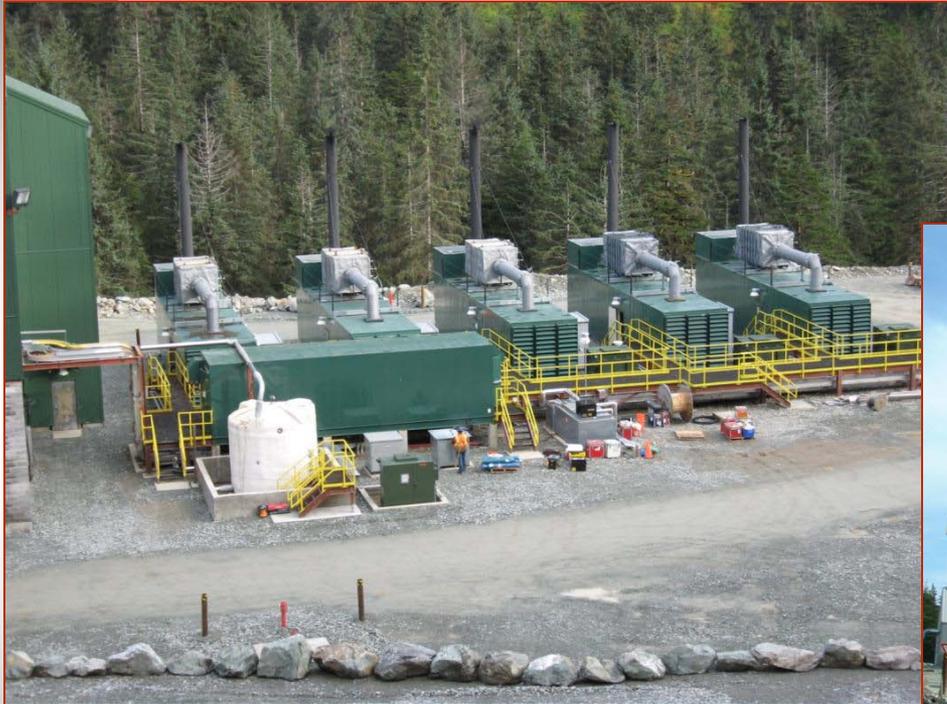
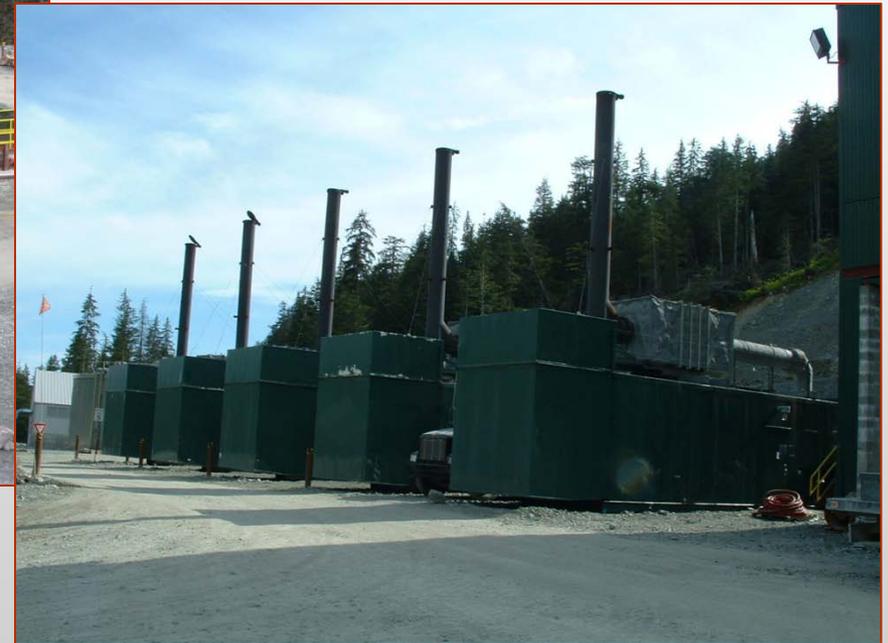
Power Generation

Five Independent, 1.75Mw (each) Diesel Powered Generators;
with a sixth gen-set being commissioned in 2012.

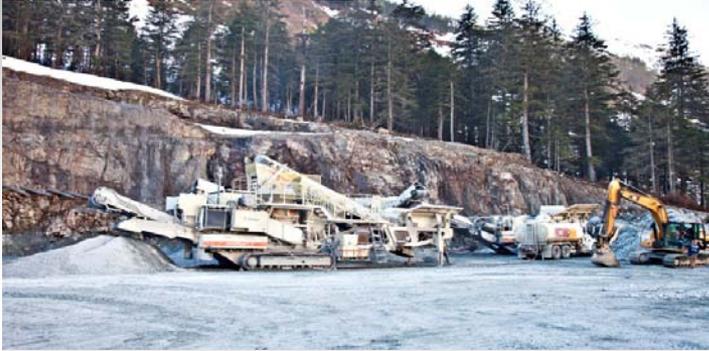
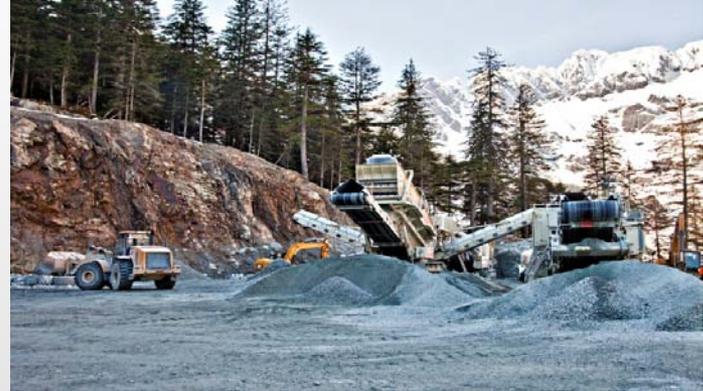
- Portable Crushers & Screening Plant Producing Mill Feed, while the Kensington Crusher Facility is undergoing Renovation.

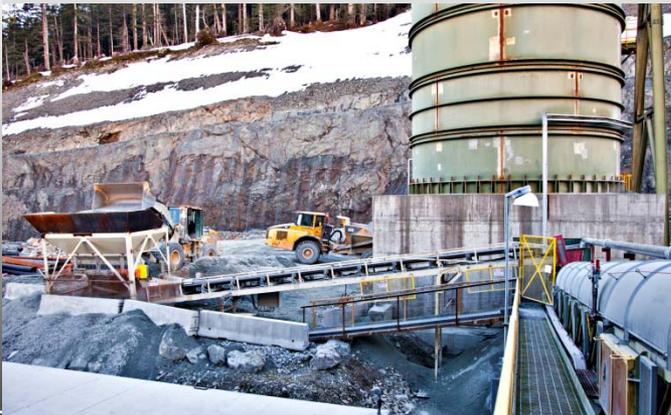
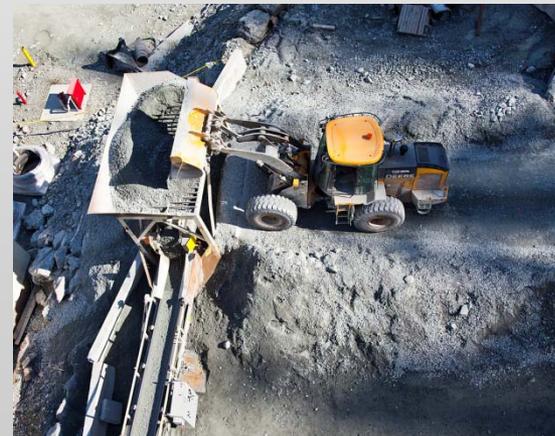
- Hopper-Feeder & Jump Conveyor for By-passing the Fine Ore Bin System, while the Crusher Facility is undergoing Renovation.

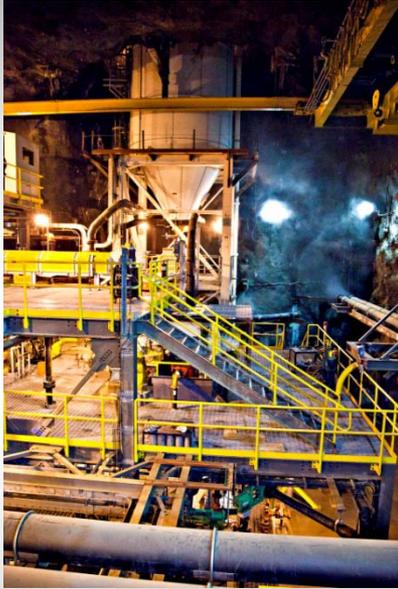
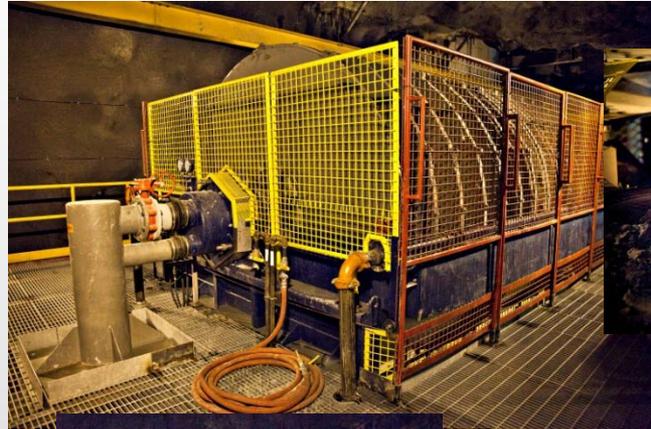
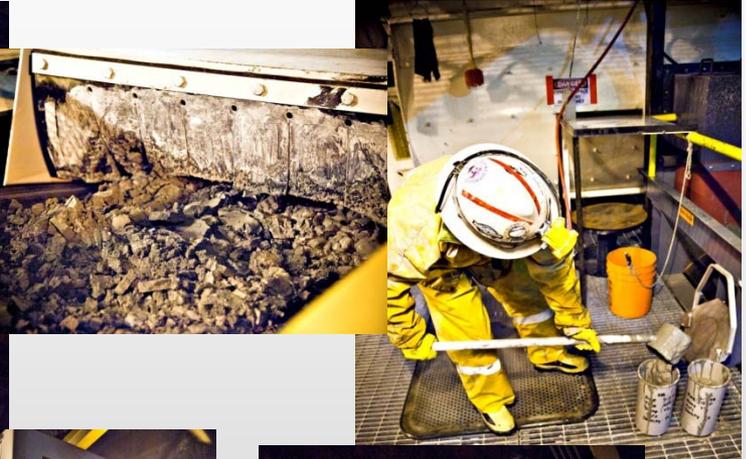
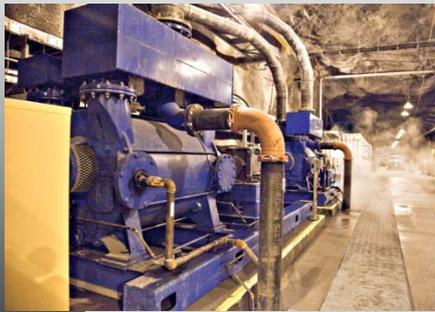
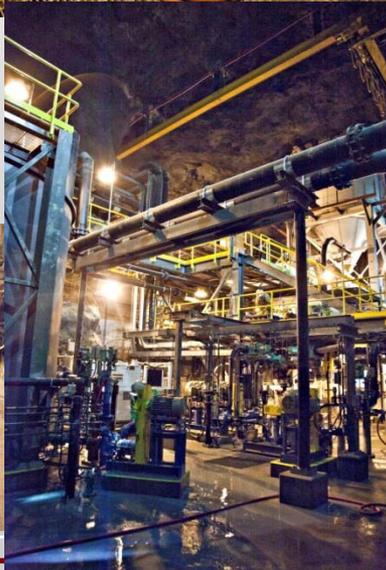
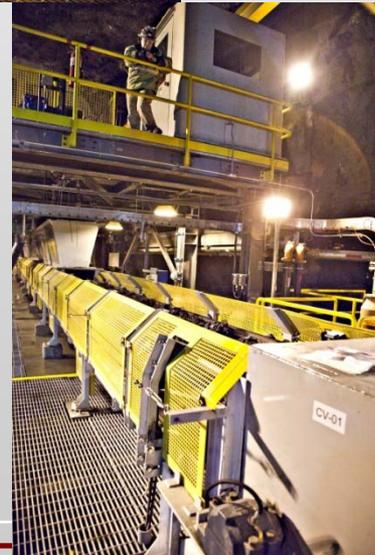
- Paste Plant – In Operation May 2012

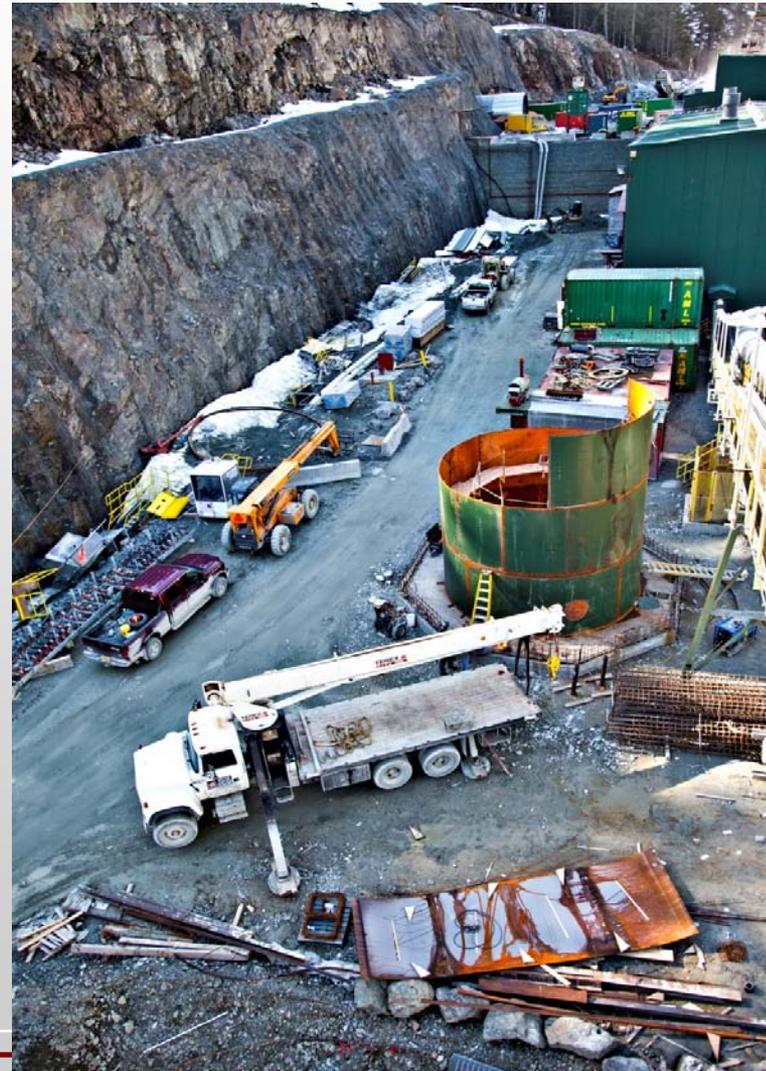
- Construction of Intermediate Tailings Holding Tank

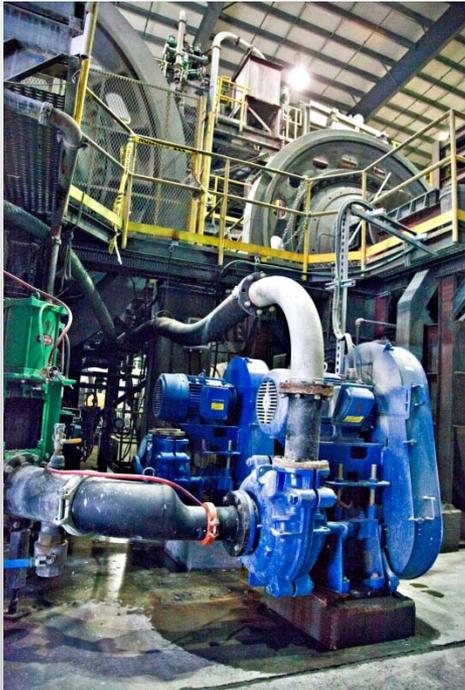
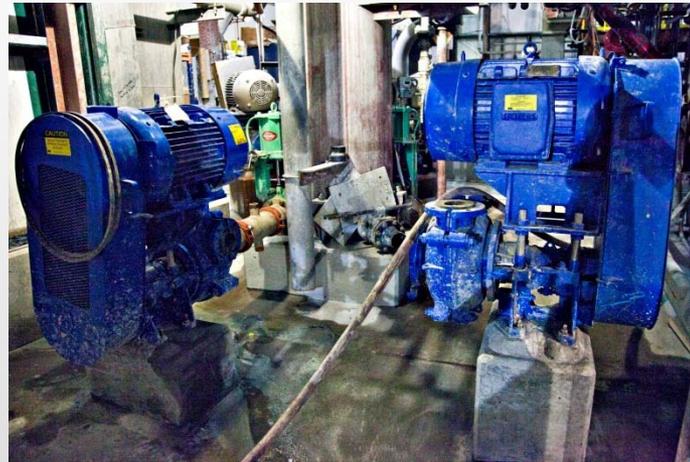
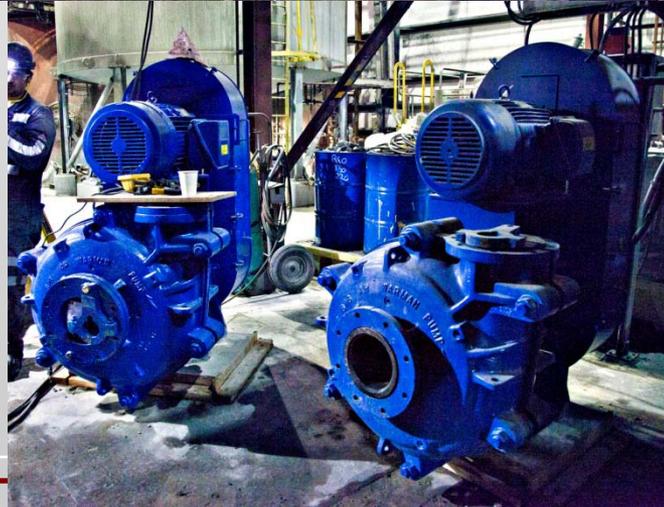
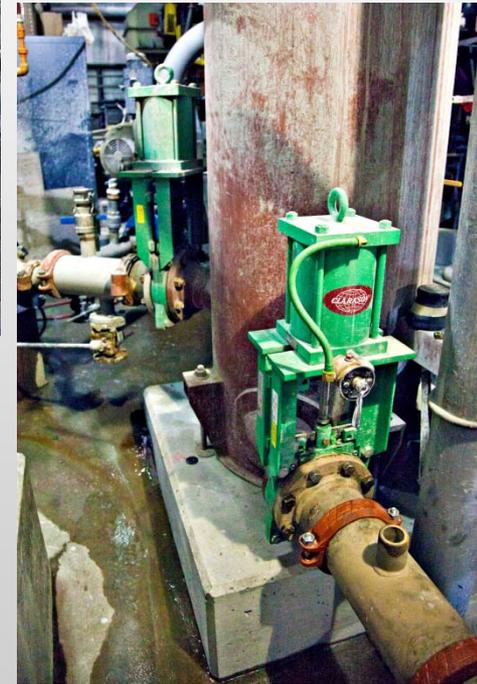
- Redundant Pump Installation in the Milling Facility

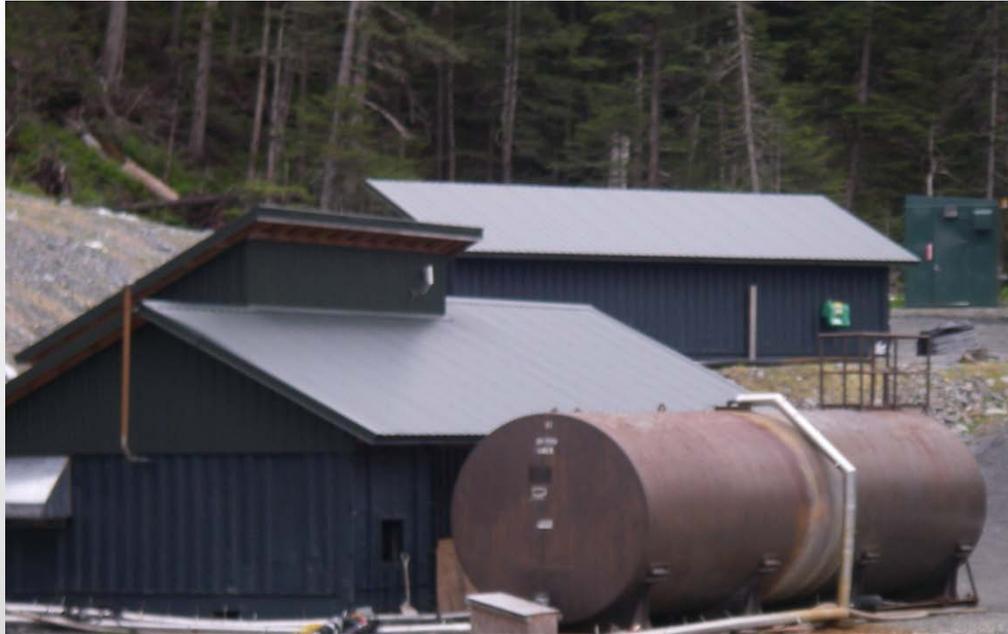
Temporary Package Water Treatment Plant at TTF

- Rotating Cylinder Treatment System (RCTS)
- Lime/Flocculent Addition
- Automated System
- Flows average 5-15 gpm/Influent pH increased

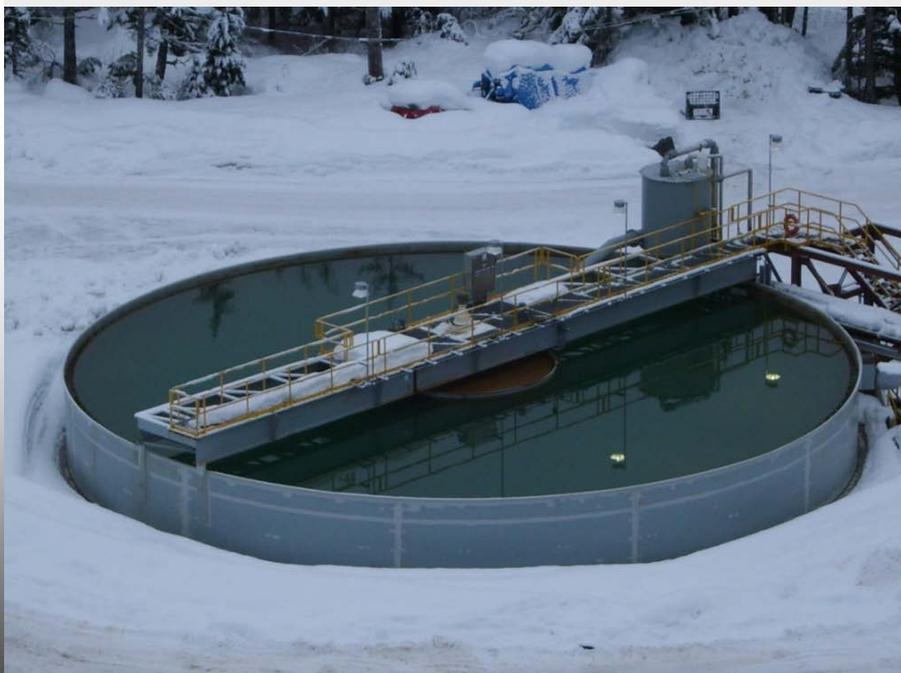
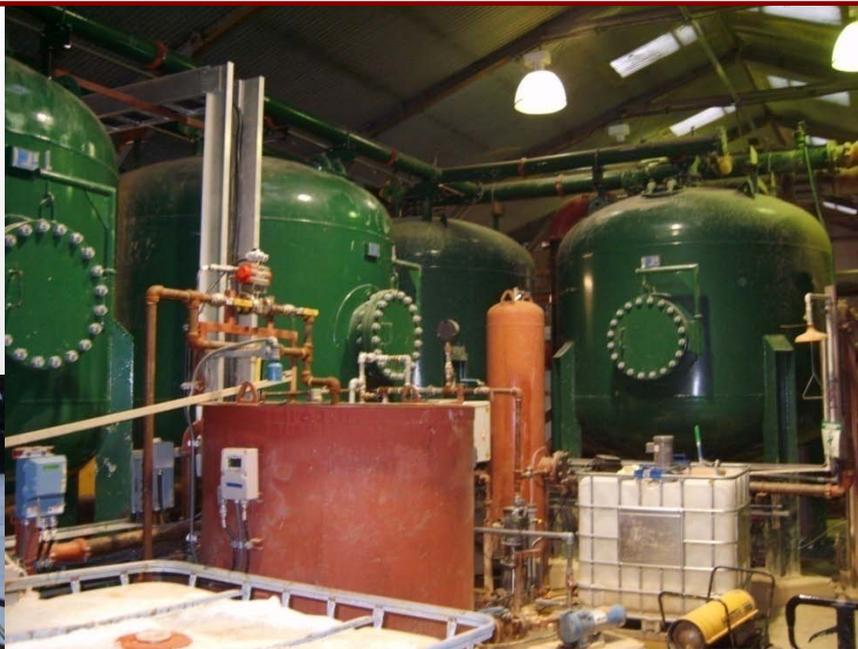
Comet Mine Water Treatment Plant

On the whole, Outfall 001 effluent discharges...

- Follow seasonal cyclic trends for temperature and dissolved oxygen
- Typically have very low levels of turbidity
- Contain total recoverable metals mostly at or only slightly above detection limits
- Are monitored for constituents that are typically well under permitted limits

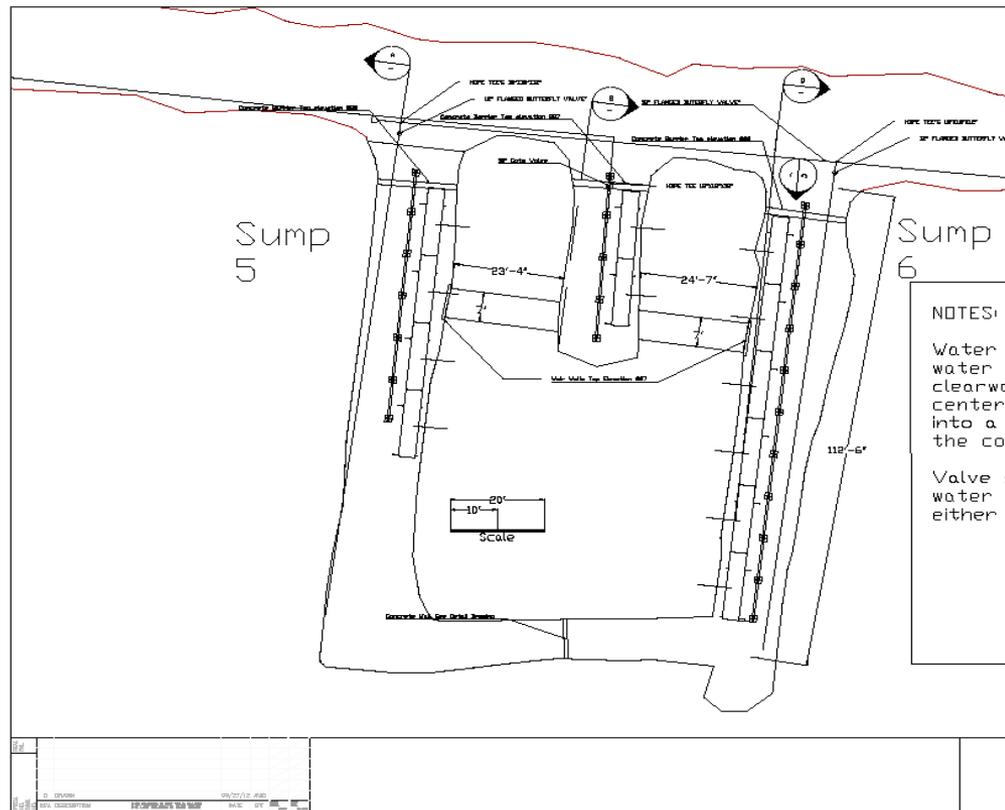
2012 Planned Activities: UG Triple Sump

Capture and Remove Sediment Prior to Exiting UG mine; Ability to Remove Sediment without affecting mine water quality

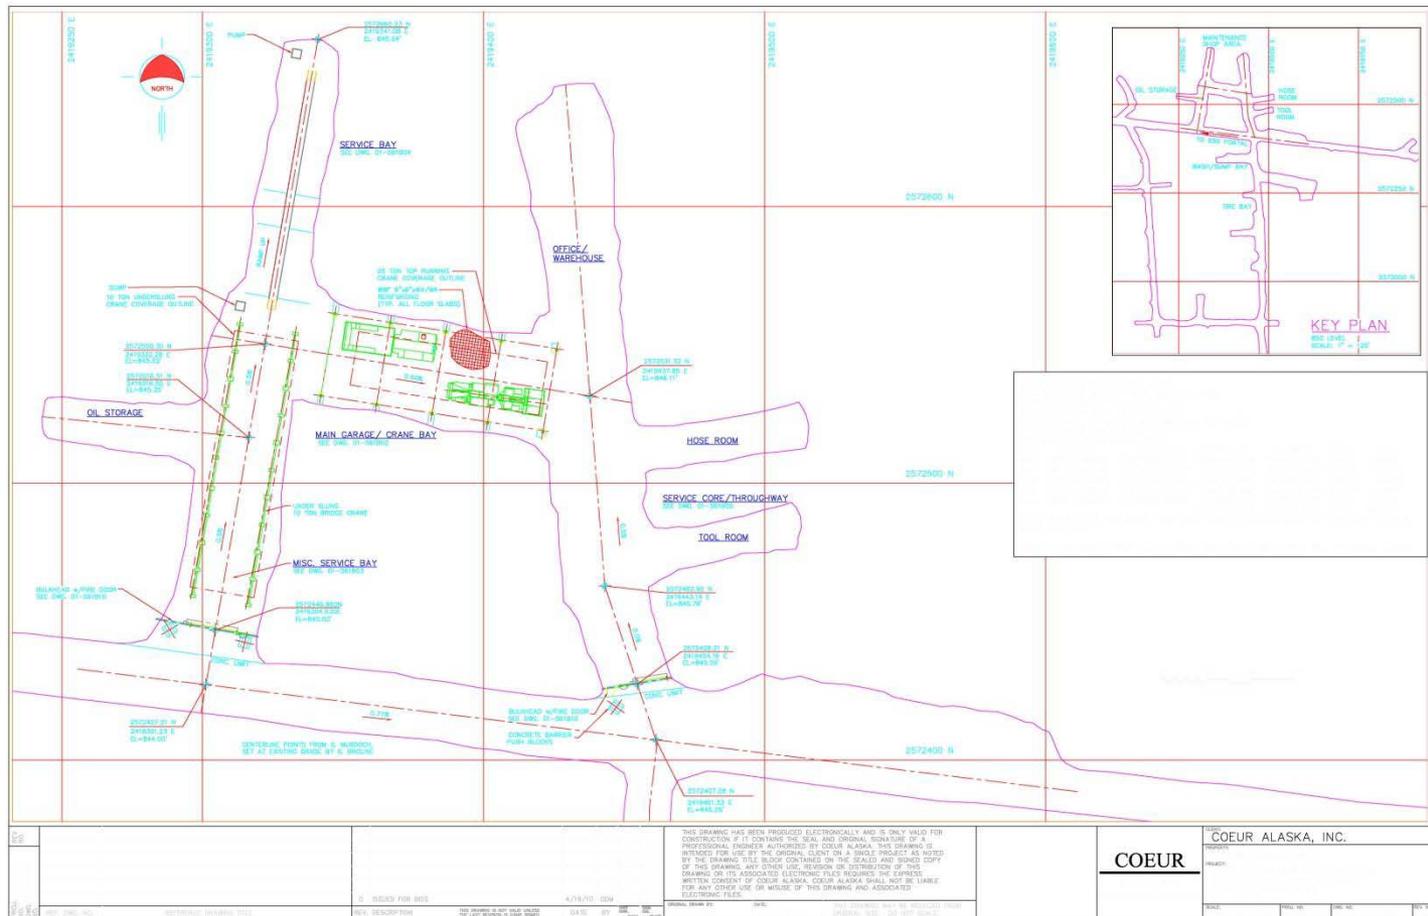
2012 Planned Activities: 850 Level Maintenance Facility

18,000 ft² of workshop, service, and warehouse space. 25 and 10 ton cranes.

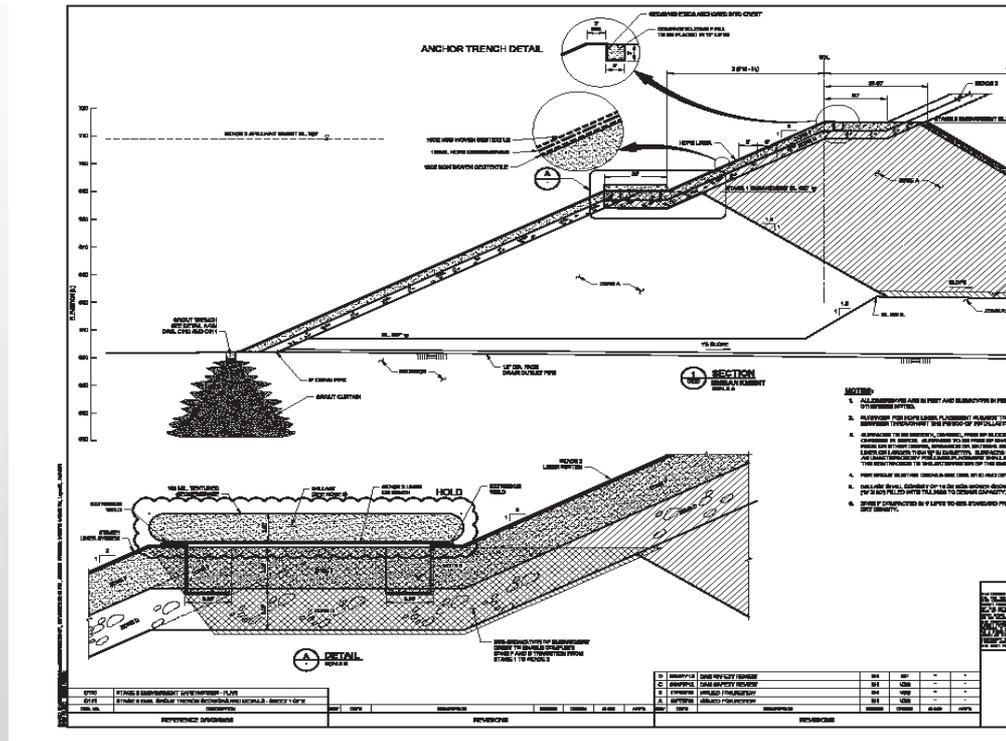
Stage 2 - Tailings Treatment Facility

- Begin Construction Activities in June 2012
- Increase height from 690' to 715'

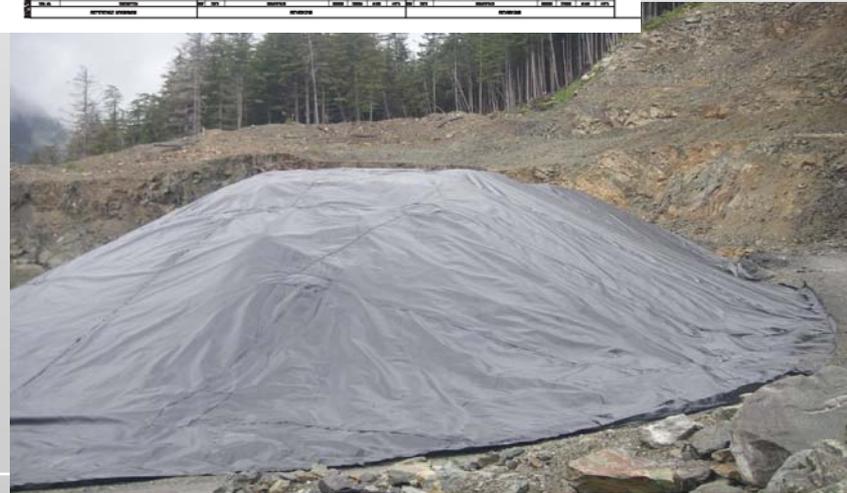
Graphitic Phyllite Temporary Storage Cell Construction

- Construct new containment cell for storage of Graphitic Phyllite (GP) (Expect 5500 cy; Capacity of 8000 cy)
- GP from the construction of the interim emergency spillway
- Spillway will be shot-creted to seal-off the GP
- Water collected in cell and conveyed to sump and transported to temporary package water treatment plant at TTF for treatment
- Under Liner sealed to Top Liner
- Temporary Storage until 2014 at which time it will be encapsulated in paste tailings in an underground stope

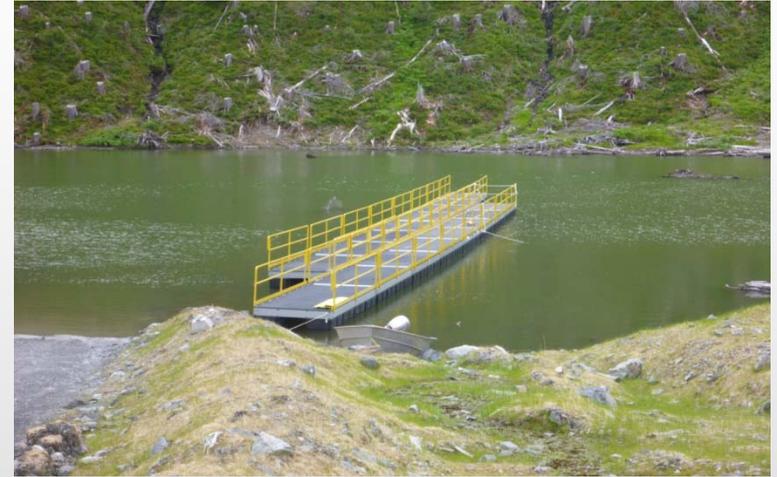
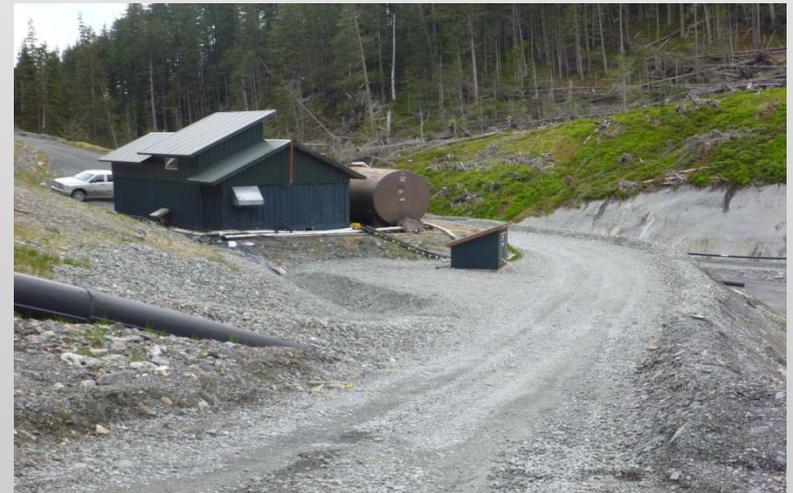
Tailings Treatment Facility

- Upgrade Reclaim Barge and Access
- Re-locate collection sump at Temporary Package Water Treatment Plant
