**APPENDIX D –
AS-BUILT REPORTS**

FLUMES

RE: As-Built Report for Installation of the 4-Ea Flumes in Liese Creek, Pogo Mine.

LIESE CREEK Flume's AS-BUILT

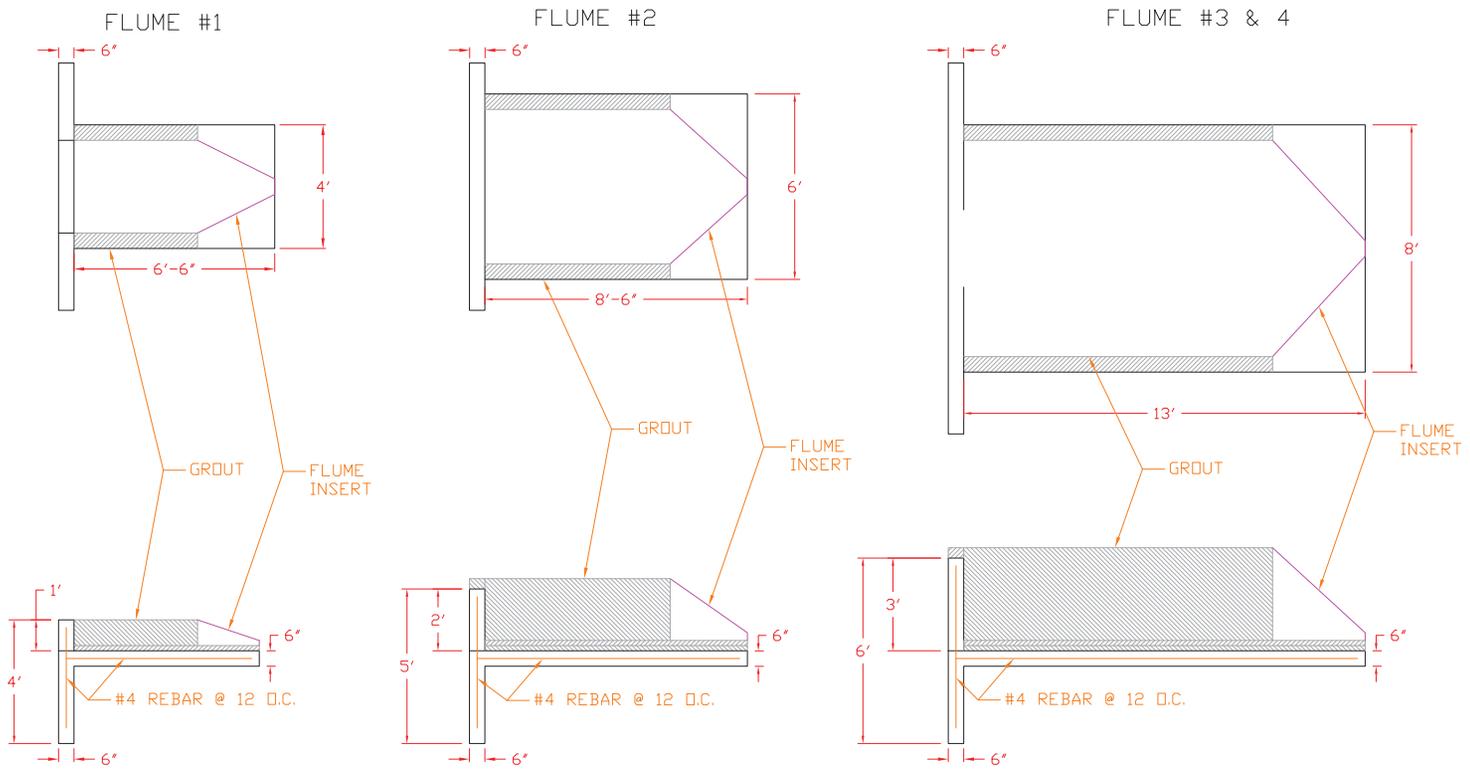
DATE:	...
PROJECT NO.:	...
DRAWN:	SPH
CHECKED:	SPH
TITLE:	SITE PLAN
SHEET:	C1.1
REVISION:	AS-BUILT

- NOTES:
- 1) ALL REBAR #4 @ 12" O.C.
 - 2) HEADWALL DOWELS #4 AT 12" O.C.
 - 3) 1' FLUMES ONLY REQUIRED 1 LAYER OF GROUT
 - 4) 2' AND 3' FLUMES REQUIRED 2 LAYERS OF GROUT DUE TO REPLACEMENT OF INSERT

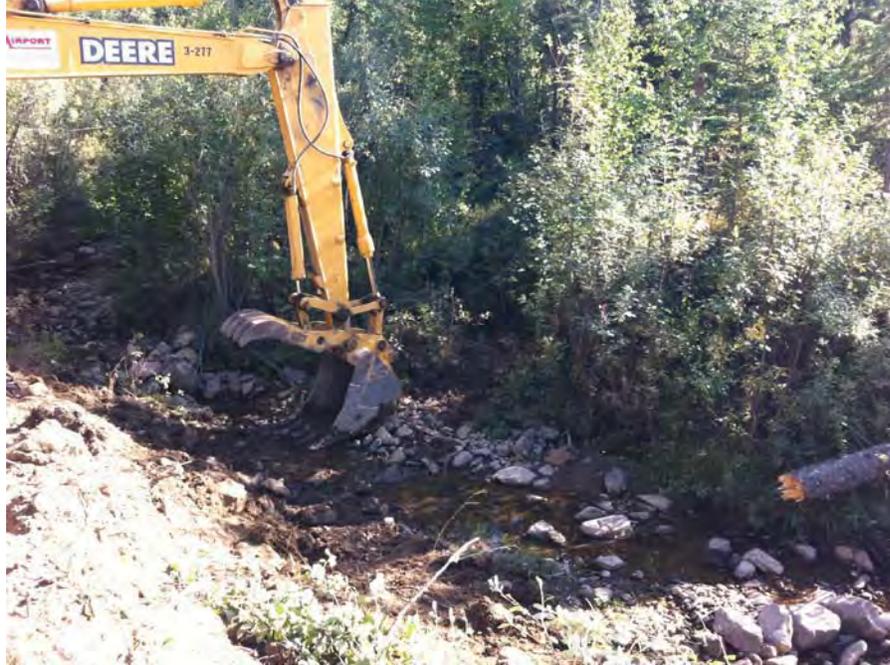
Photo 1: Excavation & Water Transfer Activities at Flume #4

- A Sump was excavated and lined with plastic ~20' ahead of the flume locations. The 4" de-watering pump was used to move the stream around the weir construction site;
- The excavator was used to move large boulders and to level the area where the flumes were to be located. A trench was dug for the below grade portion of the headwall;
- The headwall and flume base slab was formed, rebar and inserts installed, and concrete mixed and poured;
- The fiberglass insert was then set into place, leveled, and anchored to the base slab;
- The headwall upper section formwork was then custom fitted to the fiberglass insert, rebar installed, and concrete mixed and poured. This effectively secured the flume insert into place using the headwall concrete and all thread insert anchors;

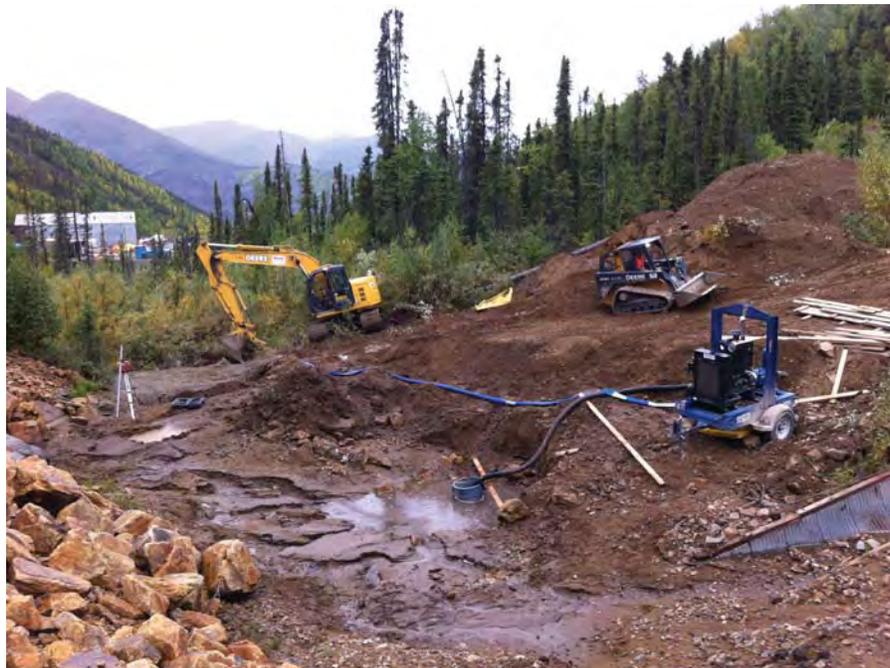
Photo 2: Excavation & Water Transfer Activities at Flume #3

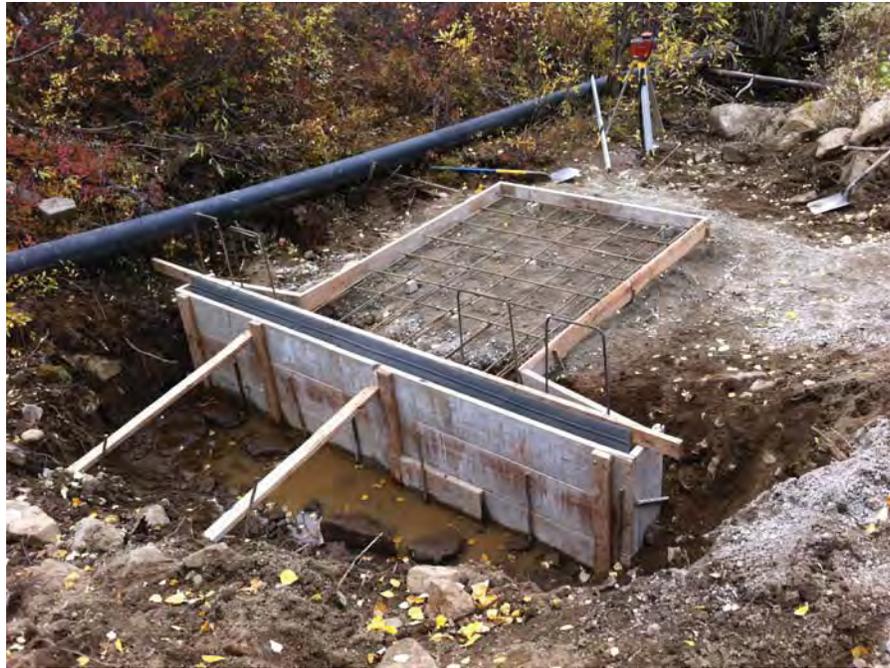
Photo 3: Base Forming Rebar, and Water Stop Flume #2 (Typ)

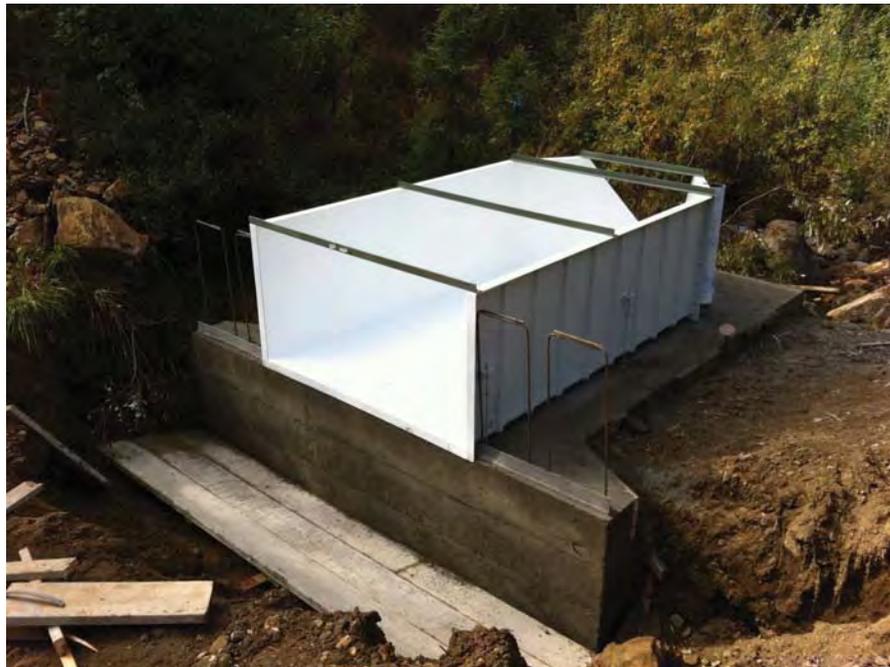
Photo 4: Form Removal and Fiberglass Insert Anchored to Base Flume #4 (Typ)

- Once removed the entire structure and immediate surrounding area was tented and heat applied for 24-48 hours prior to performing additional work;
- The new fiberglass inserts were then installed on top of the grout base and re-secured using drilled in concrete anchors and all thread. The inserts were leveled using the all thread with nuts and washers;

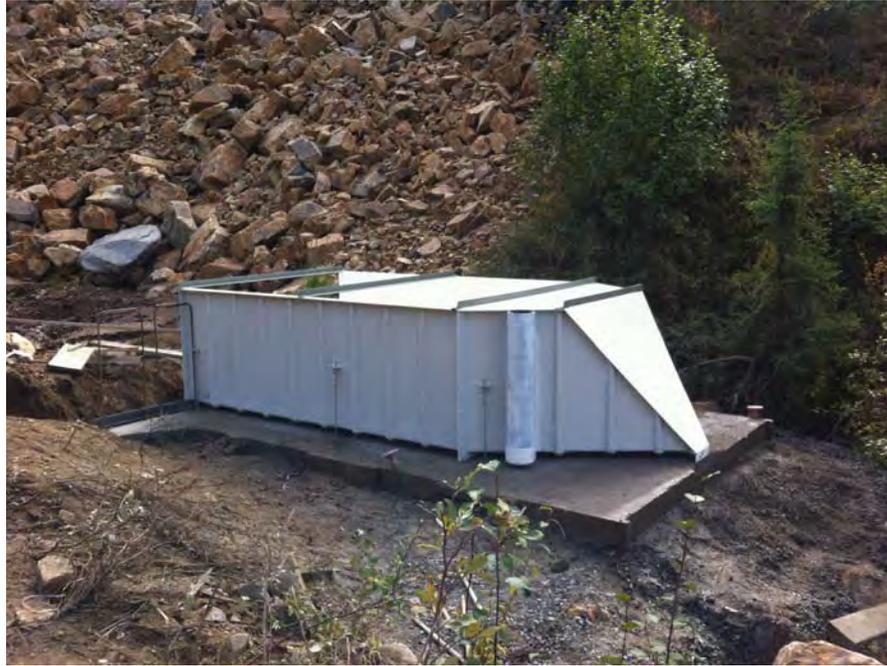
Photo 5: Side View of Anchors and Base Flume #4 (Typ)

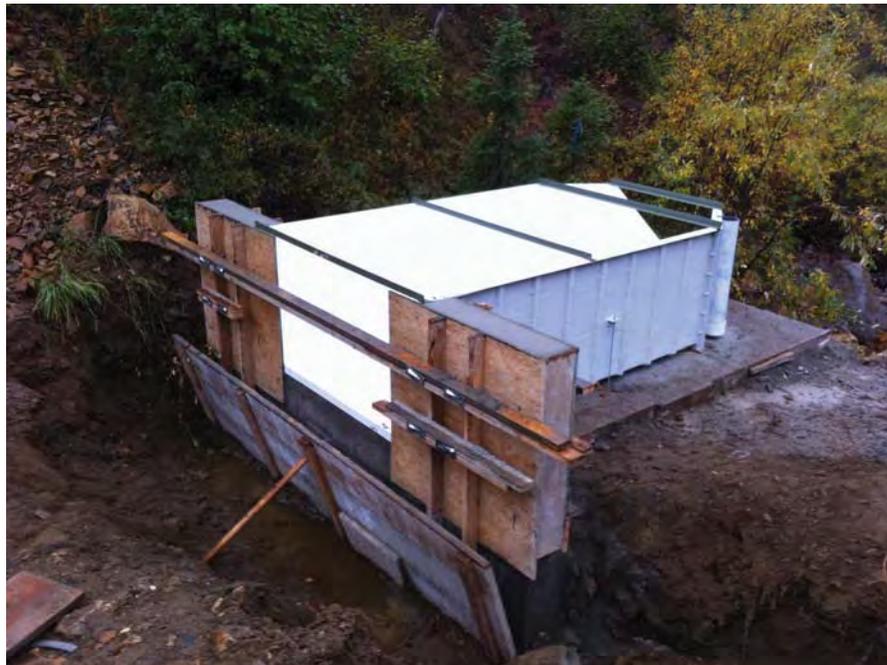
Photo 6: Headwall and Insert Concrete Flume #4 (Typ)

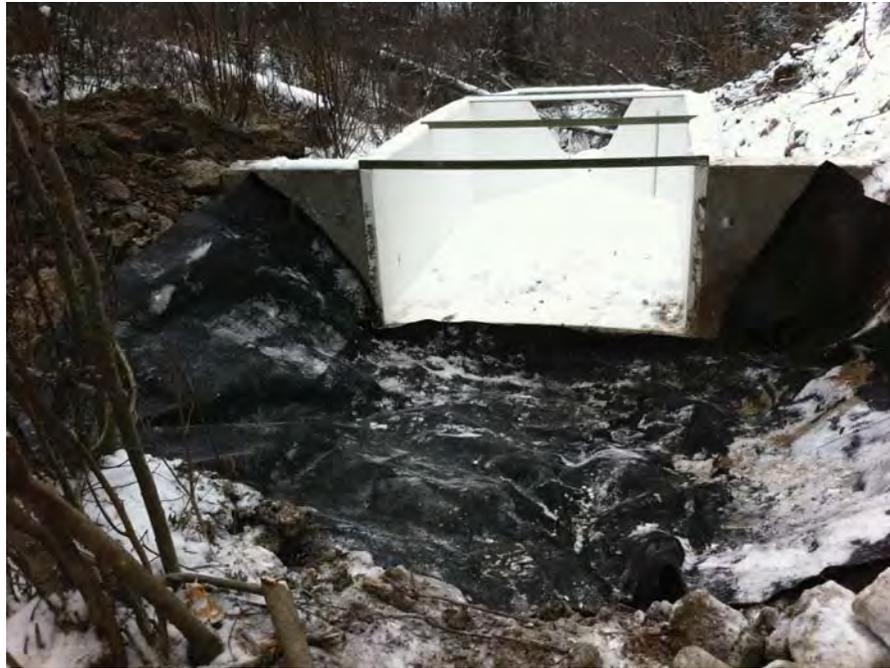
Photo 7: Geotextile Wrap at Entrance Flume #4

- During the re-installation heat was maintained on the newly placed grout for 5 days following grouting.
- Existing soils, extruded geotextile, and armor rock was finally placed at the flume entrances to allow for stream channel to feed the flume and to protect the entrance from scour and erosion.

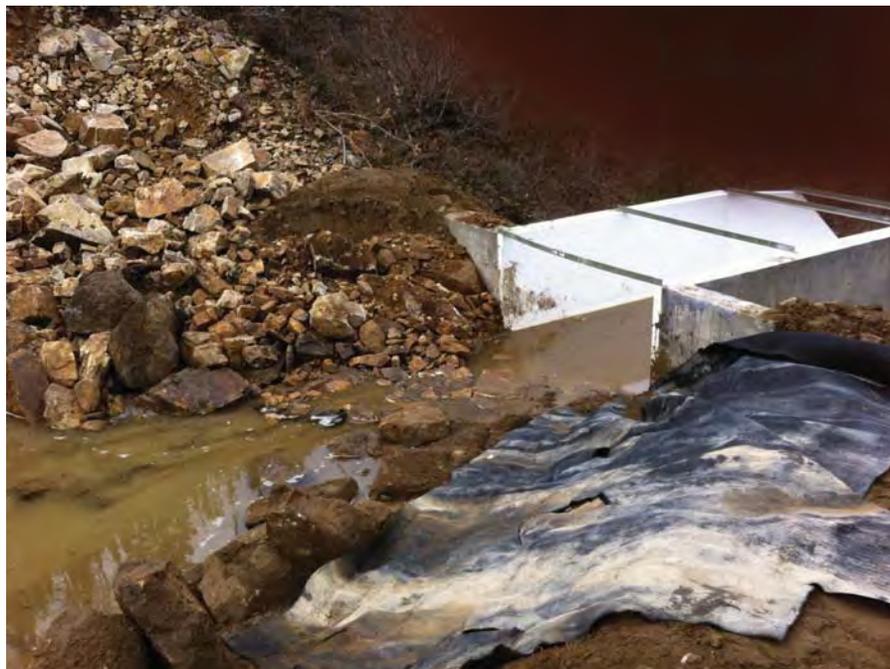
Photo 8: Geotextile Wrap Flume #3

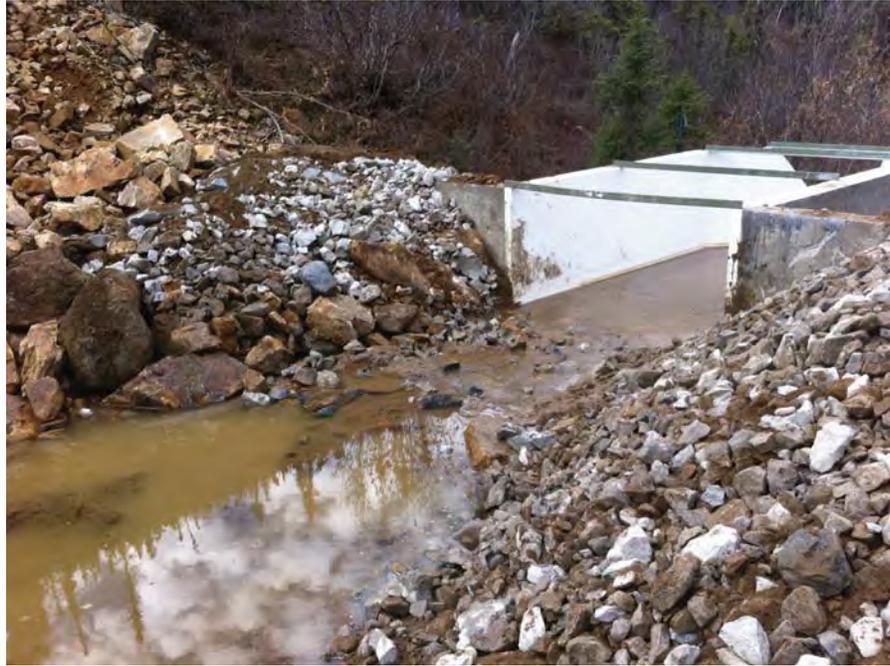
Photo 9: Rock Armor Finish Flume #3

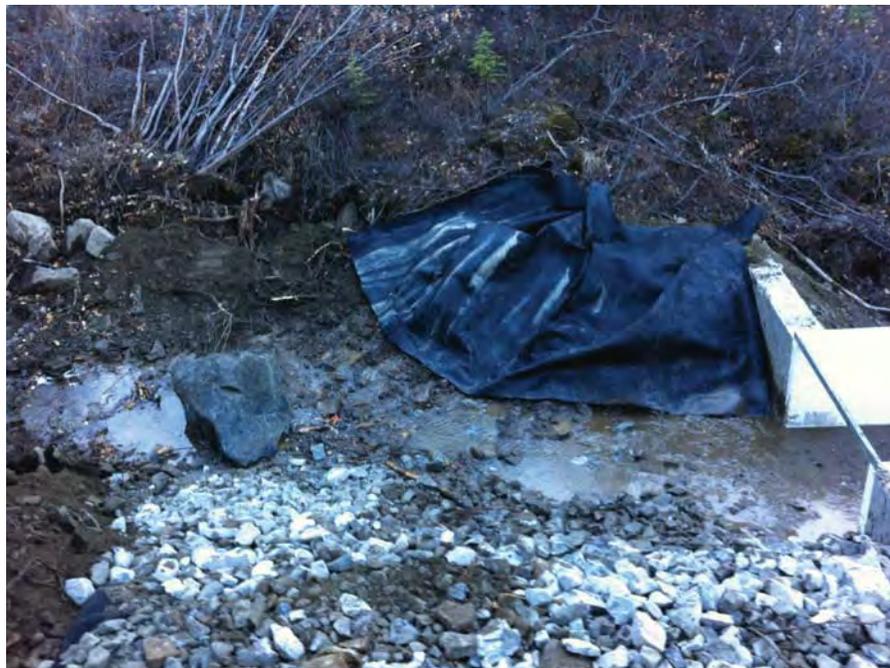
Photo 10: Geotextile Wraps and Anchor Rock Flume #2

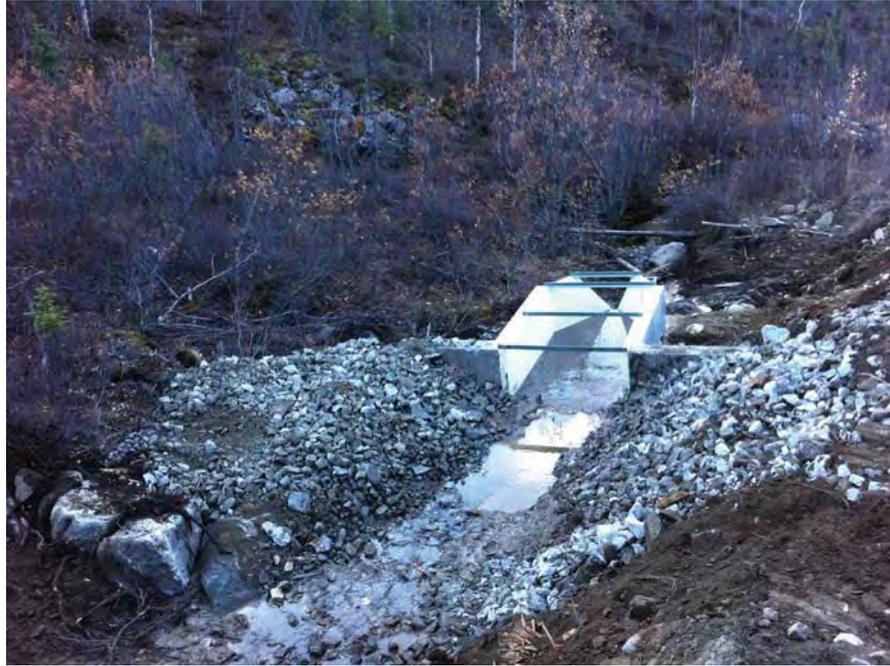
Photo 11: Wrap and Rock Armor Finished Flume #2

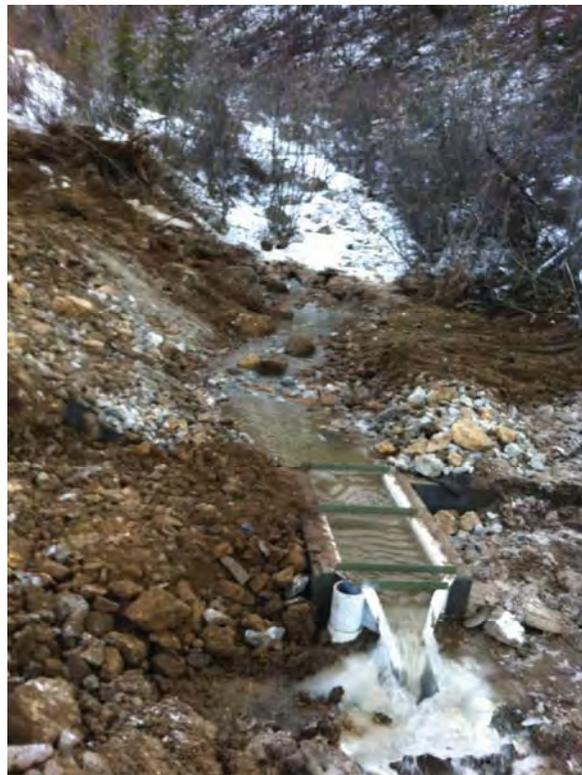
Photo 12: Geotextile and Rock Armor Finish Flume #1
