# TRIP REPORT

**State of Alaska  
Department of Fish and Game**

**Location(s):** Ikalukrok Creek and Wulik River

**Objective(s):** Chum salmon aerial survey in Ikalukrok Creek. Overwintering Dolly Varden observations in Wulik River. Capture seven adult Dolly Varden for element analysis from select tissues.

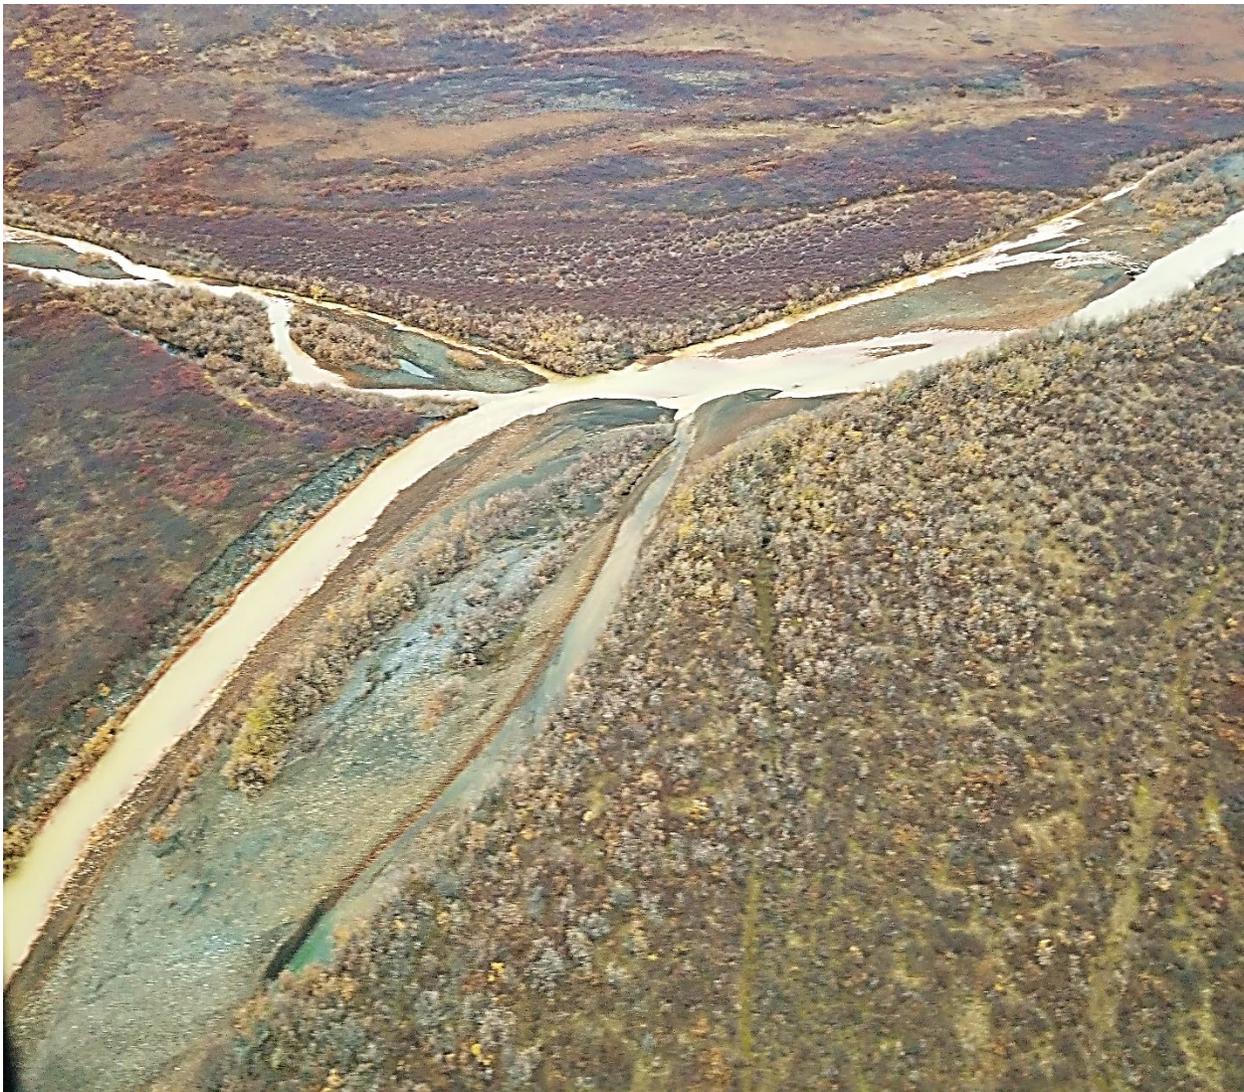
Chum salmon typically spawn in lower Ikalukrok Creek (Figure 1). We departed from Red Dog Mine on September 13 in an AC135 helicopter and followed Ikalukrok downriver from Red Dog Creek to the Wulik River. Turbid water was observed in Ikalukrok Creek from upriver of Red Dog Creek to the Wulik River (Figure 2). Dudd Creek continued to have clear water during summer 2020 despite other Ikalukrok tributaries becoming turbid in the summer of 2019 (Figure 3).

Figure 2. Confluence of Red Dog Creek (entering from left) and Ikalukrok Creek (flowing from bottom to top of picture).

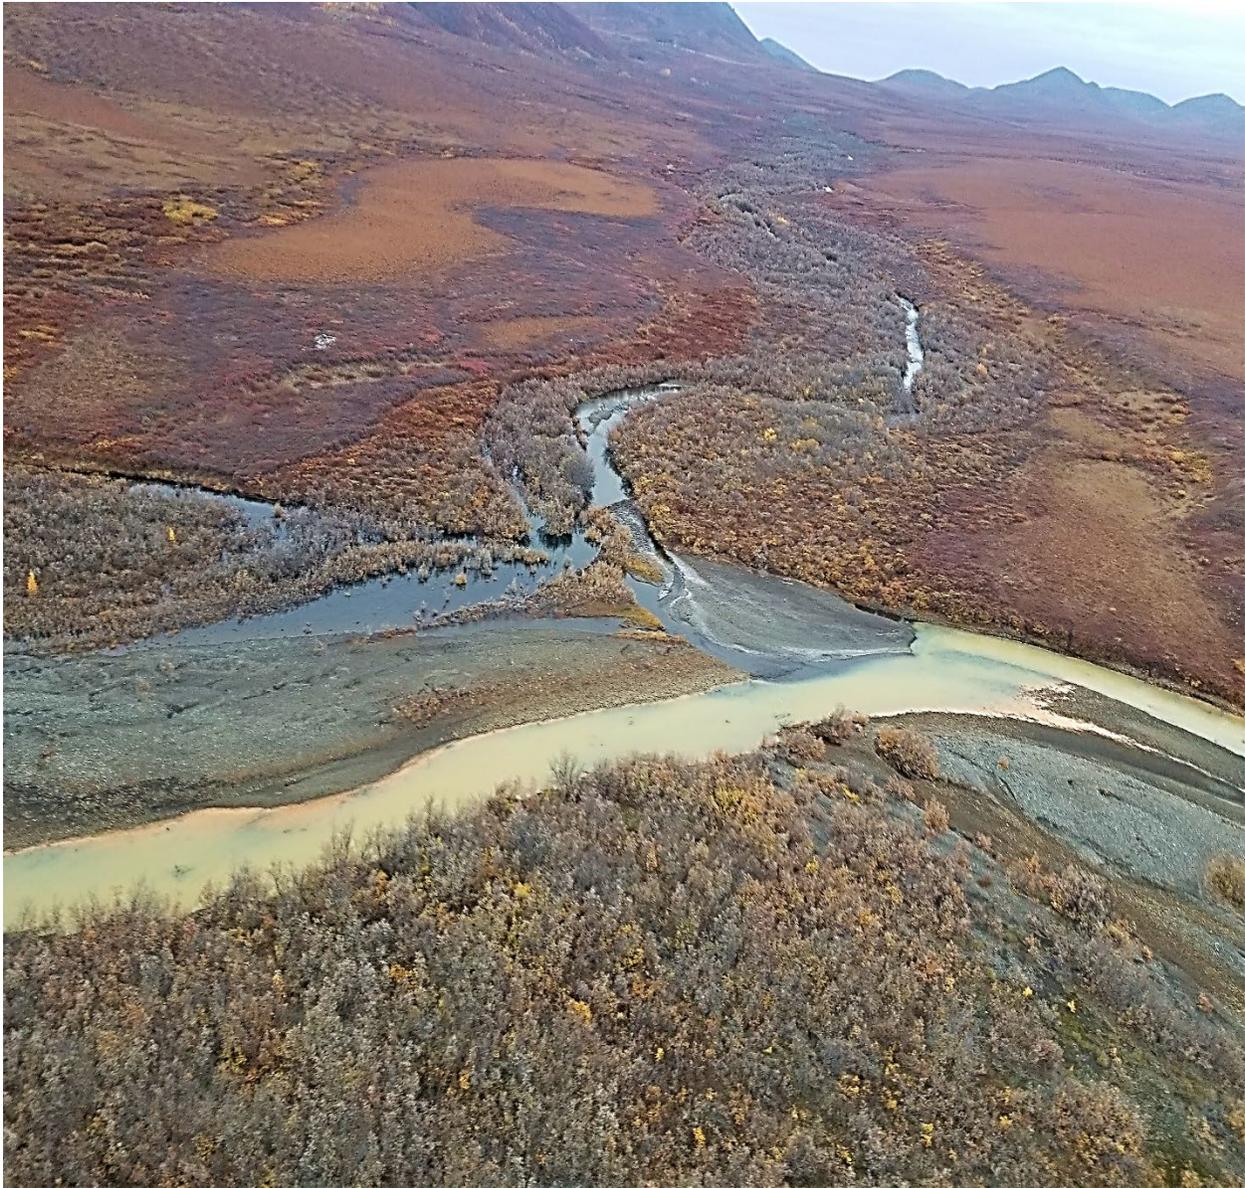
Figure 3. Dudd Creek (top) entering Ikalukrok Creek (bottom), September 13, 2020.

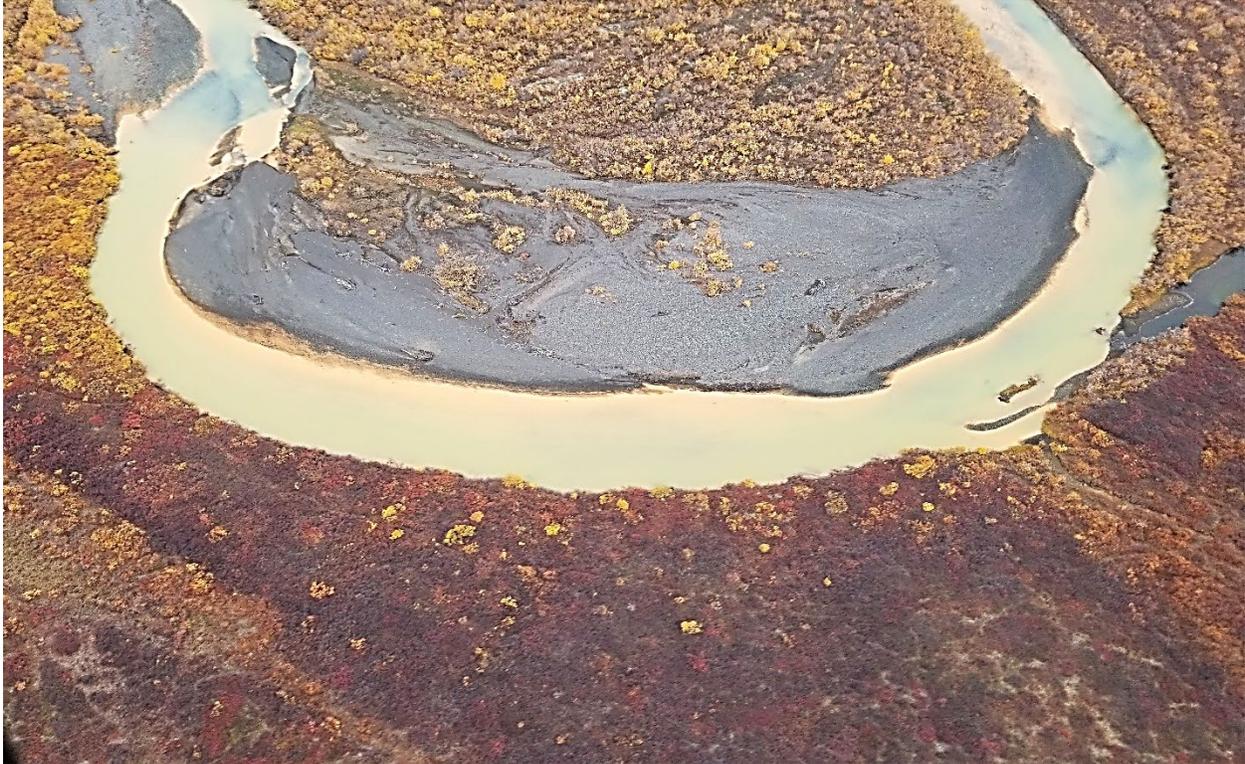
The substrate in Ikalukrok Creek was covered with precipitated material. From the air an almost complete covering of the creek bed was observed (Figure 4). The precipitate was orange to milky white in color and appeared to be from one inch to three inches deep across the bottom of Ikalukrok Creek (Figure 5). During this survey, no chum salmon were observed in Ikalukrok Creek. Typically, between one to five thousand chum salmon will return to the lower Ikalukrok Creek for spawning. Chum salmon may have been present in the deepest sections of the creek and obscured from view, but water levels were relatively low during this survey and most of the riverbed was visible. We did not observe any dead salmon on the banks or gravel bars of Ikalukrok Creek.

Figure 4. Turbidity in Ikalukrok Creek, September 13, 2020.

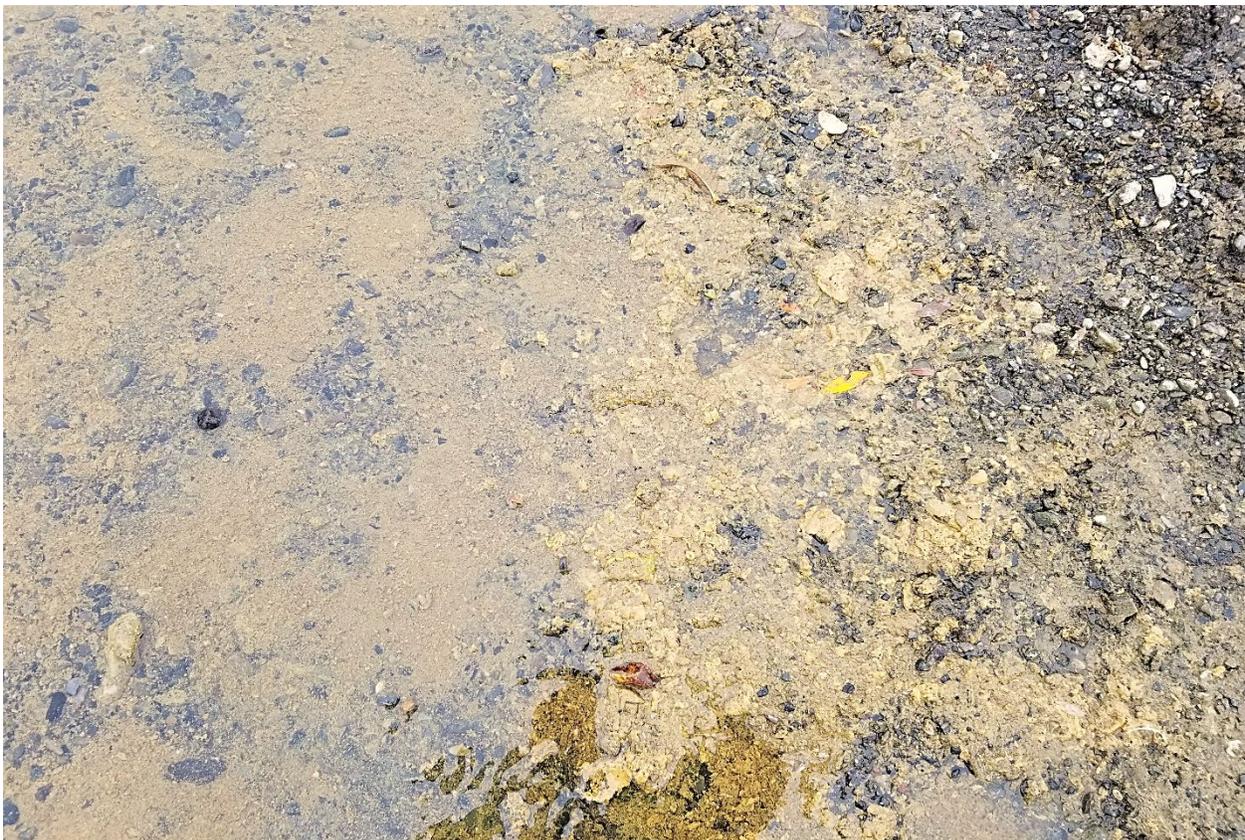
Figure 5. Orange to white precipitation on bottom of Ikalukrok Creek, September 13, 2020.

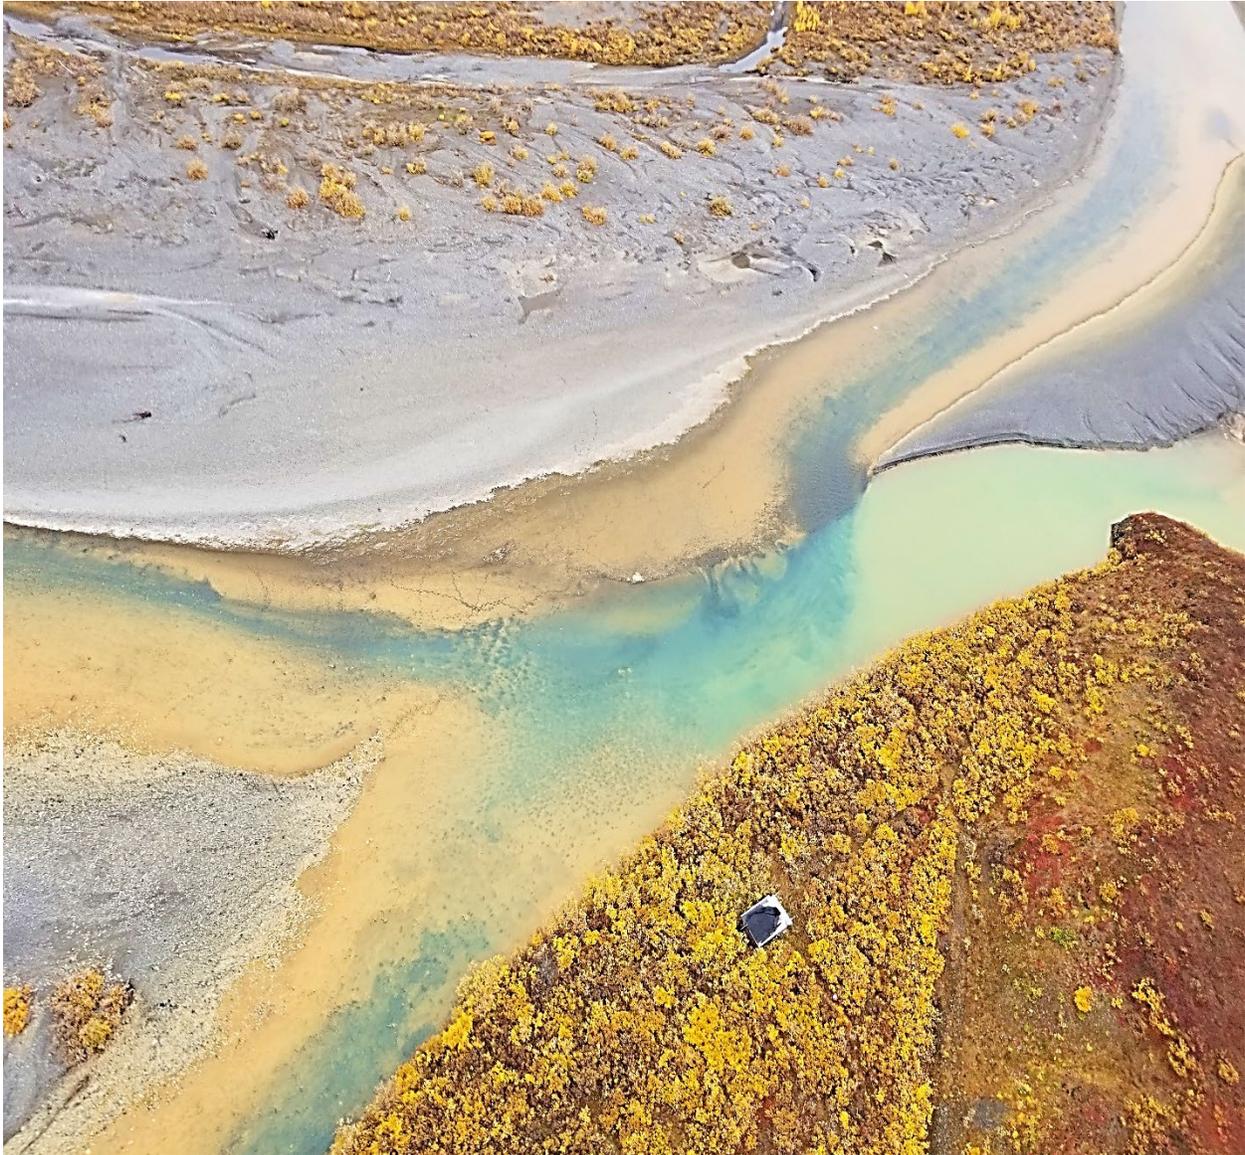
At the confluence of Ikalukrok Creek and the Wulik River the turbid water was diluted, and water clarity improved as we continued down the Wulik River (Figure 6). The orange precipitate was still visible and covering most of the bottom of the Wulik River until the end of our flight near Sivu Hill (Figure 7).

Figure 6. Confluence of the Wulik River (left side flowing from top to bottom) and Ikalukrok Creek entering from right), September 13, 2020.

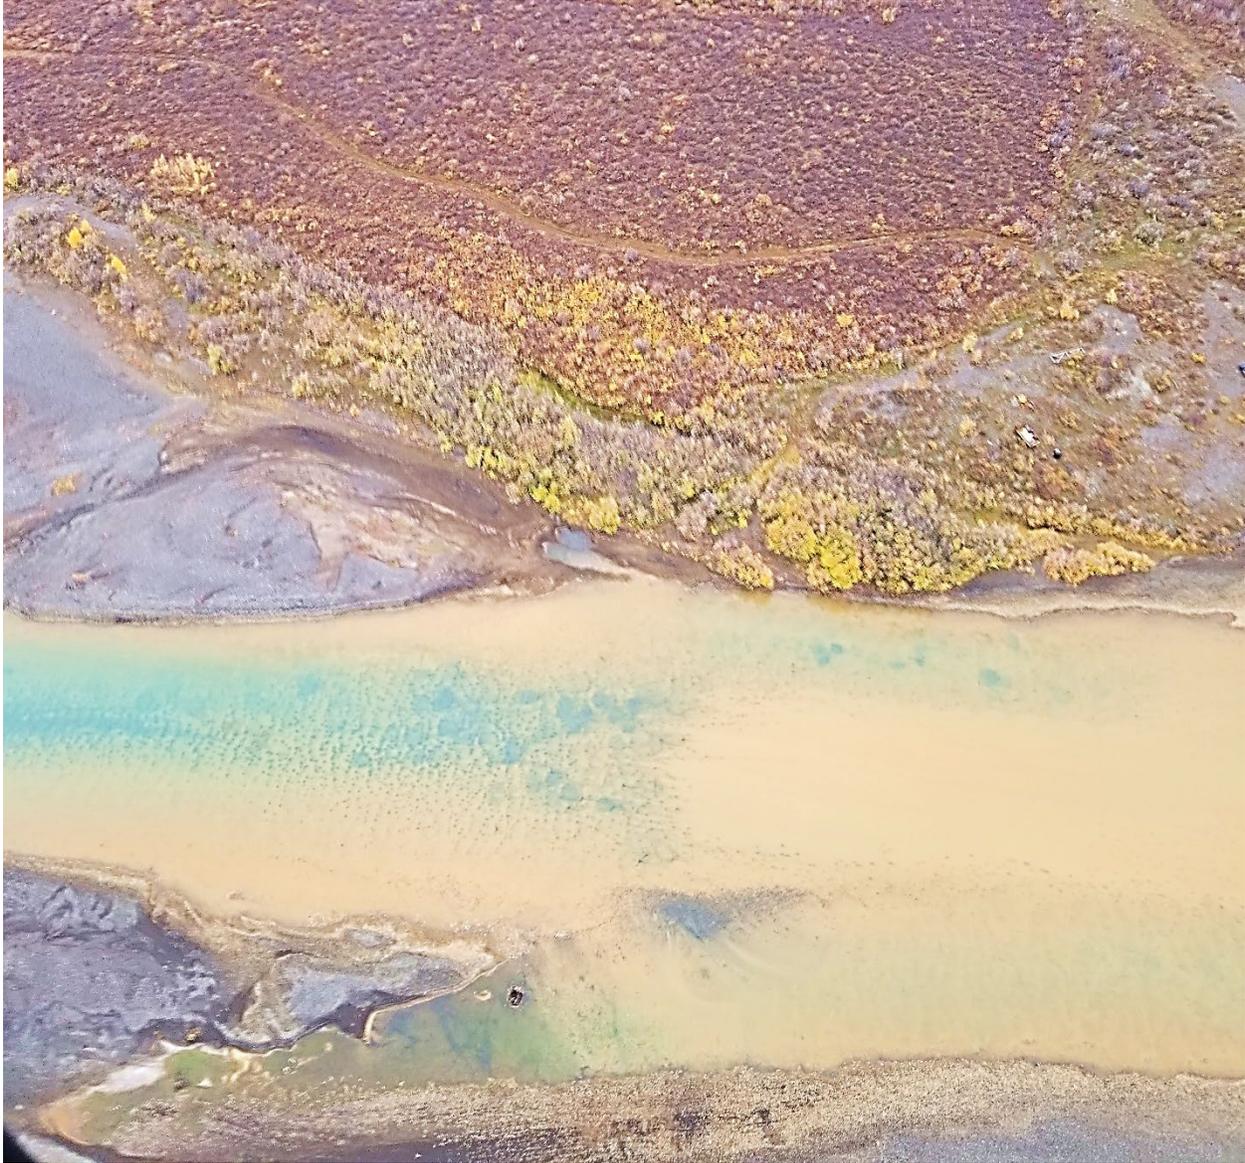
Figure 7. Wulik River below confluence of Ikalukrok Creek near Sivu Hill, September 13, 2020.

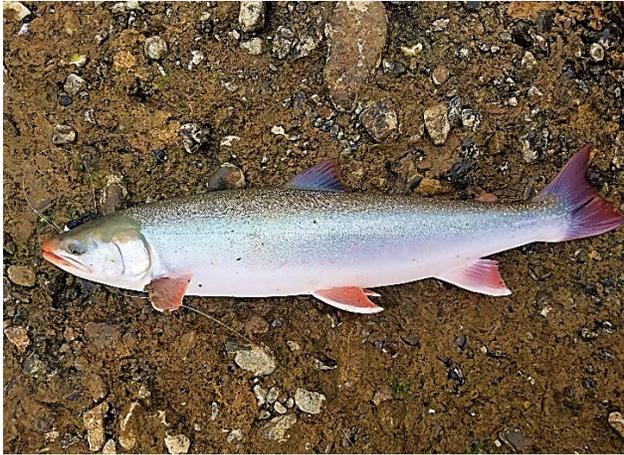
We captured seven adult Dolly Varden from the mainstem Wulik River near Driver's Camp. These are Dolly Varden that will overwinter, and they are not in spawning colors or condition (Figure 8). We observed one Chinook salmon carcass at this pool (Figure 9). Water clarity was clear but had a light white tint and the bottom of the river was covered with the orange precipitate (Figure 10). The Wulik River had a large pink salmon spawning event and tens of thousands of pink salmon carcasses were present from Sivu Hill to the uppermost portion of our survey at the confluence of the East and West Fork Wulik River (Figure 10 and 11).

Figure 8. Adult overwintering Dolly Varden.

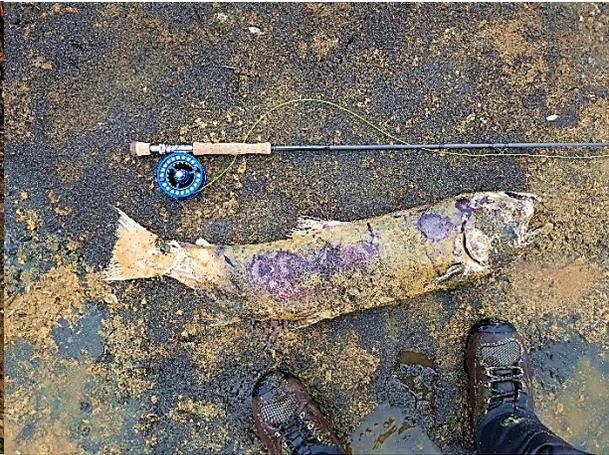
Figure 9. Chinook carcass in Wulik River.

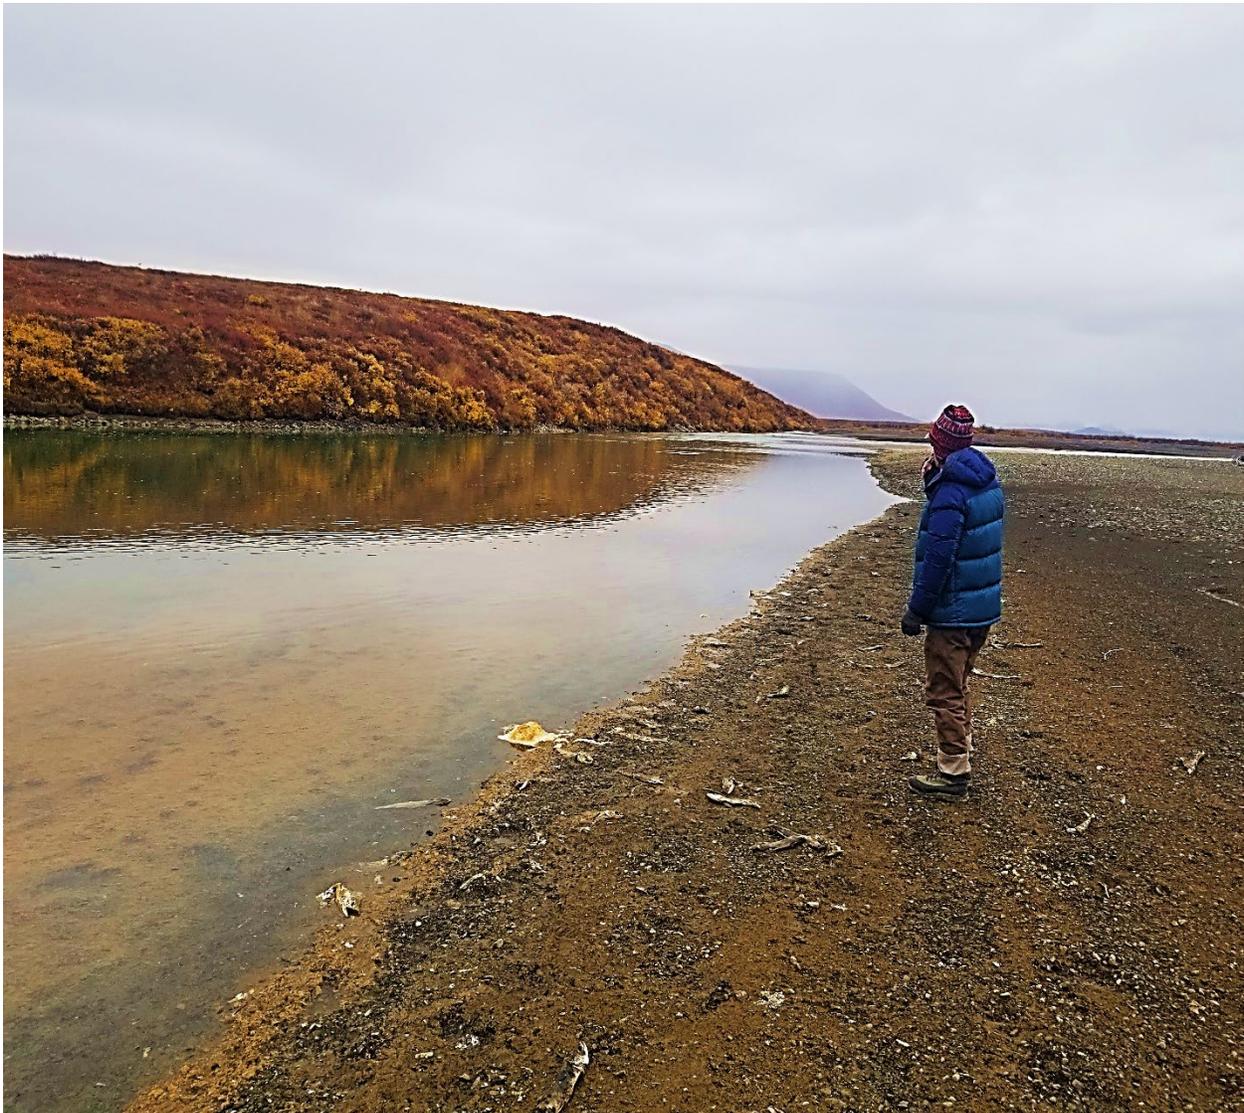
Figure 10. Mainstem Wulik River pool near Driver's Camp with orange precipitate and pink salmon carcasses.

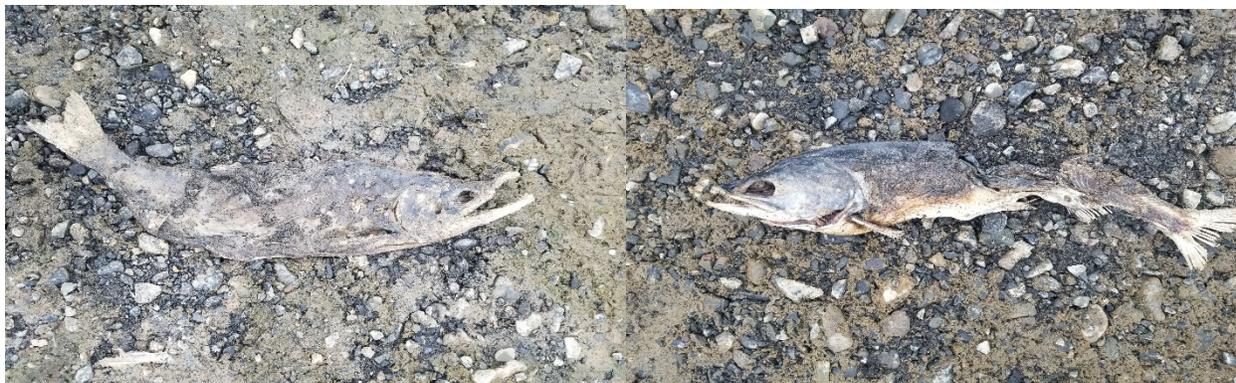
Figure 11. Spawned out pink salmon carcasses in the Wulik River.

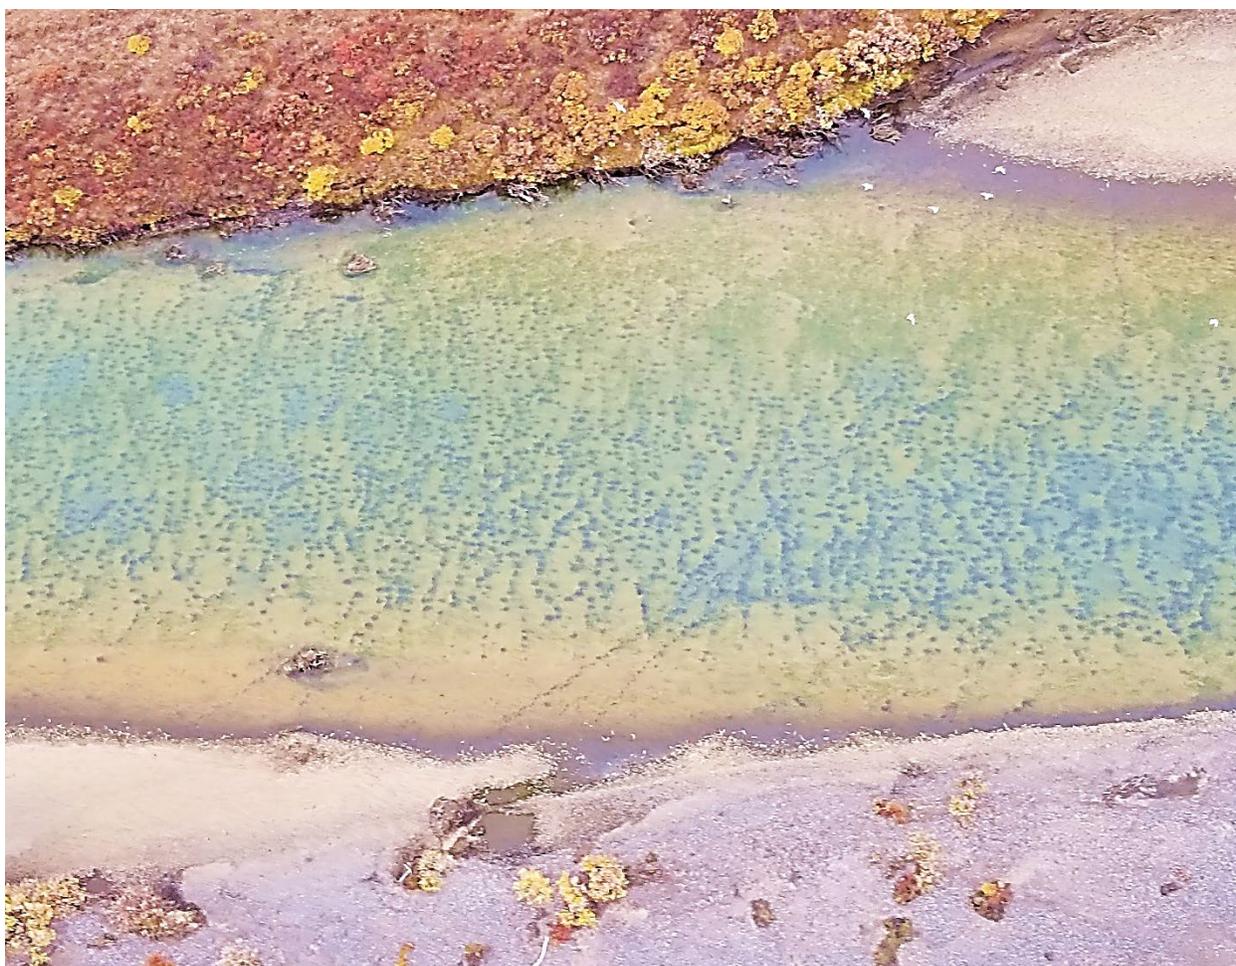
After capturing the seven adult Dolly Varden for element analysis from select tissues we flew downriver to Sivu Hill and then further up the Wulik River to the confluence of the East and West Fork (Figure 1). We observed hundreds of thousands of fish milling spots in the orange precipitate that had been made by the swimming motion of a stationary fish near the riverbed (Figure 12 and 13).

Figure 12. Milling spots in orange precipitate on bottom of Wulik River from the swimming motion of a stationary fish near the riverbed. September 13, 2020.

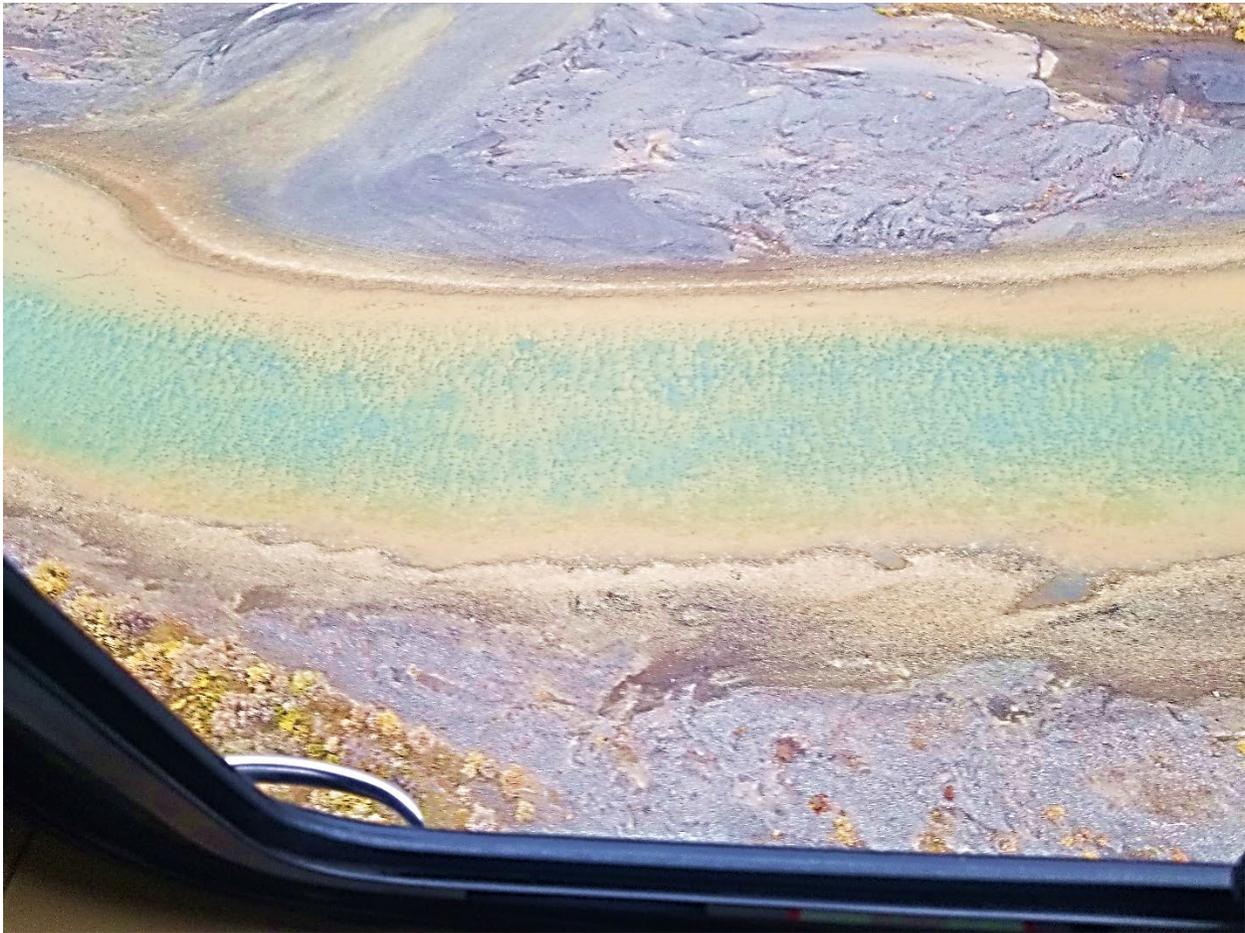
Figure 13. From Sivu Hill the confluence of the Wulik River and Ikalukrok Creek hundreds of thousands of milling spots were observed.
