Rex Trail: Long Term Monitoring Report 2016

Produced by
Department of Natural Resources
Division of Mining, Land & Water
Northern Regional Office – Lands Section

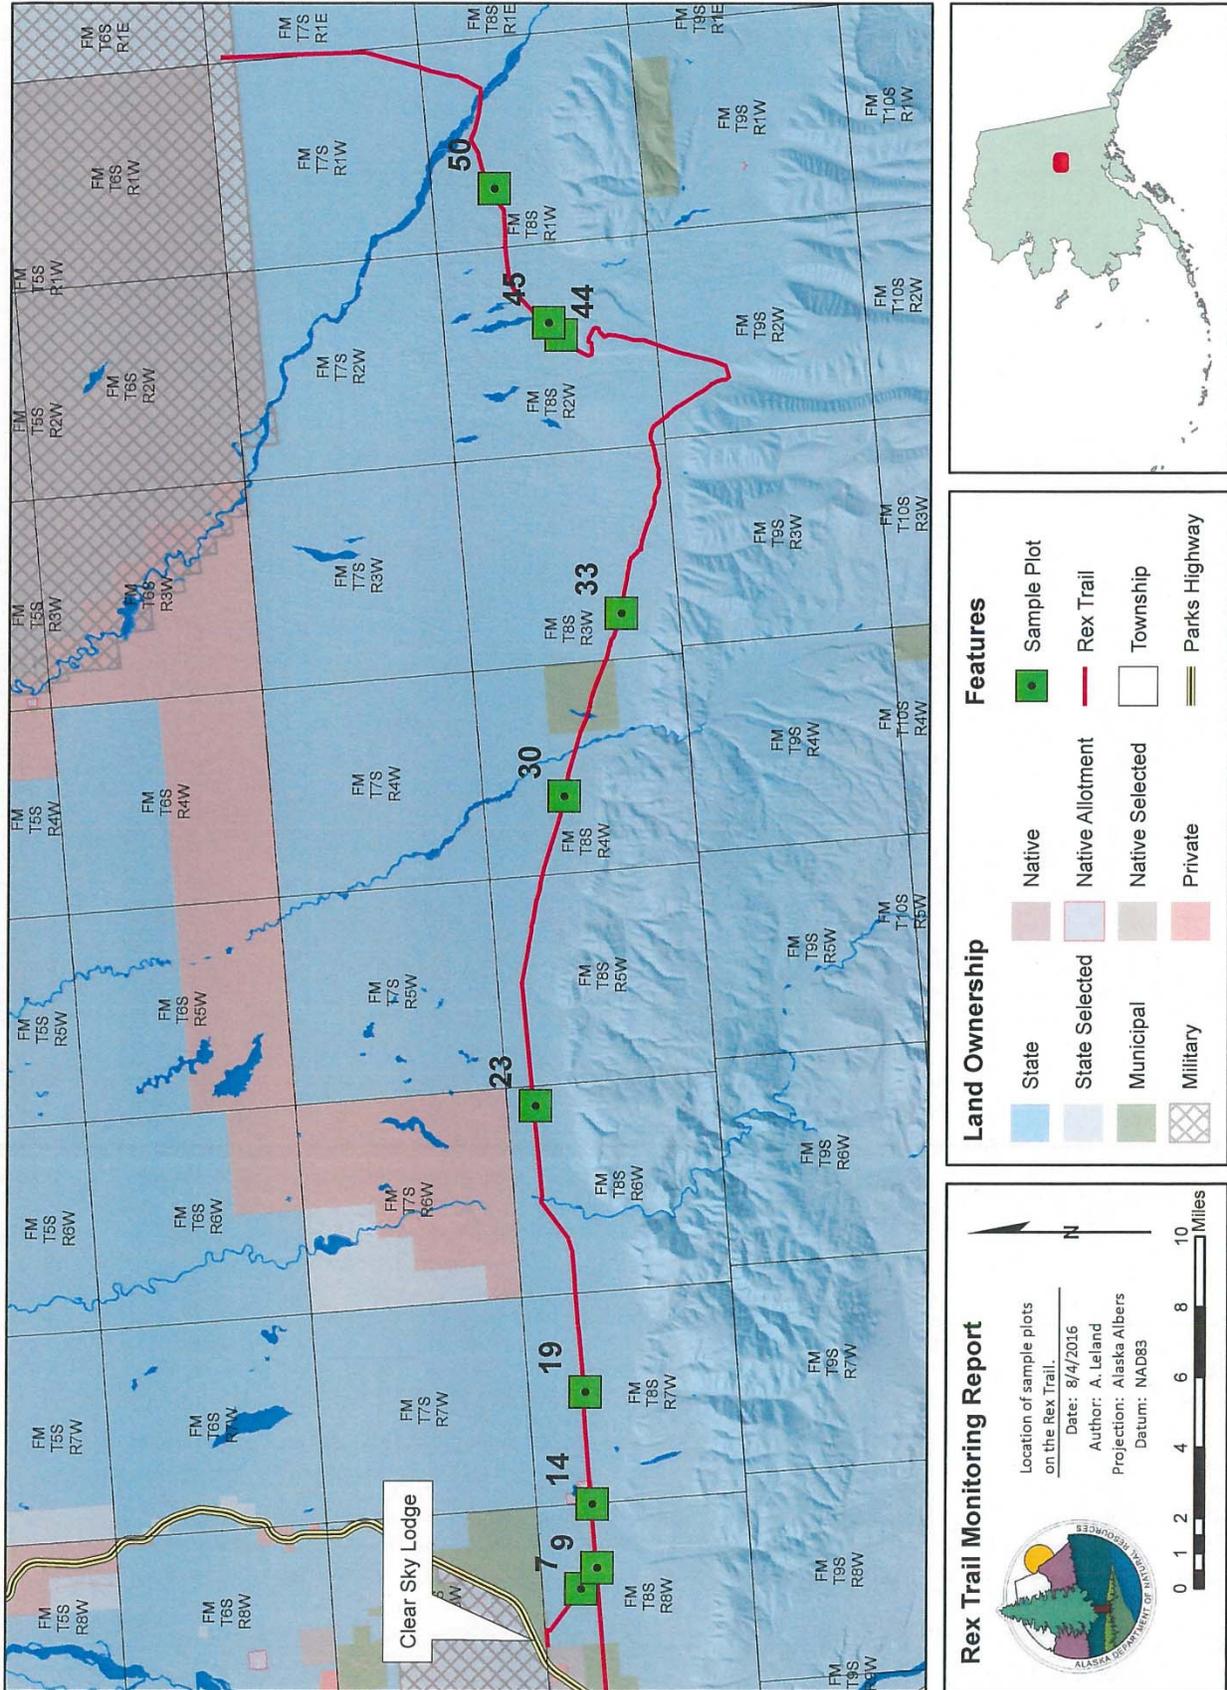
Figure 1: Overview map of the Rex Trail and sample plots.

Ten locations were chosen (Figure 1) using the sites that were left after the helicopter trip (8 sites were excluded; N=44). The site selection was performed by random sample. First, the 44 locations were separated into the five condition categories that were assigned from the 2007 work and assigned a random number using MS Excel. Within each category, sites were sorted following the random order. The top four locations for each category were copied on to a spreadsheet and used in the field to navigate to plot locations. Each plot was identified and marked so that the measurements are repeatable in exactly the same location and so that any lost markers could be re-established if needed. See Figure 2, Plot Setup Diagram.

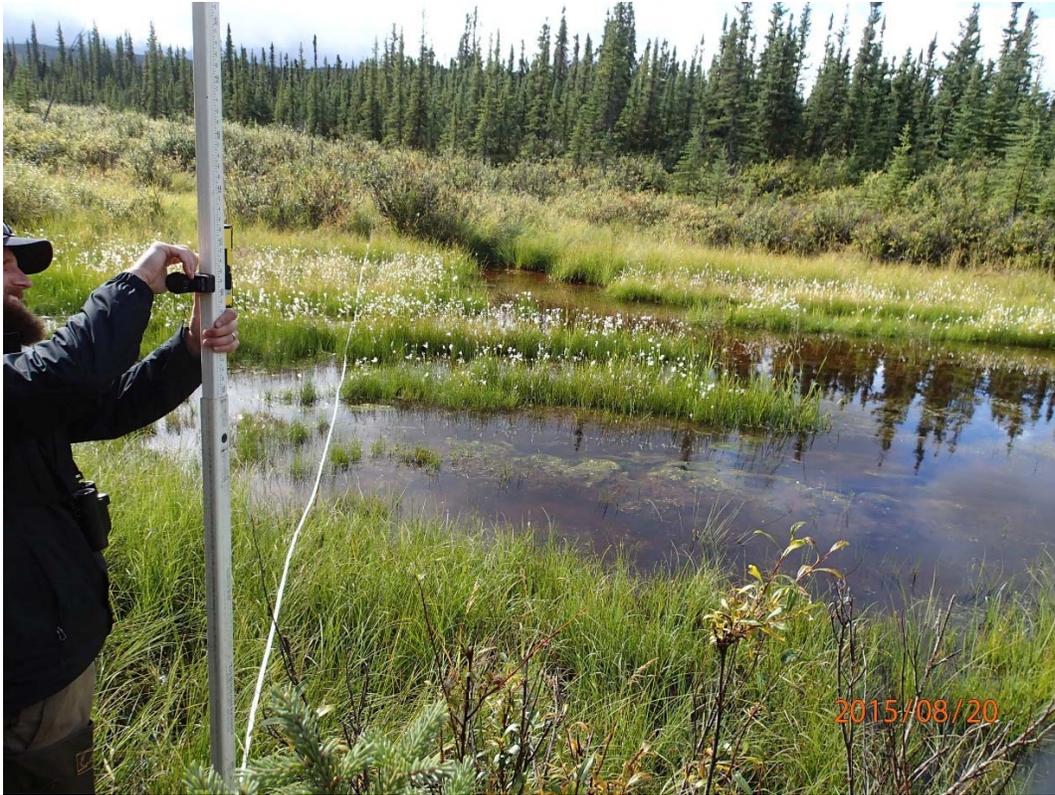
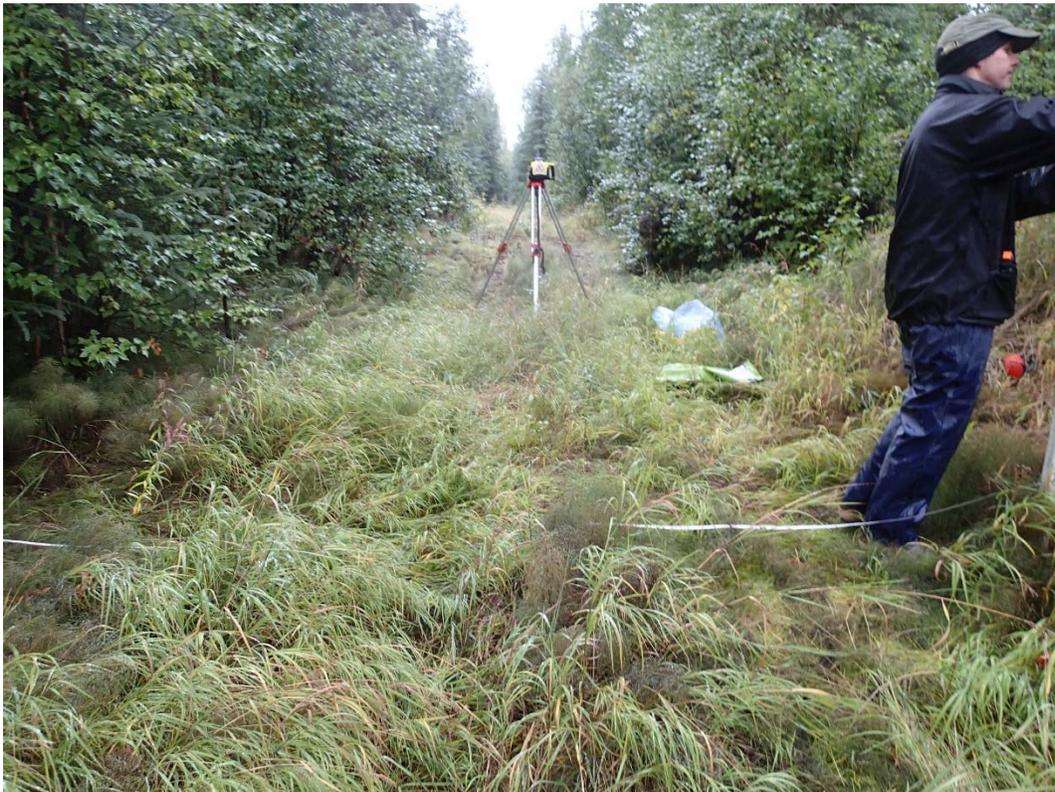
Figure 4: Sampling the trail surface elevation transect

At each transect, a profile of the surface of the trail was obtained using a laser level, stadia rod, and a known bearing. Bearings in this case were nails placed in trees within the plot so that they function as a constant for each sampling event. Transects were laid out according to the width of the trail at each

plot; transects begin off the active trail, cross all of the active area, and end in the vegetation off the active area. Laser level measurements were recorded at every 0.25 meters along the transect along with surface cover and presence/absence and depth of water. Figure 4 shows a typical transect being sampled and Figure 5 shows one page of a trail surface elevation transect datasheet. A maximum transect length of 50 meters was set to stay within time constraints for the sampling efforts. Travel to the majority of the plots is by helicopter and time efficiency and day length is a factor in completing the samples. Plot 23 was the only plot whose active zone was potentially larger than this limit.

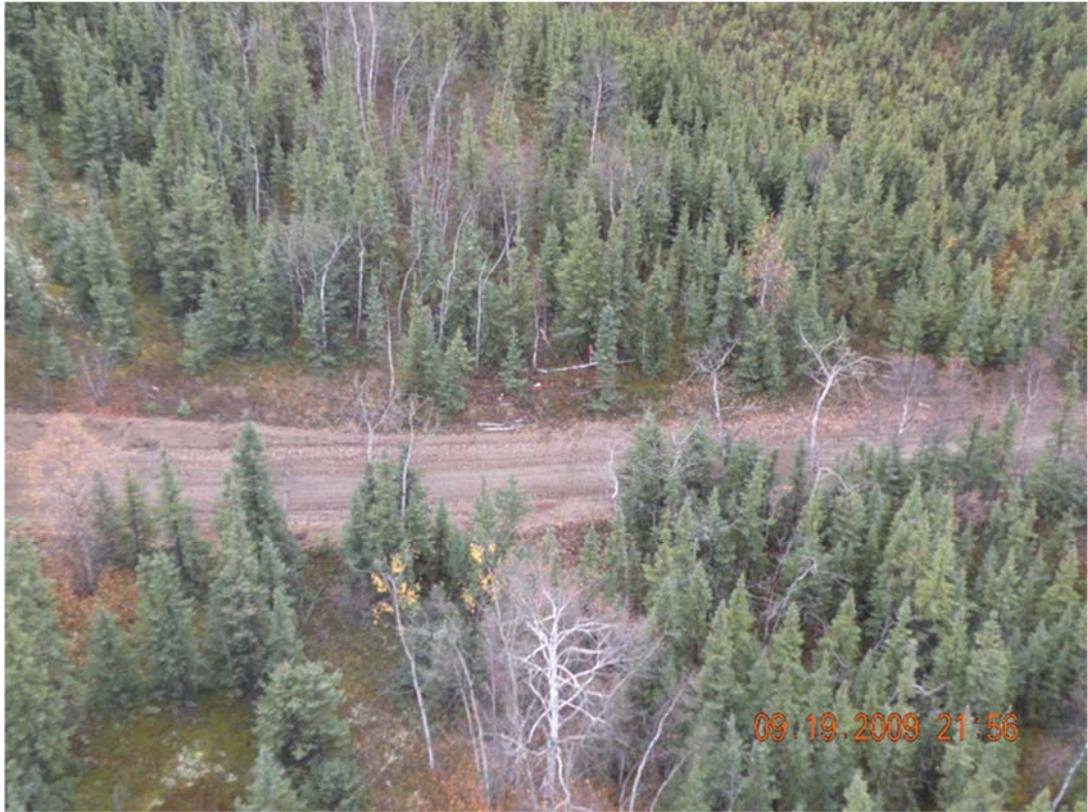
Figure 8: Plot 7

Plot 7 is one of the most stable portions of the Rex trail, and is flat from one side to the other and the surface is hard dirt and gravel. Figure 8 is a photo of Plot 7. Plot 7 was classified into the condition category, "Good," 71% of the time in August and 33% of the time in October, as shown in Figure 9. It was classified as "Fair," 29% of the time in August and 67% of the time in October. Overall, Plot 7 was slightly more often classified as Good than Fair. No other condition classes were represented.

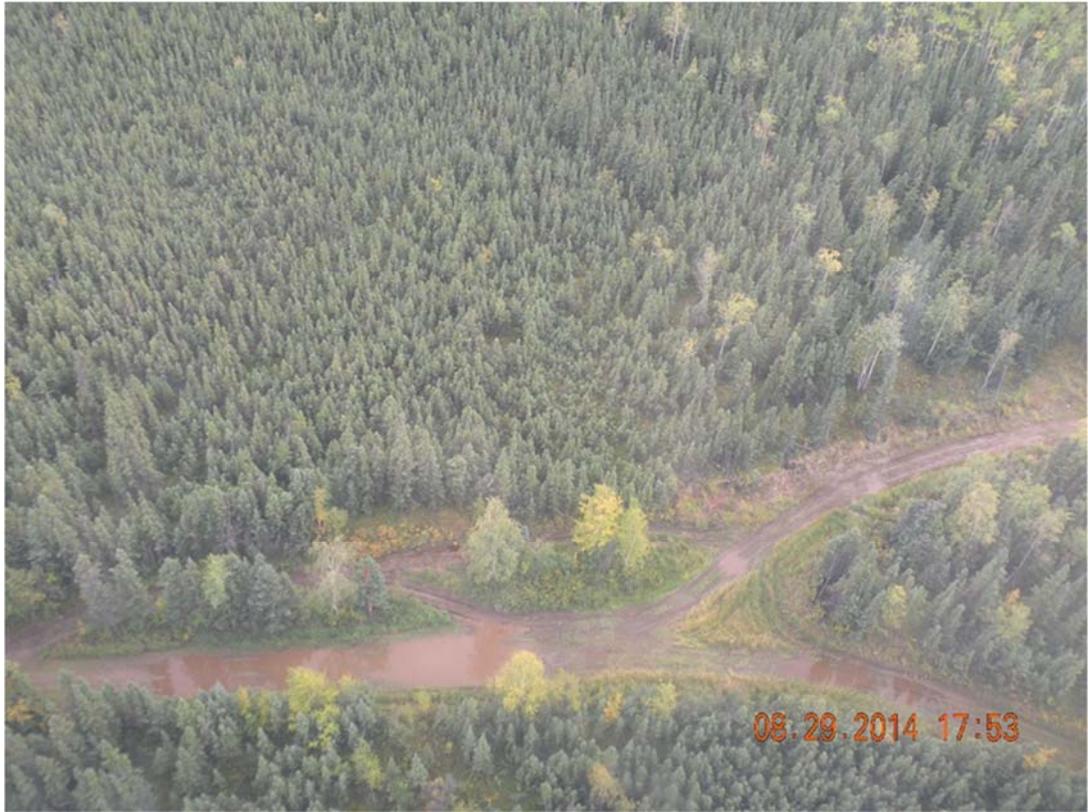
Figure 10: Plot 9

Plot 9 is just after the junction where the access trail from the Southwind subdivision meets the main stem of the Rex Trail. It consists of three braids and the most active braid is often filled with water though the trail surface is hard dirt when dry. Figure 10 is an aerial picture of Plot 9 from August 2014 and shows the braids and water. This plot was split between several condition classes in both August and October, as seen in Figure 11. The Extremely Degraded and Very Degraded categories both increased from August to October, from 29% to 50% and 29% to 33% respectively. Overall all the sample periods, Plot 9 was split fairly evenly between Extremely Degraded (38%), Very Degraded (31%), and Degraded (23%).

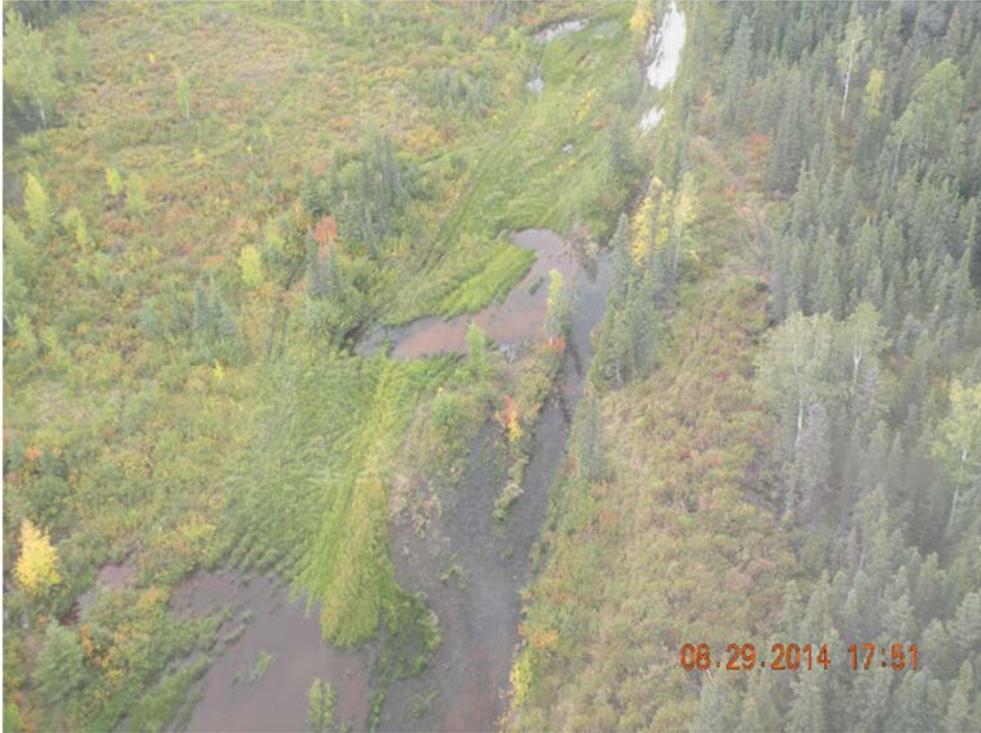
Figure 12: Plot 14

Plot 14 is just west of the Seven Mile Lake area and is characterized by many braids of varying age and use patterns. The area is a low grassy wetland and this section of the trail gets numerous wet and boggy swales, especially in high precipitation years. Figure 12 is an aerial photo of the plot from August 2014, a high rainfall year, and shows the numerous braids and water inundation. The Taylor transect results, see Figure 13, for this plot show the condition as 86% Extremely Degraded in August and 50% in the same category in October. The Very Degraded condition was 14% in August and 33% in October and there was also 17% Fair Condition in October. Across all months and years, the majority percentage was 69% Extremely Degraded with 23% Very Degraded and 8% Fair.

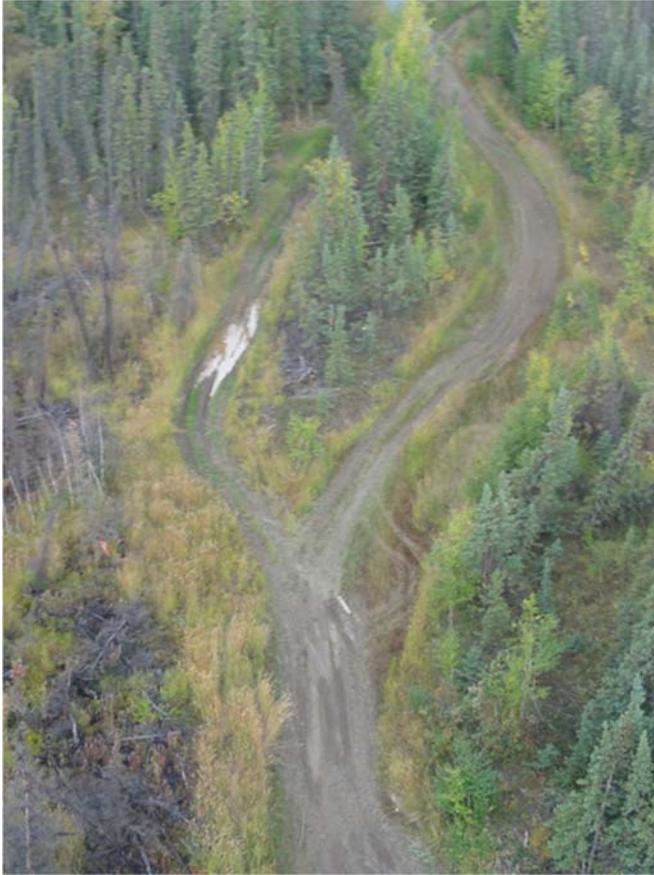
Figure 14: Plot 19

This plot is on the western edge of the Rex Fire boundary, east of where the Intertie crosses the trail. The plot consists of two to three braids with a vegetated island separating the two active sections, see Figure 14. On the northern end of the plot there is an old braid that consists of a steep sharp drop-off with deep eroding ruts and this area is impassable for most vehicles. The Taylor Transect data, Figure 15, places this plot in a Very Degraded condition 57% of the time in August and 33% of the time in October. Also in August, the plot condition was 29% Extremely Degraded and then increased to 67% Extremely Degraded in October. There was also 17% of the time in condition Fair in October. Overall, this plot was in the Extremely Degraded condition 69% of the time, Very Degraded 23% of the time, and Fair 8% of the time.

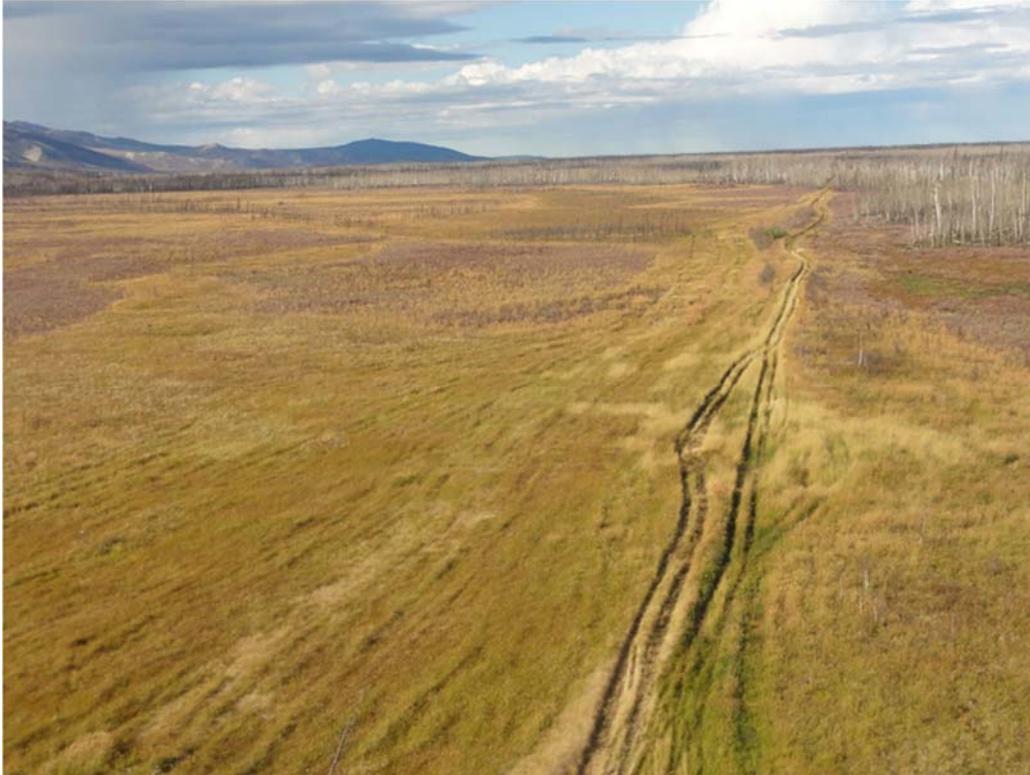
Figure 16: Plot 23

Plot 23 is east of the Totatlanika River and is also called the Big Braid as it very recognizable from the air due to the number of braids, wet swales, and the vegetation characteristics; it is a very wide open grass and sedge meadow as shown in Figure 16 (2016). The Taylor Transect results for this plot are depicted in Figure 17. This plot was classified as Extremely Degraded 86% of the time in August and 33% of the time in October. It was also Degraded 14% of the time in August and 17% of the time in October. Also in October, this plot was classified as Very Degraded 50% of the time. For all months and years, Plot 23 was classified as Extremely Degraded 62% of the time, Very Degraded 23% of the time, and Degraded 15% of the time.

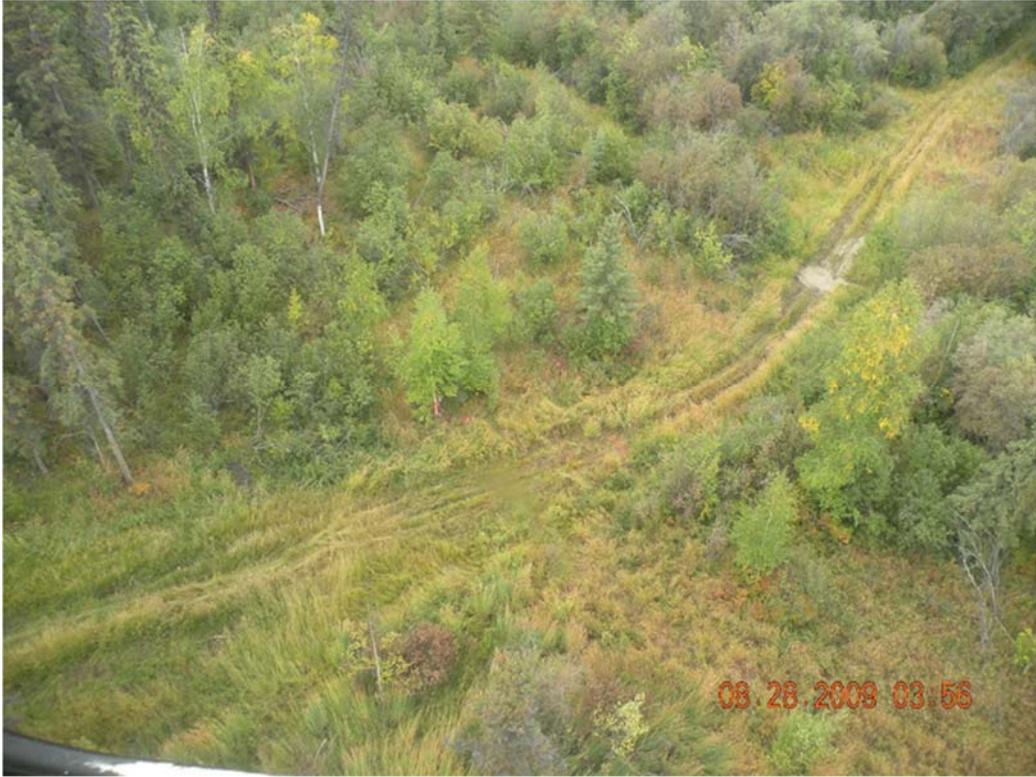
Figure 18: Plot 30

This plot is just west of the Tatlanika River and is characterized by tall, thick grass and a mix of larger spruce and birch trees. Figure 18 is an aerial photo of this plot from August 2009. The Taylor Transect data classified this plot into four of the five conditions, see Figure 19. In August, the plot was classed as 29% Very Degraded, 29% Degraded, 29% Fair and 14% Good. In October the plot was an even 50% Degraded and 50% Very Degraded. Overall, the plot was classed as Very Degraded 38% of the time, Degraded 38% of the time, Fair 15% of the time, and Good 8% of the time.

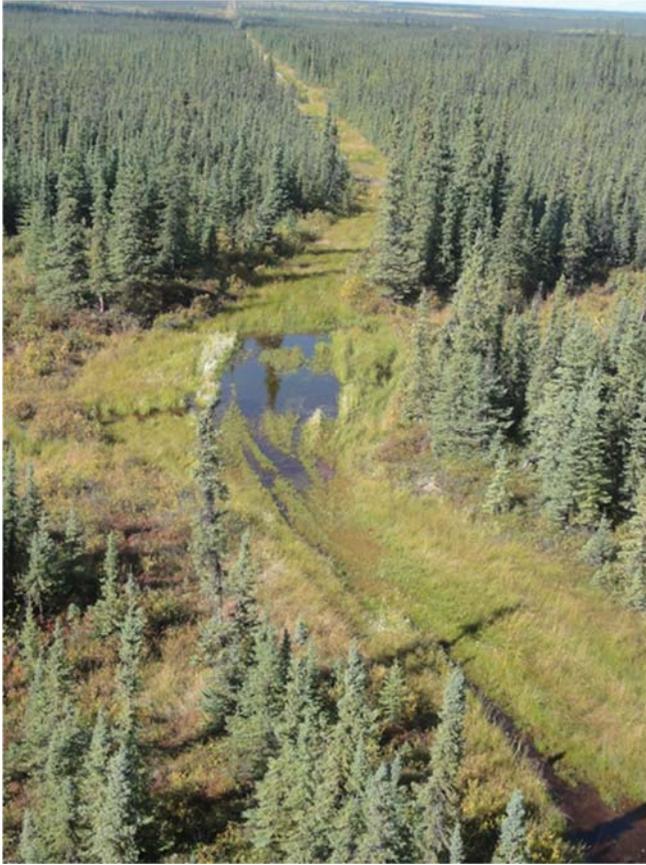
Figure 20: Plot 33

Plot 33 is east of the Tatlanika River and Fish Creek and is a low wetland swale where a small creek flows across the trail. It is predominately standing water with wetland obligate plants such as *Eriophorum angustifolium* and *Ledum palustre* growing along the edges, Figure 20. The soil here is very boggy and easily churned by disturbance. The Taylor Transect data classifies this plot as Extremely Degraded 57% of the time in August and 100% of the time in October, Figure 21. The second August classification is Very Degraded 43% of the time.

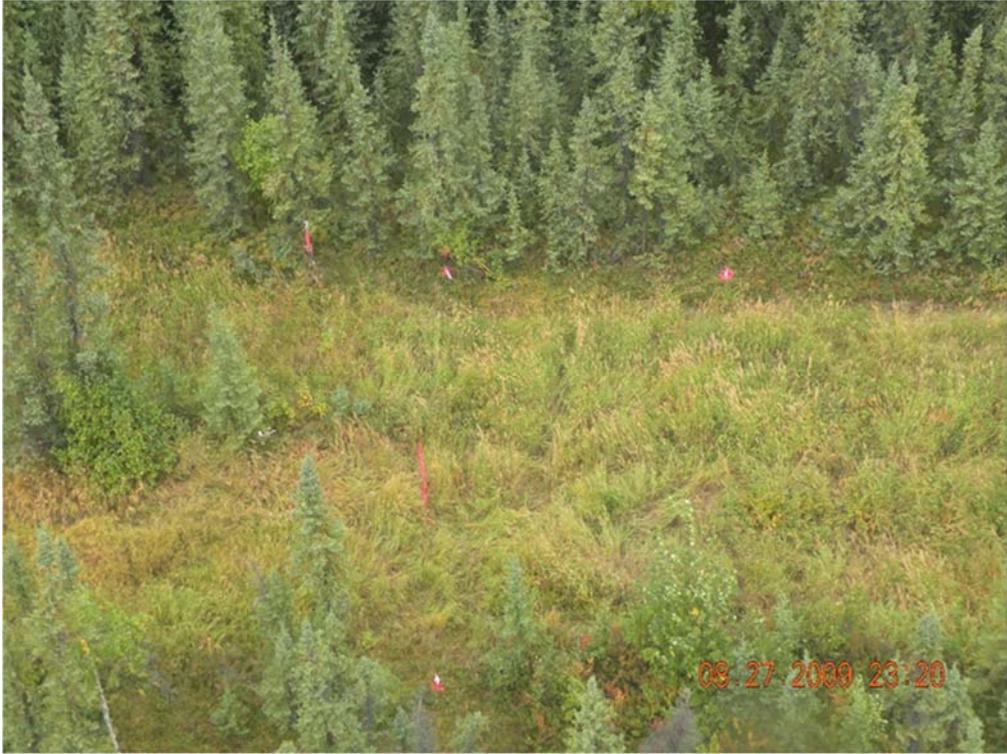
Figure 22: Plot 44

This plot is just north of Gold King, in the flats below the plateau where the airstrip is located. There are two braids here that are usually grass covered in August and the surrounding vegetation is black spruce forest, Figure 22. This plot is classified in August as 43% Very Degraded, 29% Extremely Degraded, and 29% Fair, Figure 23. In October those values change to 50% Very Degraded, 33% Extremely Degraded, and 17% Degraded. Across all months and years, Plot 44 was Very Degraded 46% of the time, Extremely Degraded 31% of the time, Degraded 8% of the time, and Fair for 15% of the time.

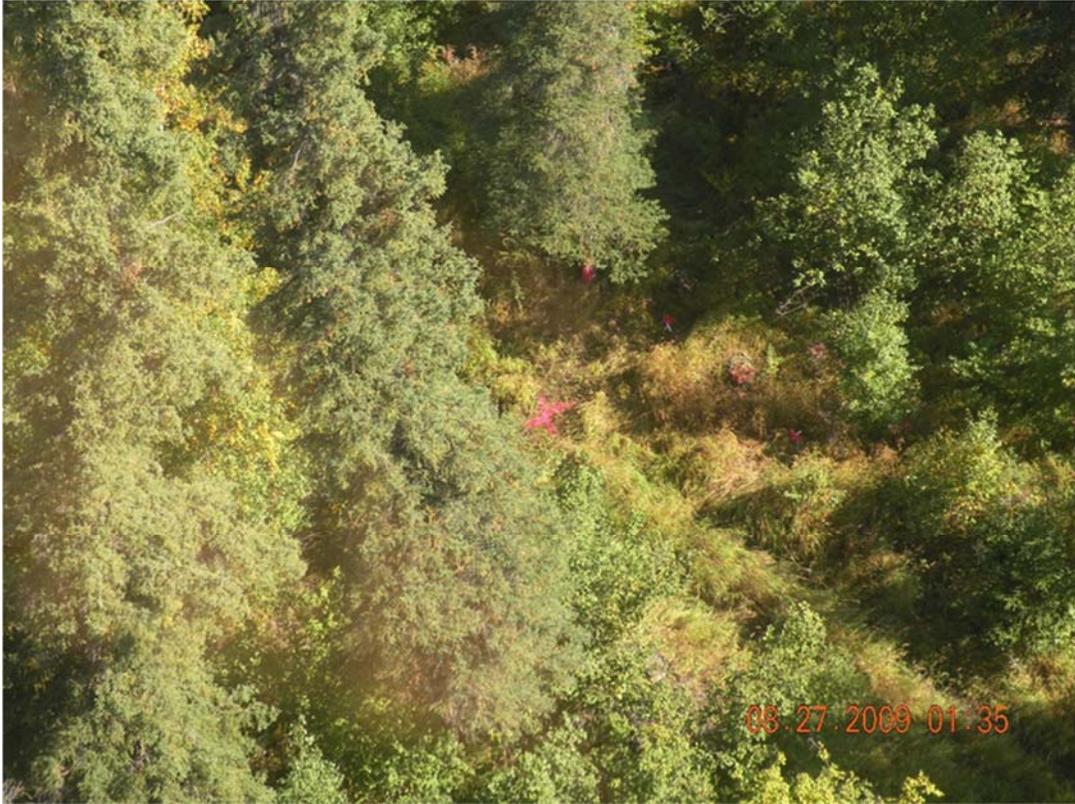
Figure 24: Plot 45

Plot 45 is less than a mile east of Plot 45 and is in a stand of large spruce and birch trees. Figure 24 is an aerial photo of Plot 44 from August of 2009. The Taylor Transect data classifies this plot as 57% Fair and 43% Good in August and 50% Fair, 33% Degraded, and 17% Good in October. Overall, Plot 45 was in Fair condition 54% of the time, Good condition 31% of the time, and Degraded condition 15% of the time, Figure 25.

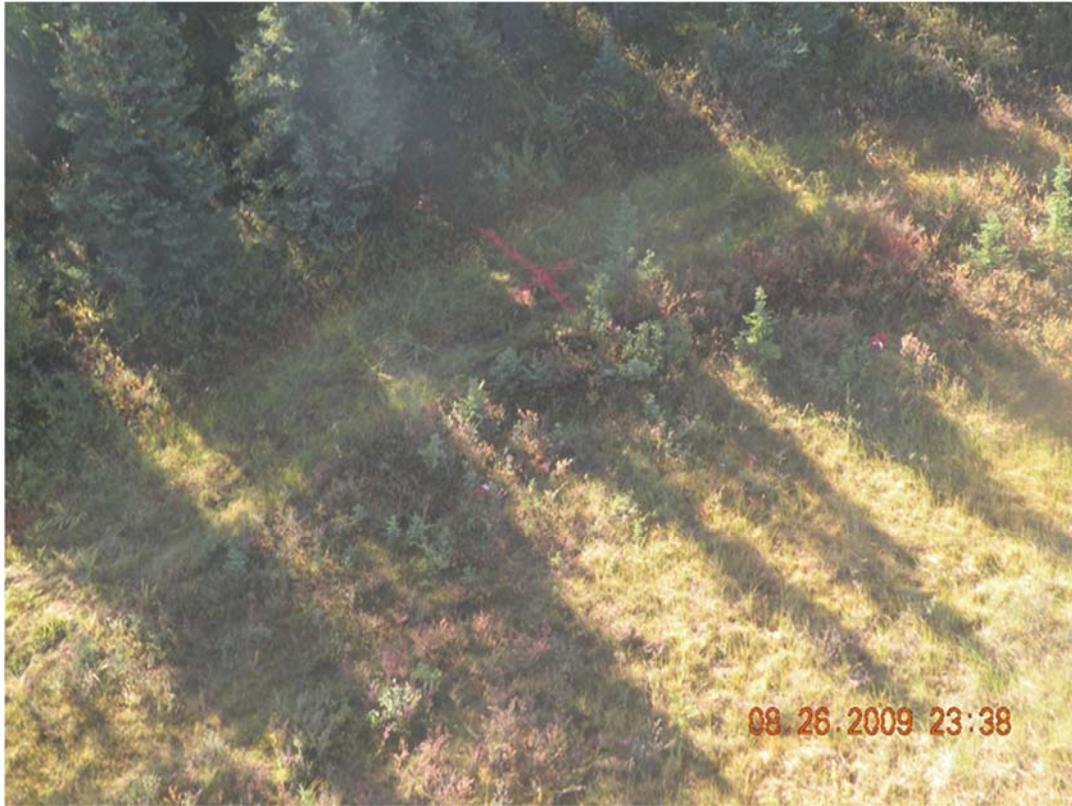
Figure 26: Plot 50

This plot is the easternmost plot in the monitoring program and is about 2 miles west of the Wood River. The plot is situated between an open wetland meadow and pond and a mixed birch spruce forest, Figure 26. The vegetation on the trail is mostly sedges and grasses and the soil is often saturated. The Taylor Transect data classifies this plot in August as 43% Very Degraded and Degraded and 14% Extremely Degraded. In October those values change to 67% Degraded and 17% Very and Extremely Degraded. During the period of this monitoring, Plot 50 was Degraded 54% of the time, Very Degraded 31% of the time, and Extremely Degraded 15% of the time, Figure 27.

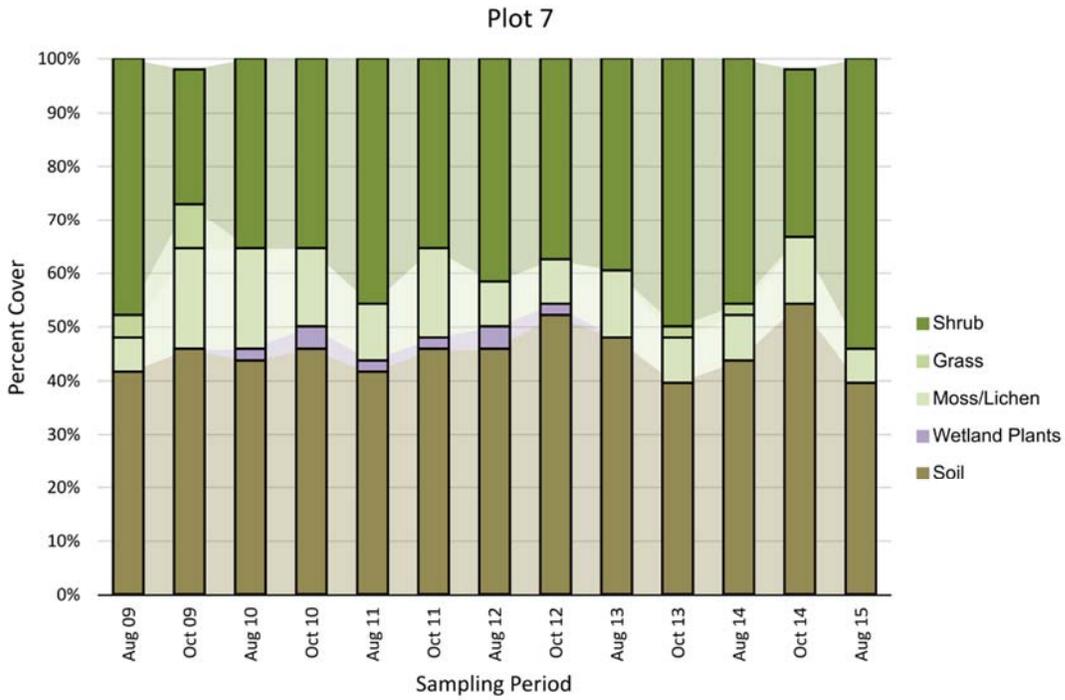
Figure 39: Plot 7 Vegetation Cover Graph

Plots 7 and 44 (Figures 39 and 46) did not show any evidence of this pattern. Plot 7 is a well-established portion of the trail with a relatively hard surface and good drainage. Current vehicle use is unlikely to damage trail topography in such a way as to cause rutting or pot-holing. A lack of a pattern at Plot 44 cannot be explained since site experiences water saturation and ponding and is expected to experience similar pressures to other sample plots.

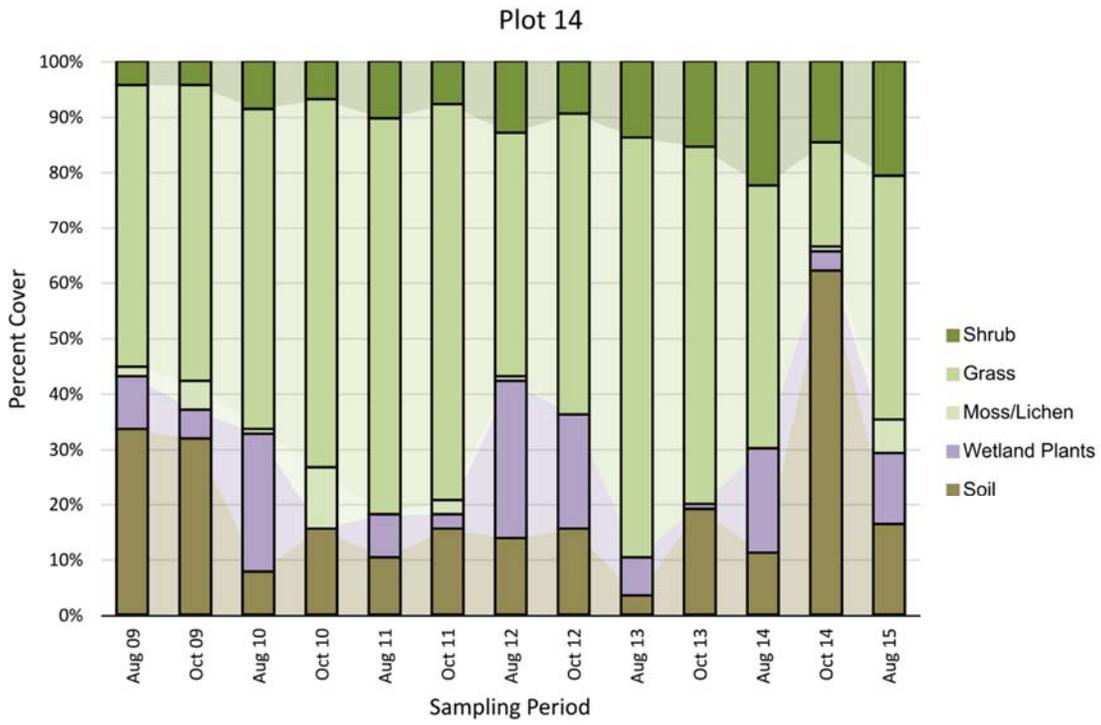
Figure 41: Plot 14 Vegetation Cover Graph

The vegetative cover of Plot 14 is shown in Figure 41. The proportion of bare soil fluctuates widely across years and seasons within the sampling period, ranging from 3% to 62% of total cover, with an average of 20%. The trend noted in Plot 7 appears in this plot as well: for sampling years 2010, 2011, 2013 and 2014, the proportion of bare soil increases from August to October, coinciding with increased vehicle traffic and trail degradation, followed by some recovery of vegetation the following sampling period. In contrast to the previous plots, wetland plants make up an important proportion of the overall vegetative cover, ranging from 0% to 28% of total coverage, with 11% cover on average. The higher portion of wetland plants is related to a higher saturation of the plot as portions of the trail regularly experience ponding. The other dominant vegetation category is grass, which ranges from 19% to 76% with an average of 55%.

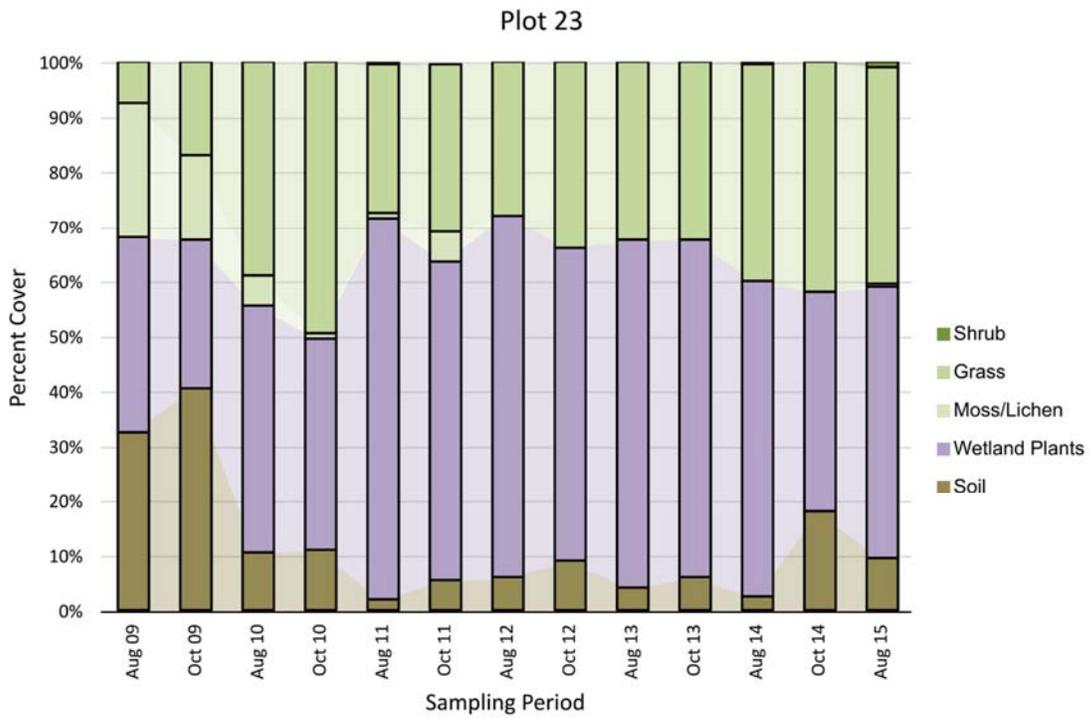
Figure 43: Plot 23 Vegetation Cover Graph

The vegetative cover of Plot 23 is shown in Figure 43. This plot is dominated by wetland plants and grasses. Wetland plants ranged from 27% to 70% with an average of 51%, while grasses ranged from 8% to 50% with an average of 32%. In contrast to previous plots, in most of the sampling periods, bare soil made up a small proportion of the overall cover. Overall, bare soil coverage ranged from 2% to 41% with an average of 12%. However, the highest proportions of bare soil were found in the first two sample periods. As described in previous sections, Plot 23 had a high level of braiding at the start of the monitoring period, corresponding to a high proportion of bare soil. Through the monitoring period, the use of trail braids decreased and the old braids recovered, decreasing the proportion of bare soil in subsequent sampling periods. As a result, the decrease braiding is captured in the vegetative cover graph. As with previous plots, a pattern of increasing proportion of bare soil from August to October corresponding to increased vehicle traffic is evident in all sampling years, with a recovery period (decreasing proportion of bare soil) between years.

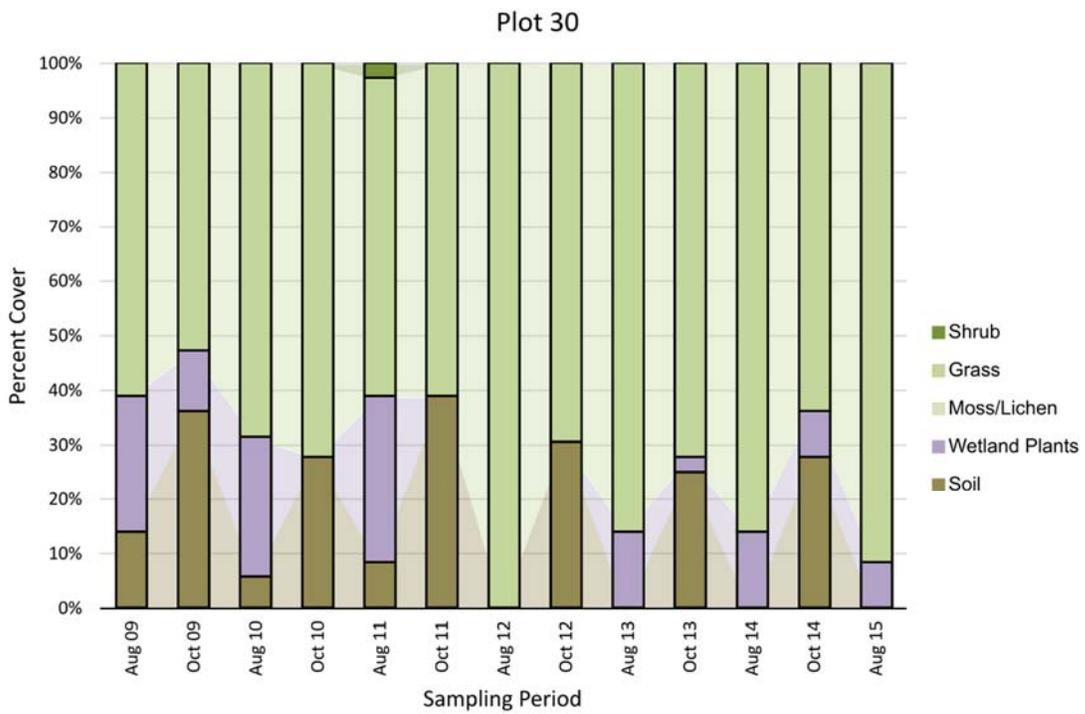
Figure 44: Plot 30 Vegetation Cover Graph

The vegetative cover of Plot 30 is shown in Figure 44. This sample plot is dominated by grasses which range in cover from 53% to 100% with an average of 73%. Both bare soil and wetland plants fluctuate widely across sampling periods: bare soil ranged from 0% to 39% with an average of 16%, and wetland plants ranged from 0% to 31% with an average of 11%. The pattern of a higher proportion of bare soil in October relative to August, corresponding to traffic volume, continues every year in this plot, with wetland plants being replaced by bare soil in most sampling years (the exception being August and October of 2012). Therefore, the width and vegetative cover of this portion of the trail varies seasonally and across years.

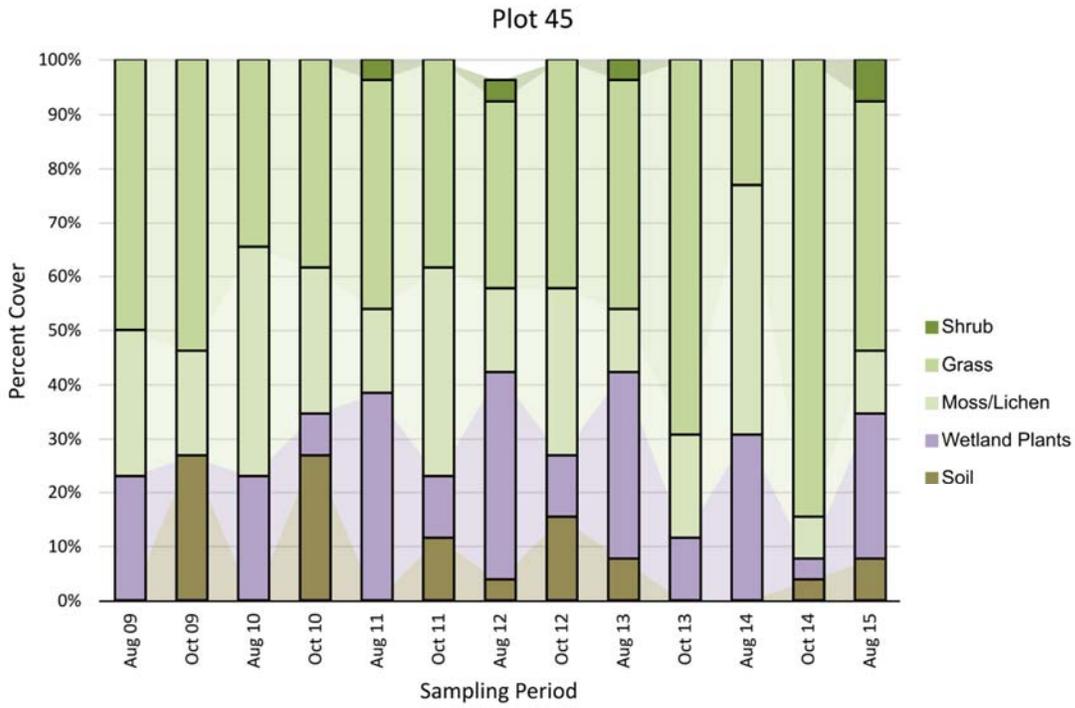
Figure 47: Plot 45 Vegetation Cover Graph

The vegetative cover of Plot 45 is shown in Figure 47. The proportions of particular vegetation classes are more variable, and mosses and lichens are found in higher proportions in this plot than other plots. The proportion of bare soil ranges from 0% to 27% with an average of 8%, wetland plants range from 0% to 38% with an average of 20%, mosses and lichens range from 8% to 46% with an average of 24%, and grasses ranged from 23% to 85% with an average of 46%. Bare soil was not found in every sampling period, but a pattern of higher proportions of bare soil in October than August of a given year, consistent with higher vehicle traffic, was present in all years except 2013. This pattern is consistent with similar patterns found in previous sample plots.

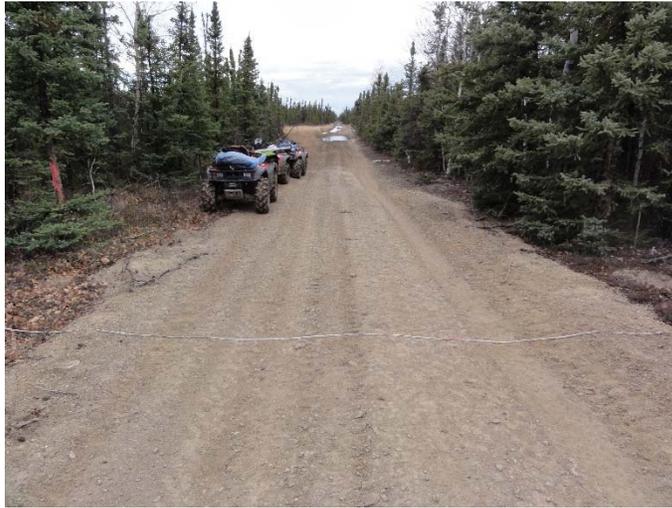
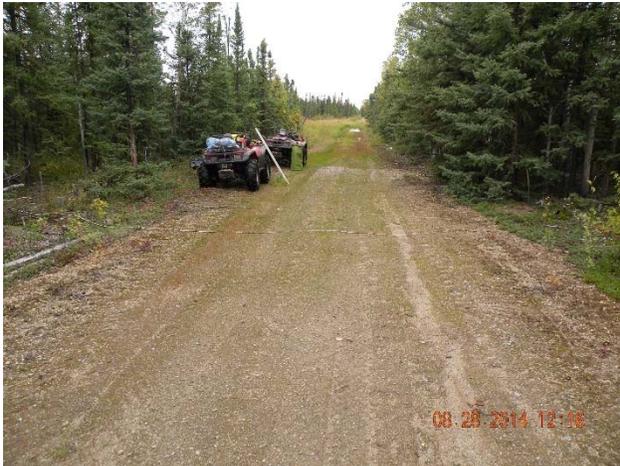
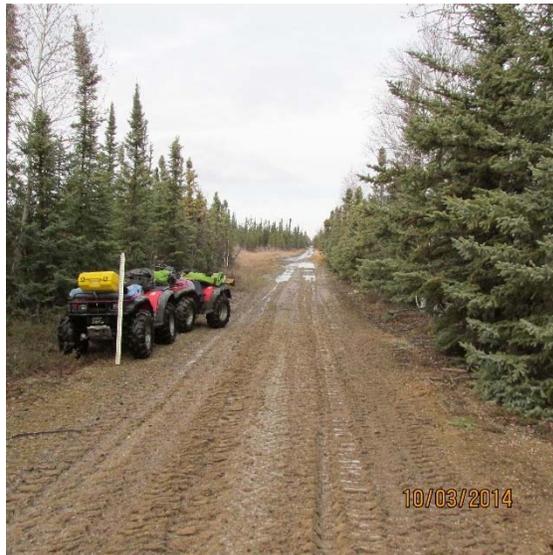
Figure 50: August (left side) and October (right side) Plot 7 photos for 2012-14

Figures 49 – 52 show time series sets of photos for Plots 7 and 33. These plots were chosen as examples of what the photos of plots look like throughout the study period because they are at opposite ends of the condition classes. Plot 7 was originally a Good condition plot and has maintained that condition throughout the study period. Plot 33 was originally a Very Degraded condition plot and through the Taylor transect data has been classified as Extremely Degraded 100% of the time in October. The photos of Plot 7 are taken from the same perspective every year and show how little the trail surface has changed over the six years of sampling. The photos of Plot 33 are all aerial photos, taken from a hovering helicopter, and show how this plot changes within every year from August to October and also

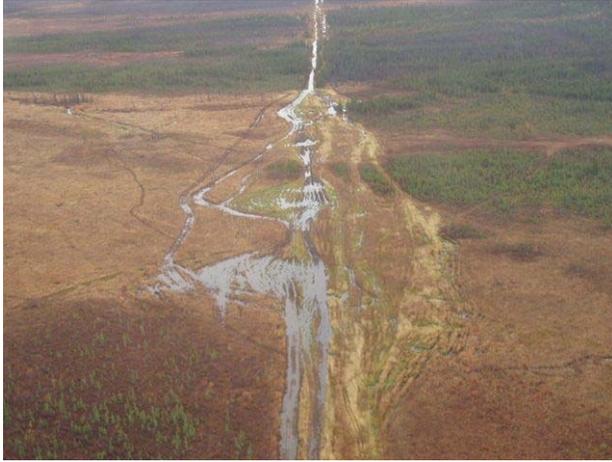
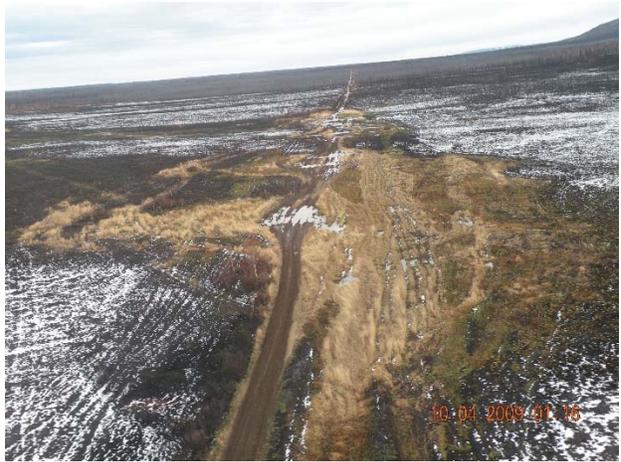
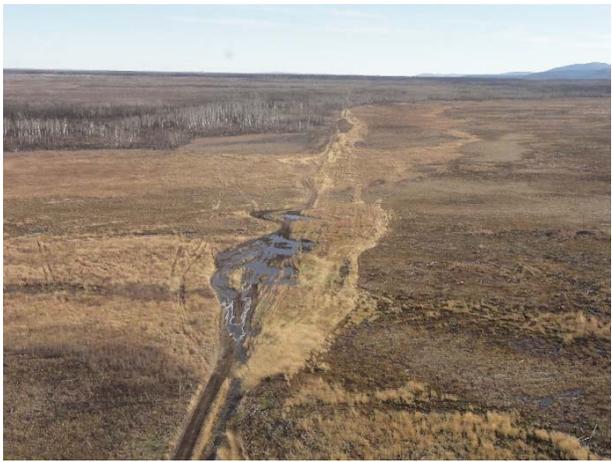
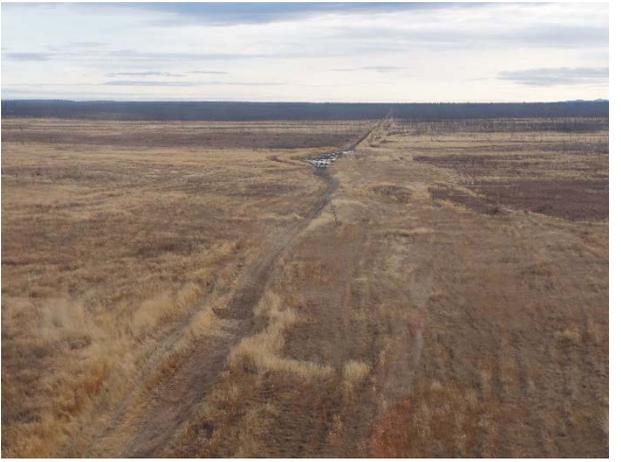
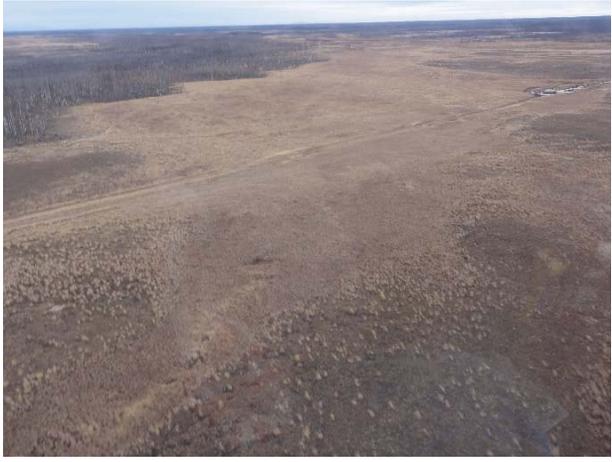
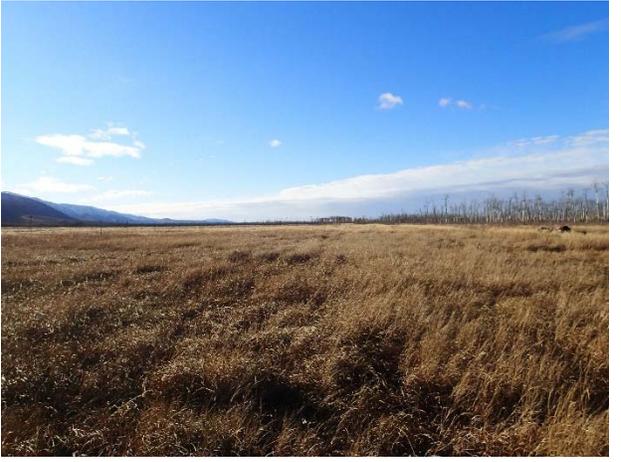
Figure 54: Plot 23 October Photos, 2007 and 2009 to 2013

These examples are important to consider when discussing the impacts of trail restrictions on the condition of the Rex Trail. Plot 23 would appear to have improved over this time period where Plot 14 appears to have become more degraded. Looking at the surface elevation transects for both of these plots (Figures 12 and 14), Plot 14 has a higher standard deviation and more variability in certain parts of the transect. Note also the large and deep trough towards the left side of the Plot 14 transect that has been present since the monitoring began. For Plot 23 there is a lot of small elevational variation but low overall standard deviation values. Plot 23 does have one main trough in the middle that corresponds to the location of the active trail. Figure 32 shows the changes in vegetation cover for Plot 14 and the largest bare soil percentages occur in October of 2014, the same as seen in the photos. Figure 34 shows the vegetation cover for Plot 23 and it seems like there is an overall decrease in the amount of bare soil, which corresponds with the photo series data.
