**TAILINGS AND PRODUCTION ROCK SITE
2013 ANNUAL REPORT**

Hecla Green Creek Mining Company

April 15, 2014

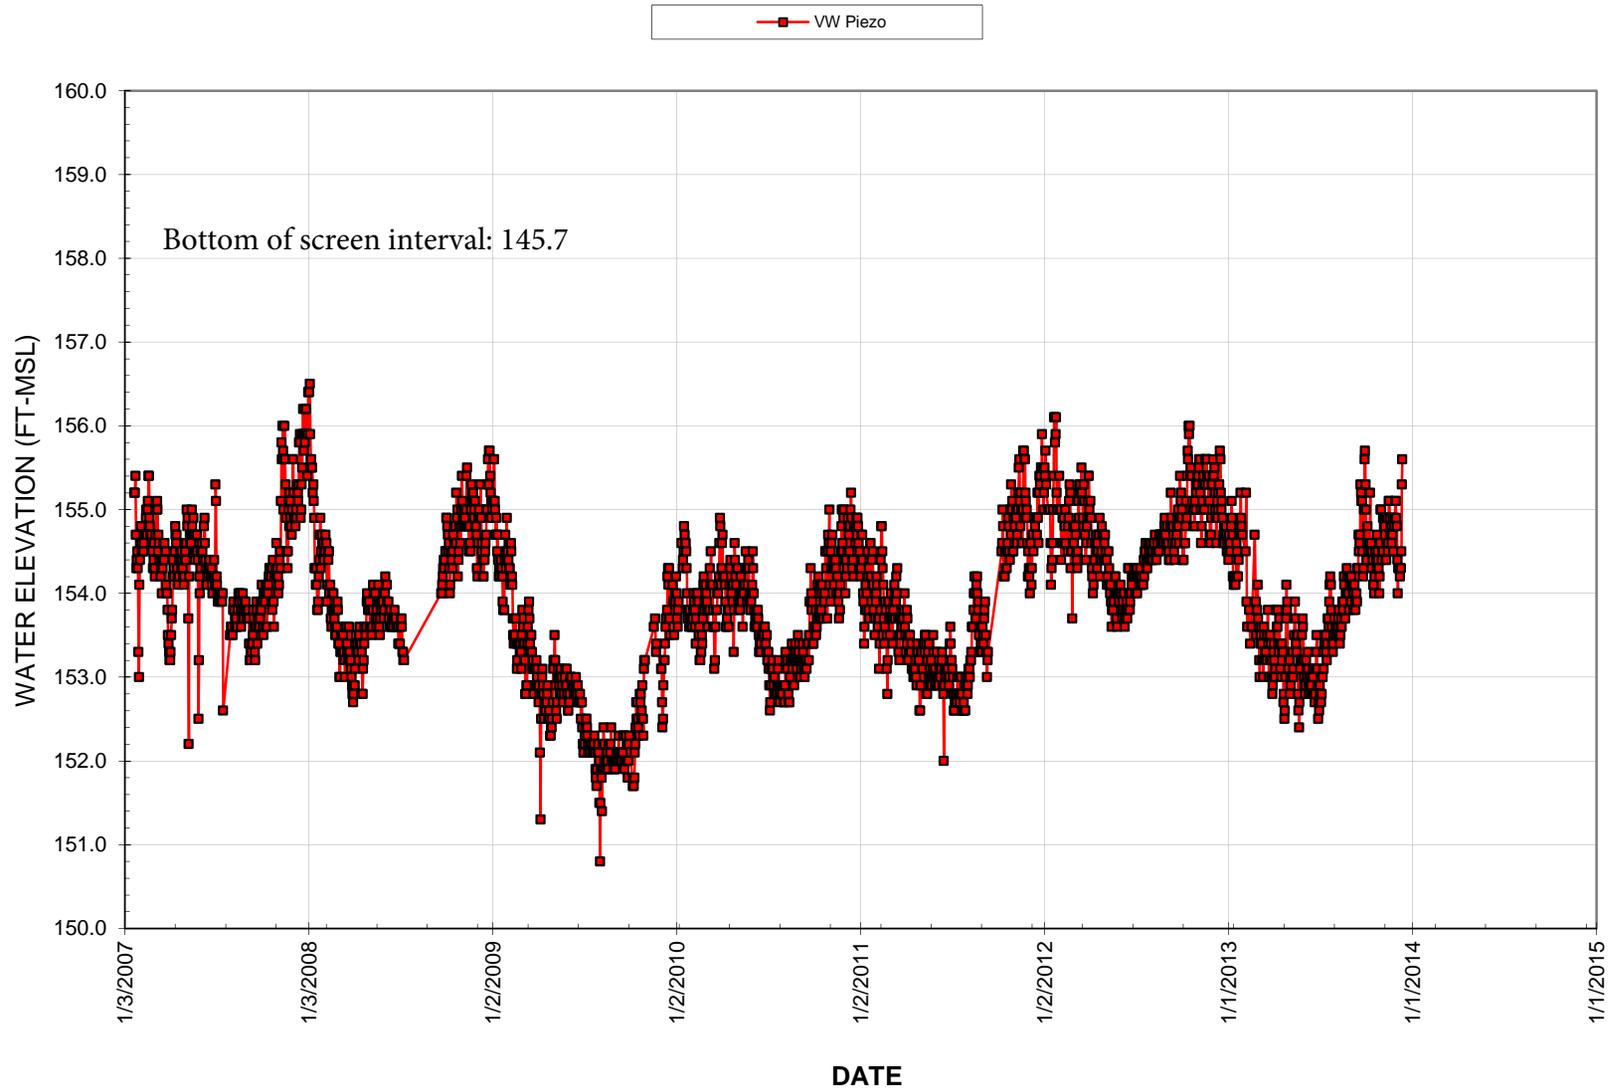
Figure 2.12 Water Level Data for Standpipe Piezometer PZ-T-00-02

The data from standpipe and pneumatic piezometers completed above the blanket drain (Piezometer 76, PZ-T-00-01, PZ-T-00-02, PZ-T-00-03 in Figures 2.10, 2.11, 2.12, 2.13) indicate that saturated conditions can develop above the unsaturated underdrains to a thickness of approximately 12 feet. This is consistent with the low permeability of the tailings and the uncapped condition of the pile. Covering the pile will help minimize the saturated zone in the pile. This was demonstrated by the over 10 foot decrease in the water table that occurred from 1995 to 1997 when the pile was covered (see Figures 2.1 to 2.7). Water levels have rebounded to, and in some cases above, 1994 elevations in most areas. Areas where water levels exceed their 1994 values are areas where the pile is considerably thicker than it was in 1994. The increase in water levels observed in PZ-T-00-01 (and to a lesser extent in instruments nearby) from 2005 to 2007 is likely a result of new tailings placement in the area and staged decommissioning of Wet Well 2.

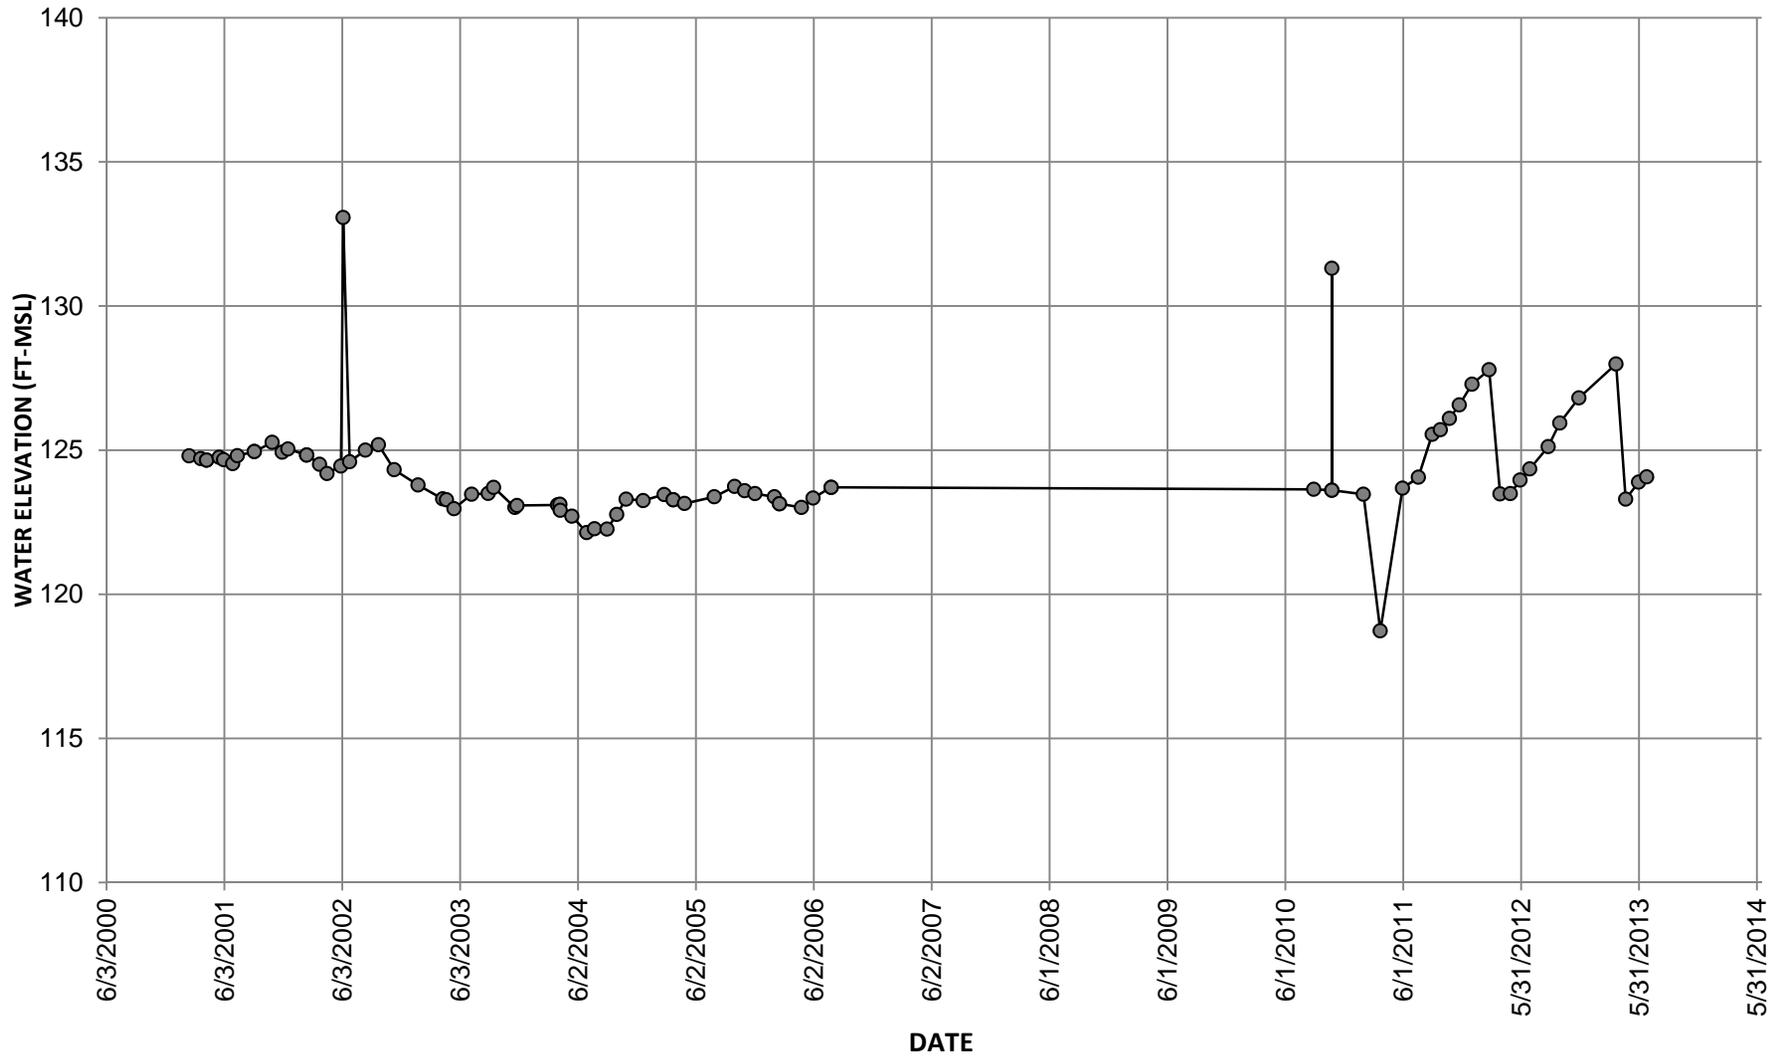
Figure 2.17 Water Level Data for Well MW-T-01-03A

03B are installed west of the pile. Their water levels are shown in Figures 2.17 and 2.18, respectively. MW-T-01-03A is completed in bedrock to a depth of 20 feet and MW-T-01-03B is completed in clayey silt to a depth of 12 feet. These wells show similar water level fluctuations with weather conditions as the two eastern wells. However, the water level in MW-T-01-03B shows a larger differential than MW-T-01-03A because silts and clays hold more water in tension, so a small increase in water content causes a large change in head. The ground surface elevation is 134 feet in the proximity of these two wells. Both MW-T-01-03A and MW-T-01-03B were damaged by bears in 2006 and attempts to recover them were not successful until 2010. A rapid decrease followed by a gradual increase to levels above recent historical values occurred in MW-T-01-03A in 2011. In 2012, the level decreased to levels seen in the past. The cause for the change is not known at this point, however this type of behavior has been documented in the companion well (MW-T-01-03B).

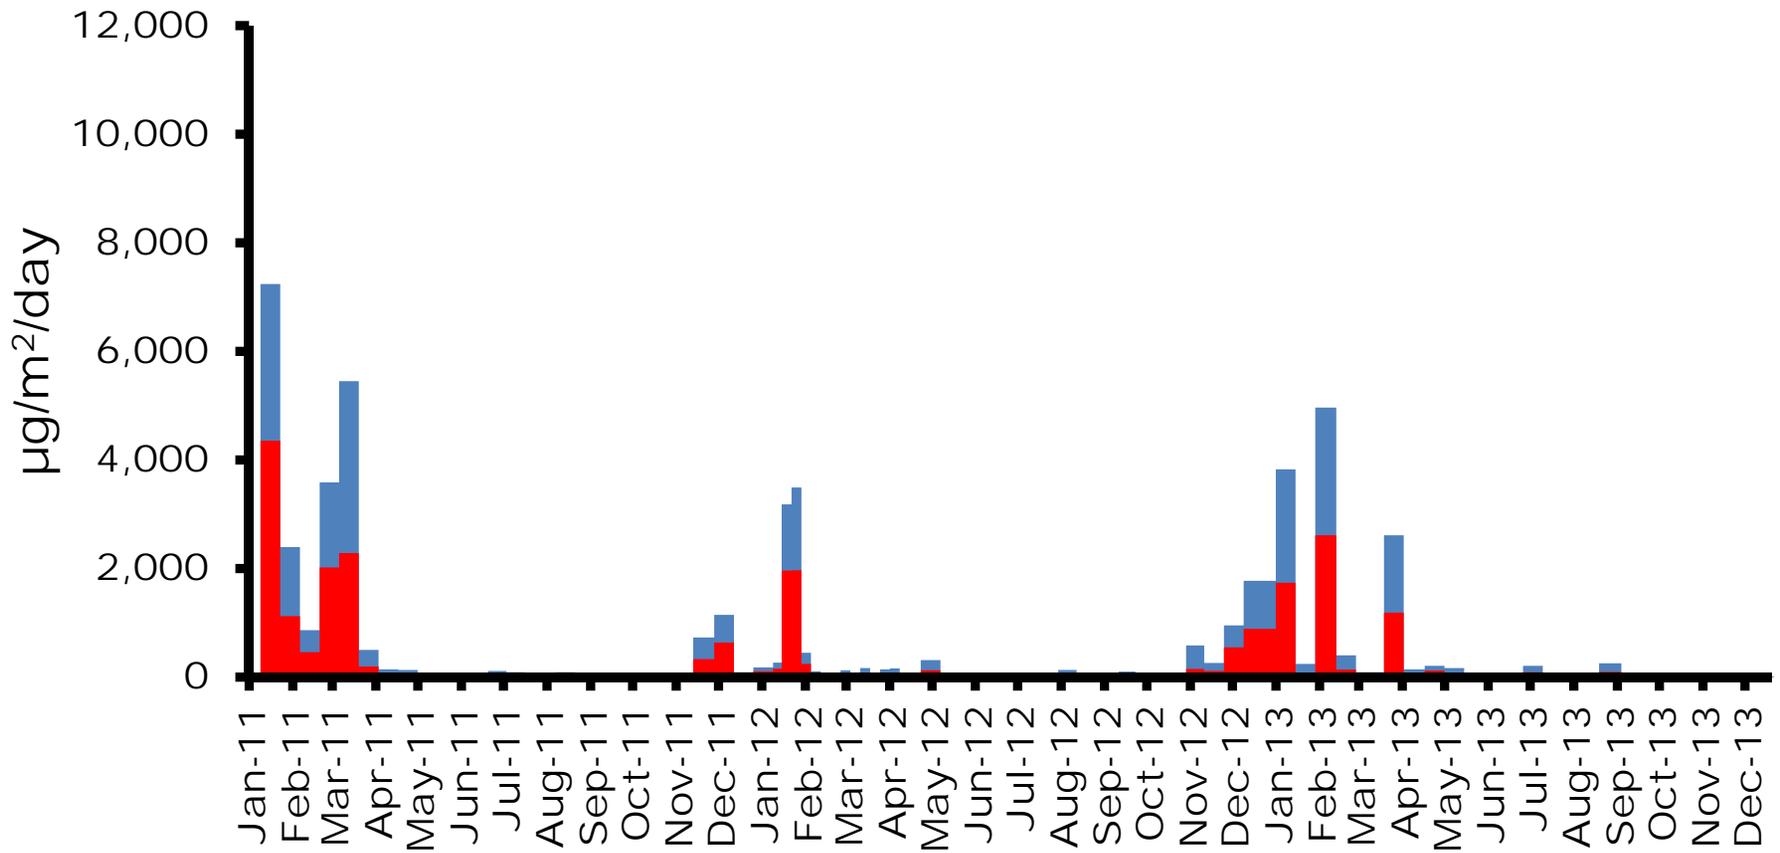
FIGURE 2.37

This data supports and verifies the statements made previously about the seasonality (winter) of this issue (Figure 2.37): it occurs under cold dry desiccating conditions with moderate wind speeds from the north or northeast. Out of the five ADP systems deployed in 2011, three received a higher rate of loading than the other two; they were ADP systems in the west, southwest, and south. Out of these three systems the southwest had the highest yearly accumulative lead load of 95,882 ug/m²/year and the west system with accumulative lead load of 94,468 ug/m²/year. The system to the south accumulated a lead load of 67,031 ug/m²/year (Table 2.9). This lower load may reflect that the ADP system here is farther away from the pile than the other two. Overall, 2013 presented more lead dusting than 2012 and less lead dusting than 2011.

Approximately 93% of the load collected was deposited in 148 days out of the 377 days that were monitored. This period consisted of two sub-periods that were from 1/2/2013 – 4/3/2013 and 11/18/2013 - 1/11/2014. These results were very similar to those obtained for the previous years (2011-2012). There was an increase in the lead loading in 2013 at each monitoring location. Results were consistent with past years except for the lead loading increase in the southwest which was nearly three times the amount of 2011 and 2012 results. Another difference is the least amount of lead loading occurred in the south as shown in Table 2.9a. Lead and zinc daily loading from 2011 through 2013 is shown in Figure 2.37.

Average **lead** and **zinc** daily loading of the ADP on the western side of the tailings disposal facility over a 3 year period.

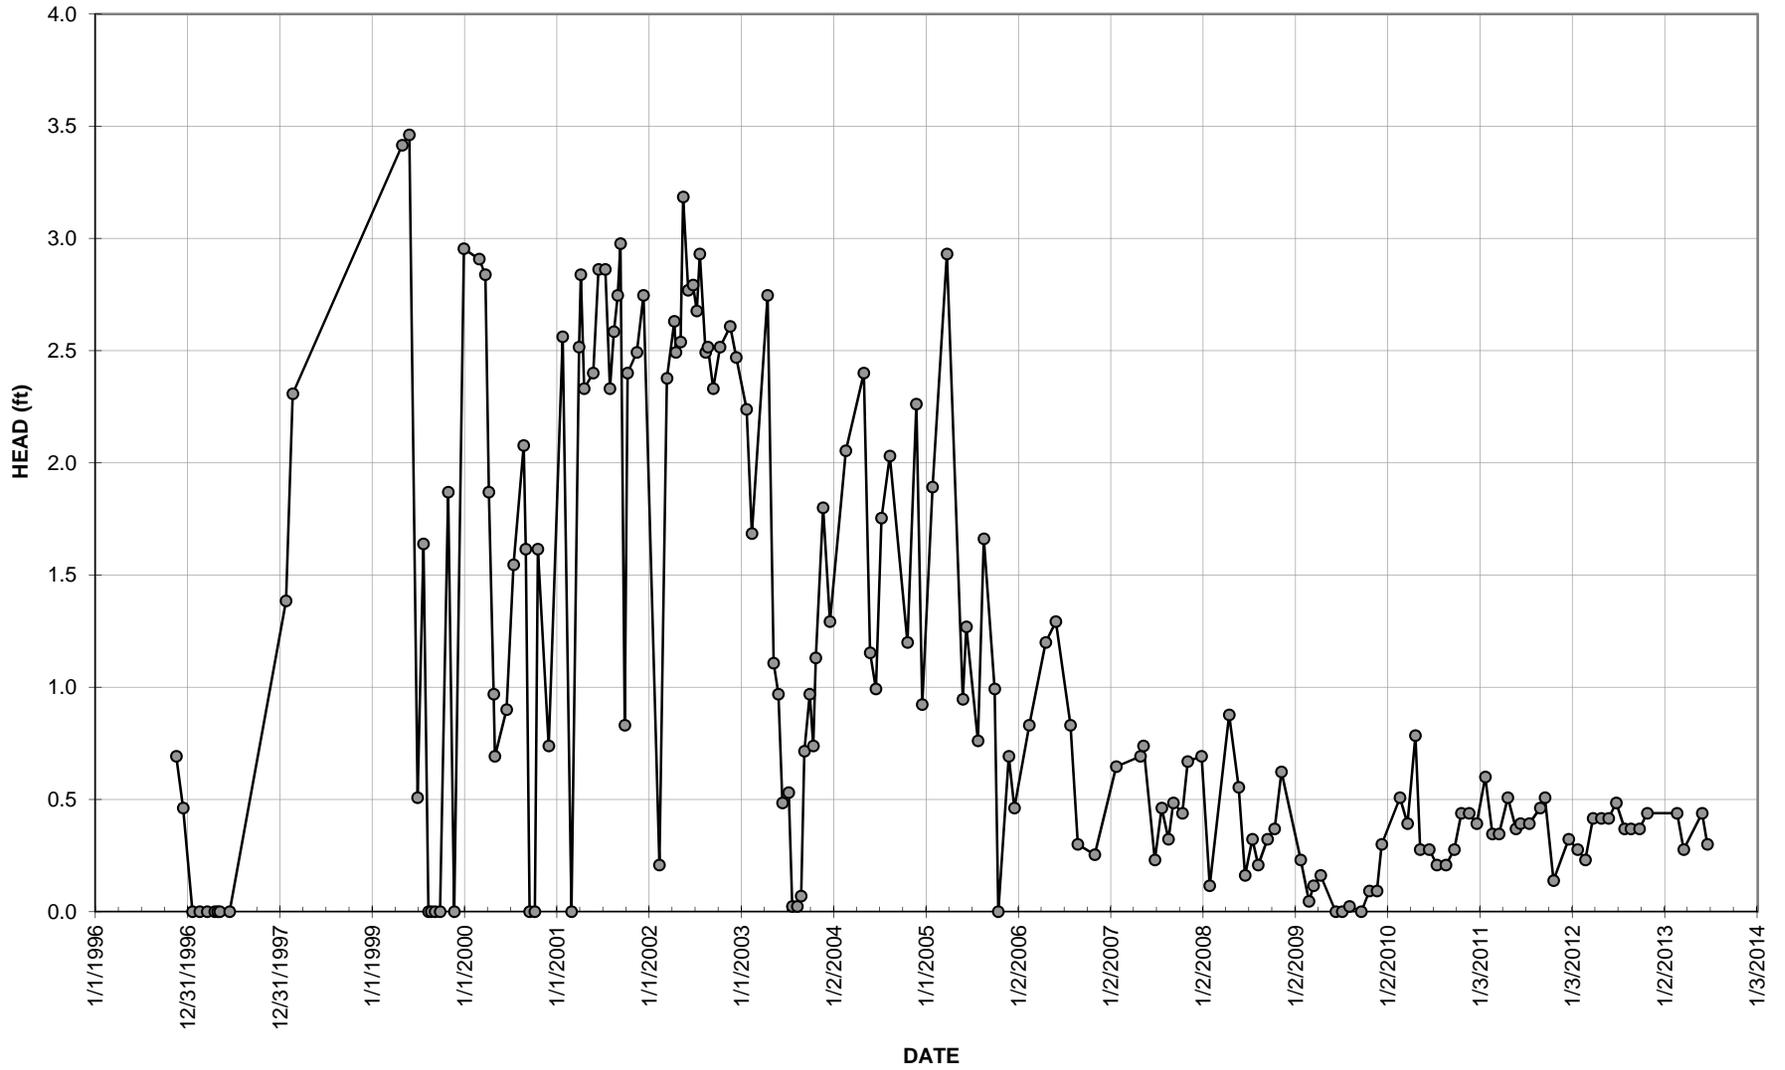
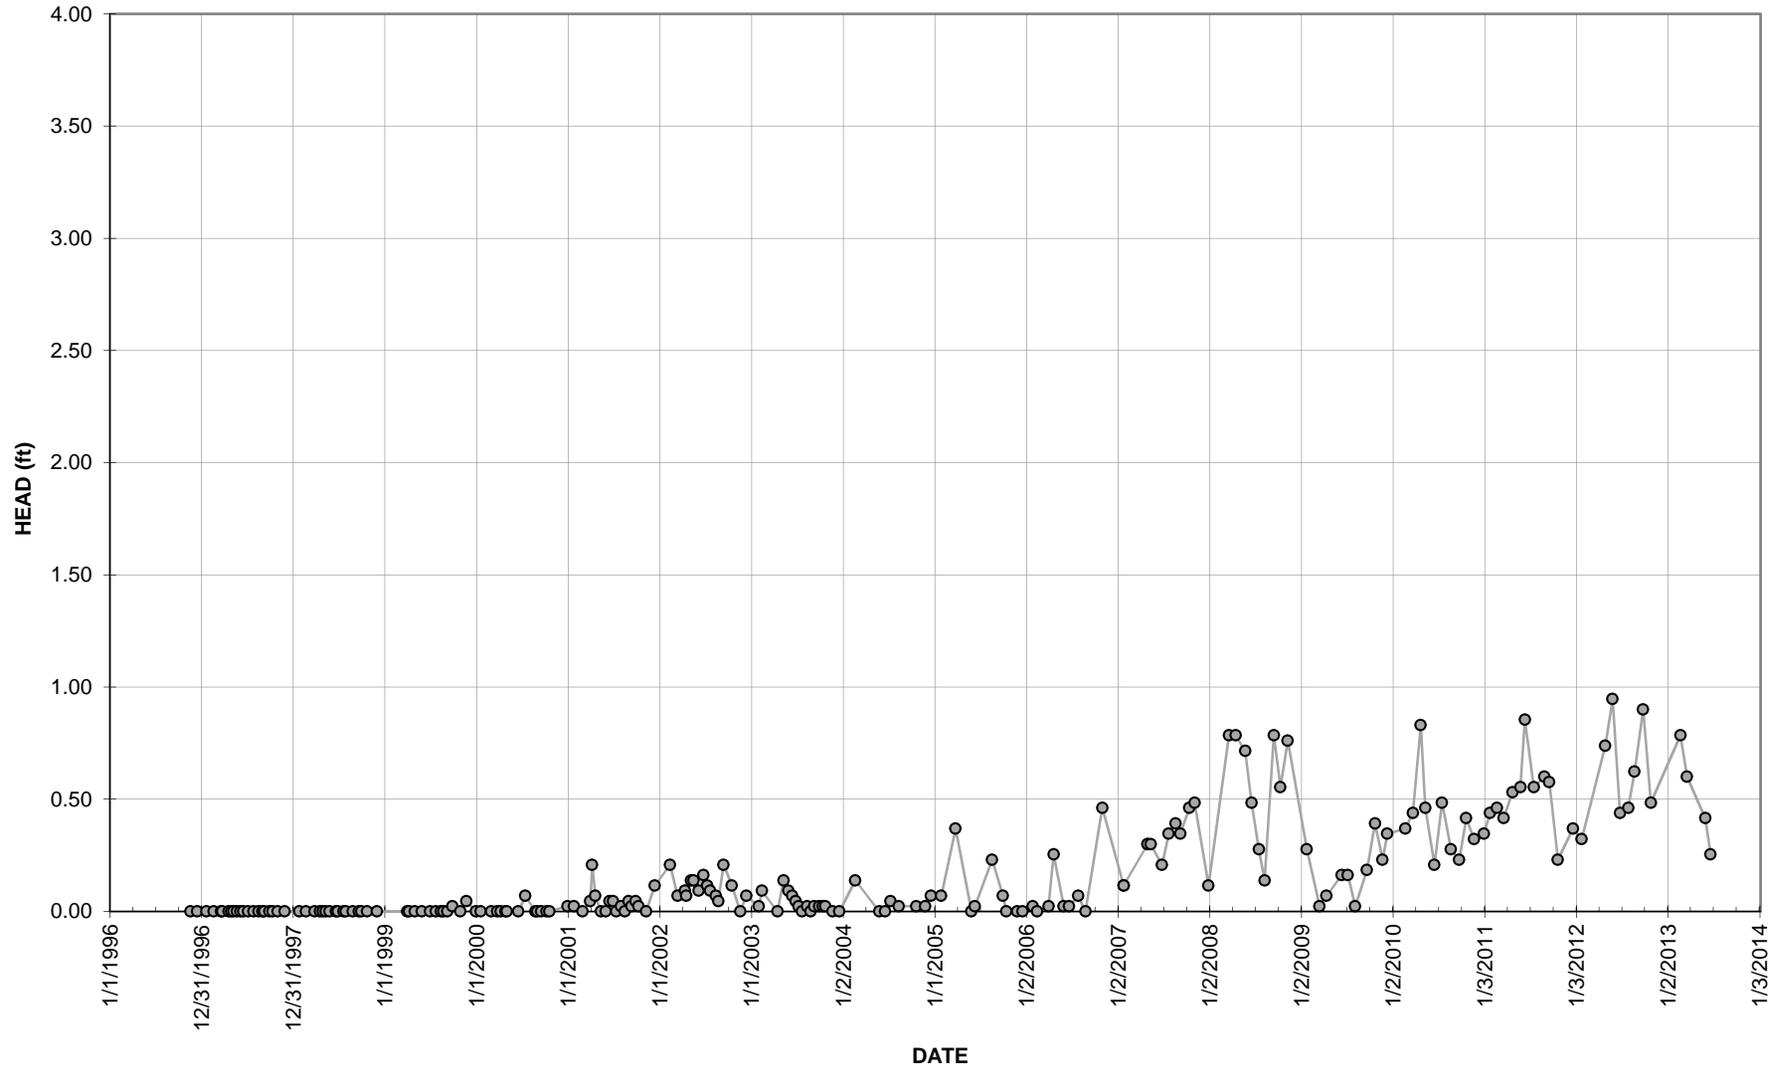
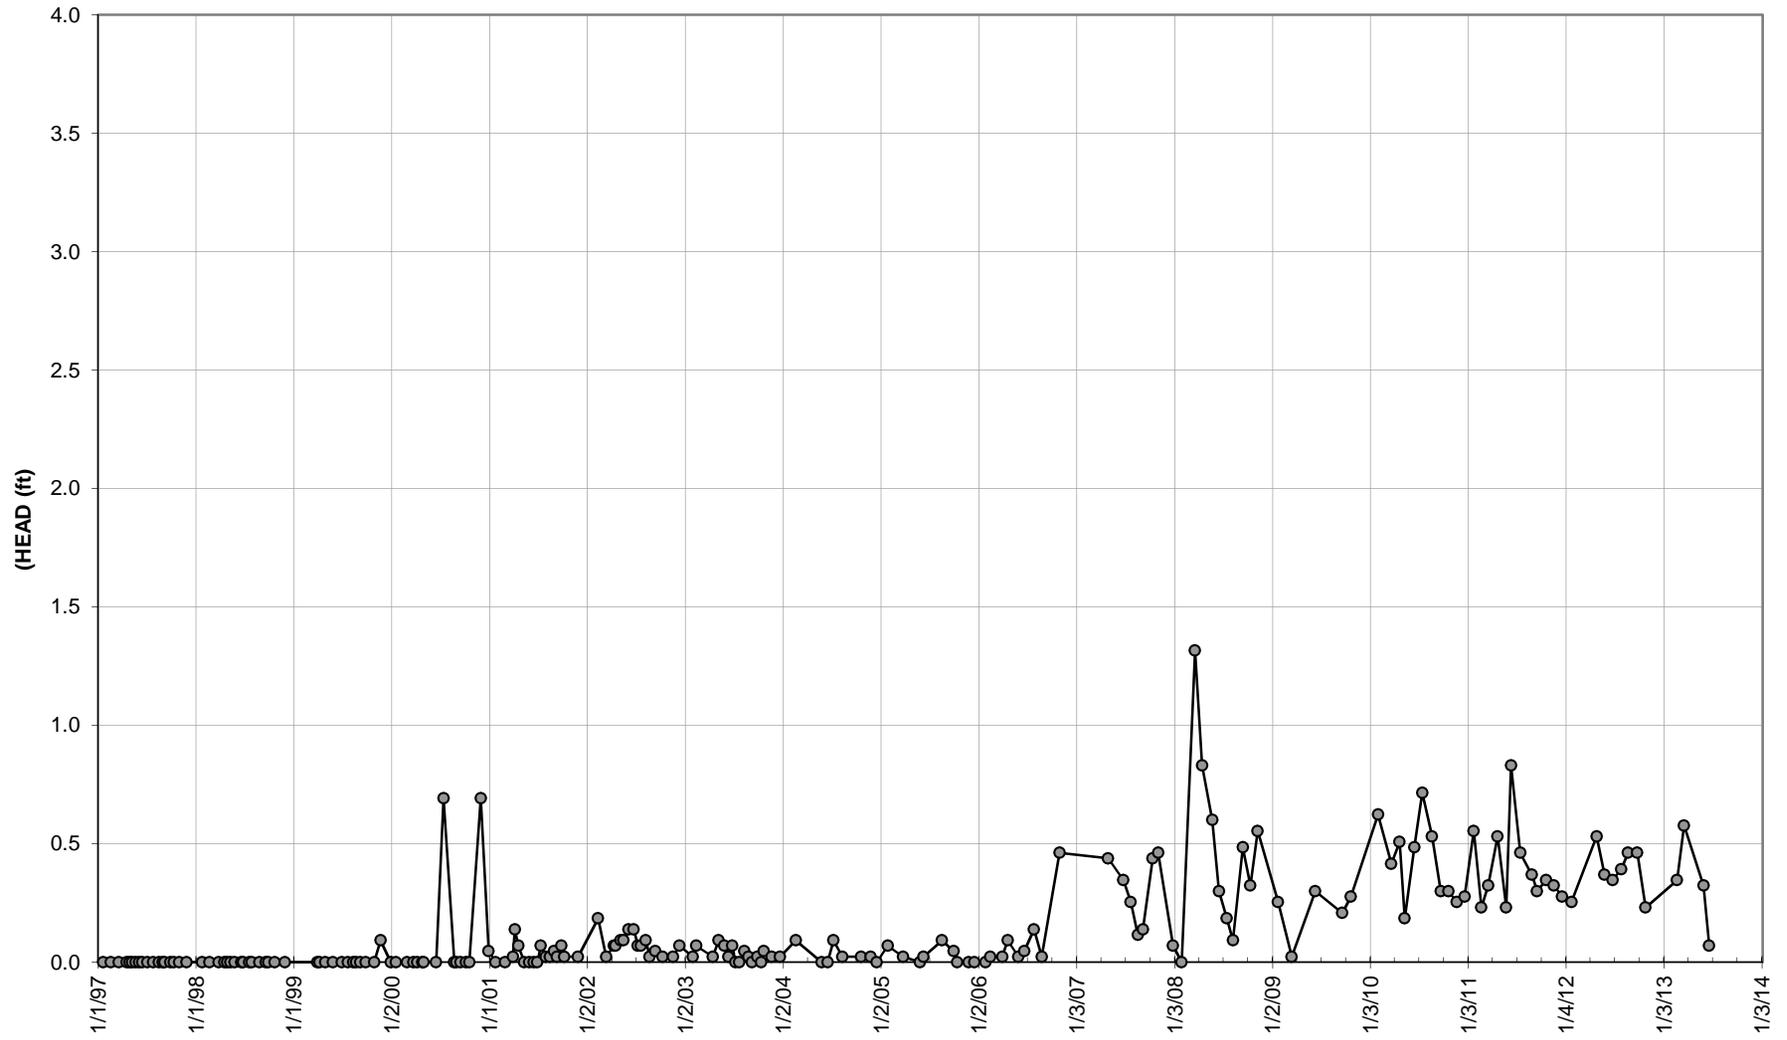
Well and piezometer water level data are provided in Figures 3.1 to 3.12. The lack of significant pressure in piezometers installed close to the base of Site 23 (piezometers 52-55, Figures 3.1 to 3.4) demonstrates that the pile remains free draining. This is consistent with the construction of a network of finger drains under the pile and a blanket drain at the pile toe. Comparison of historic versus modeled flow from the finger drains and the curtain drain indicated they are performing as designed and as necessary (EDE 2004). The lack of pore pressure at the toe indicates that pile stability has been maximized. The inferred water table is 30 to 60 feet below the base of the production rock pile material up-slope of the Site 23 active placement area and 5 to 20 feet below the base of material placed in Site D and the toe of Site 23, respectively (see also Figures 3.5 to 3.12). Observations from wells completed in the colluvium below the sites indicate that perched water tables and braided flow paths exist beneath the site (e.g. compare Figure 3.6 and 3.7). This unit also shows large (up to 10 feet) fluctuations in head levels, which are consistent with perched, confined conditions and channel-like flow. There is a distinct seasonal pattern to the water level fluctuations beneath Site 23/D, particularly in the alluvial sands (Figures 3.9 and 3.11).

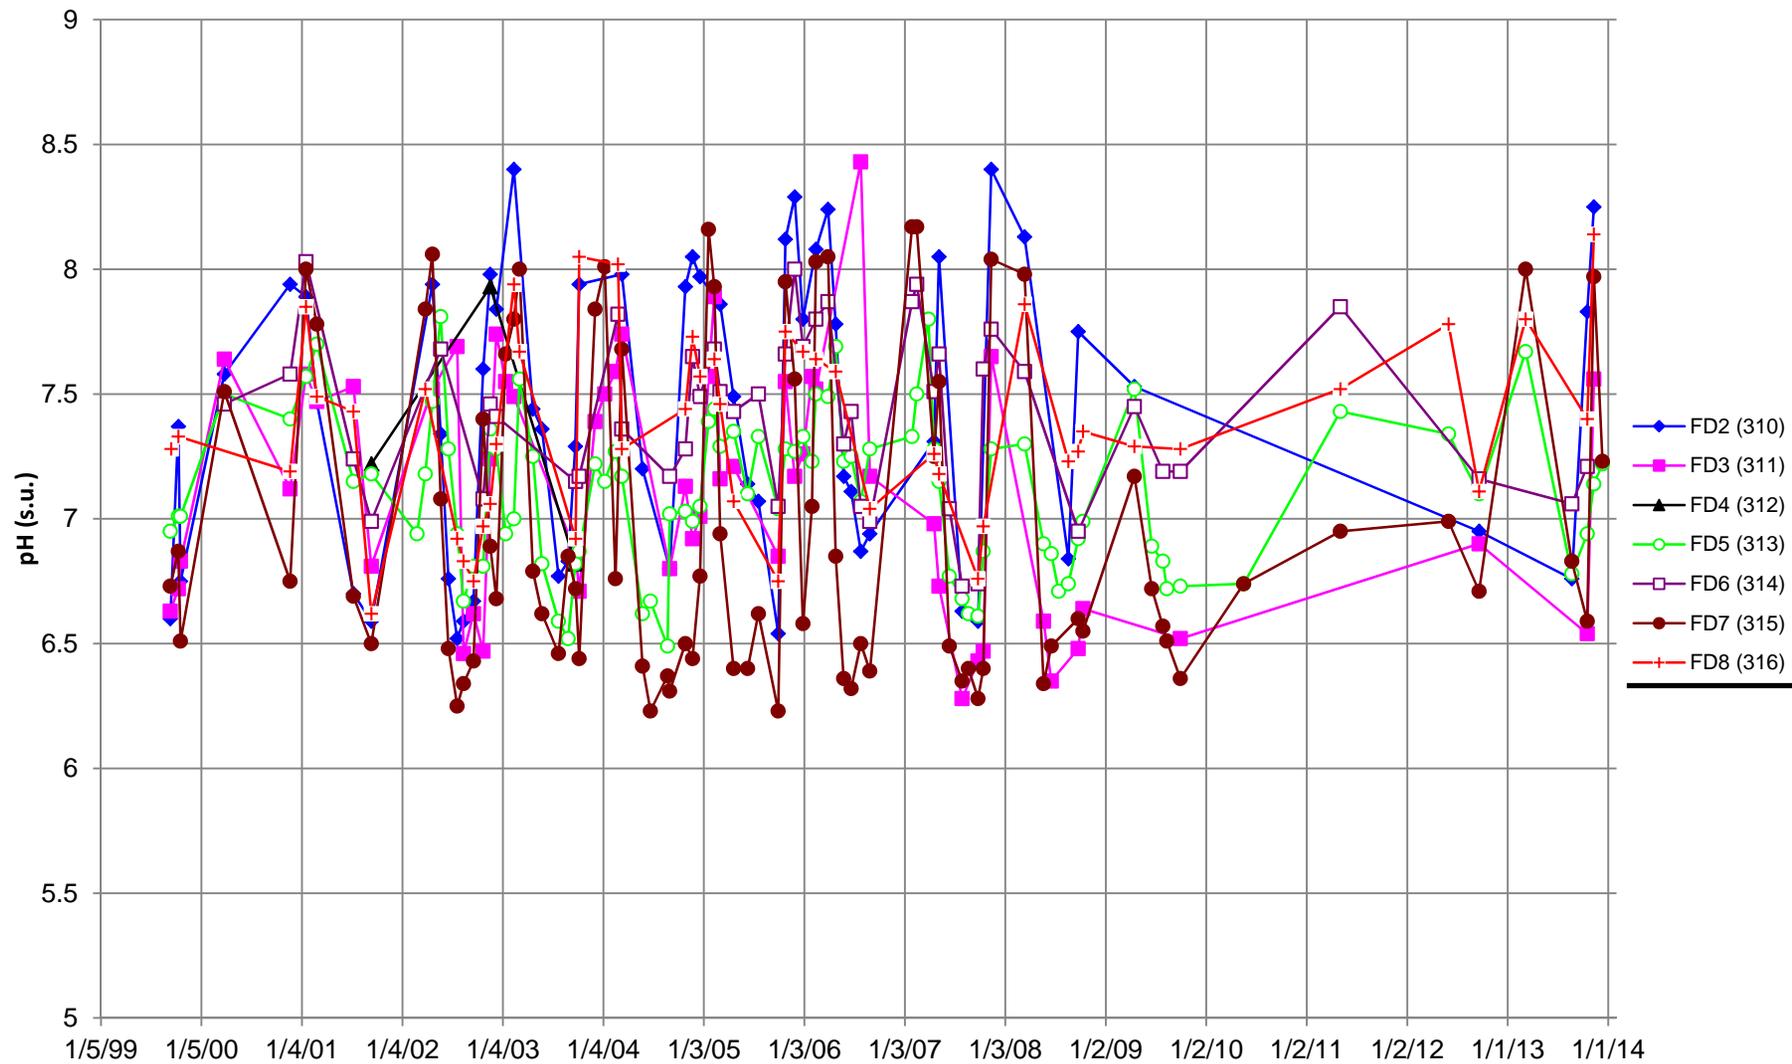
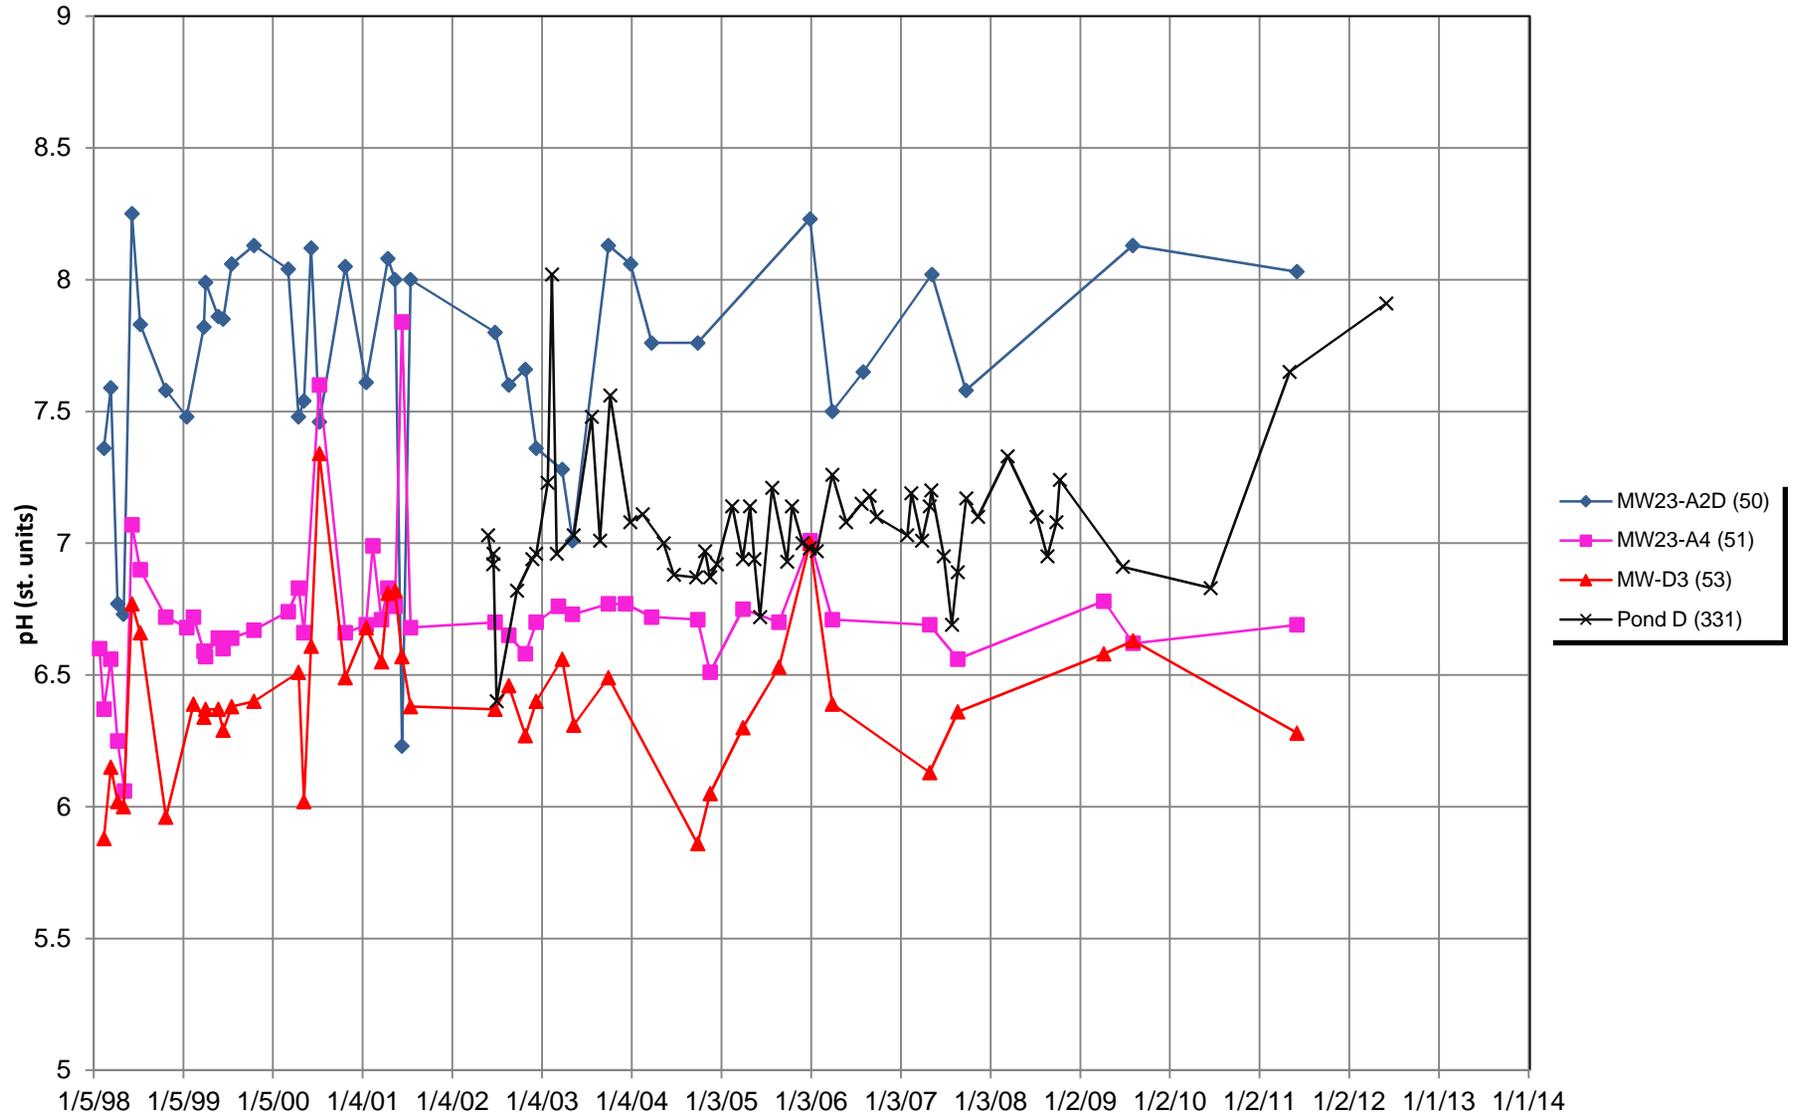
Figure 3.14a shows the pH of waters collected from Site 23 Finger Drains 2 through 8, and Figure 3.14b shows the pH of monitoring wells MW-23-A2D, MW-23-A4, MW-D3 and Pond D (see as-built in Appendix 2 for locations). Monitoring of pH at these sites was not conducted in 2013. The lower pH values (generally pH 6.0 to 7.0) were recorded in MW-23-A4 and MW-D3, both of which are completed in alluvial sands beneath Site 23 and Site D, respectively. MW-23-A2D, which screens colluvium upgradient of Site 23, typically has the highest pH (generally pH 7.0 to 8.5). The Site 23 finger drains fluctuate at values between those of the monitoring wells. Figures 3.14a and b suggest that waters from different foundation units have different pH values and that Site 23 and Site D contact waters and the materials with which they are in contact exhibit sufficient buffering capacity to prevent acidification of site drainage in the near term. Seasonal fluctuations are apparent in the finger drains with highest pH values occurring in winter months and lower pH in mid to late summer.

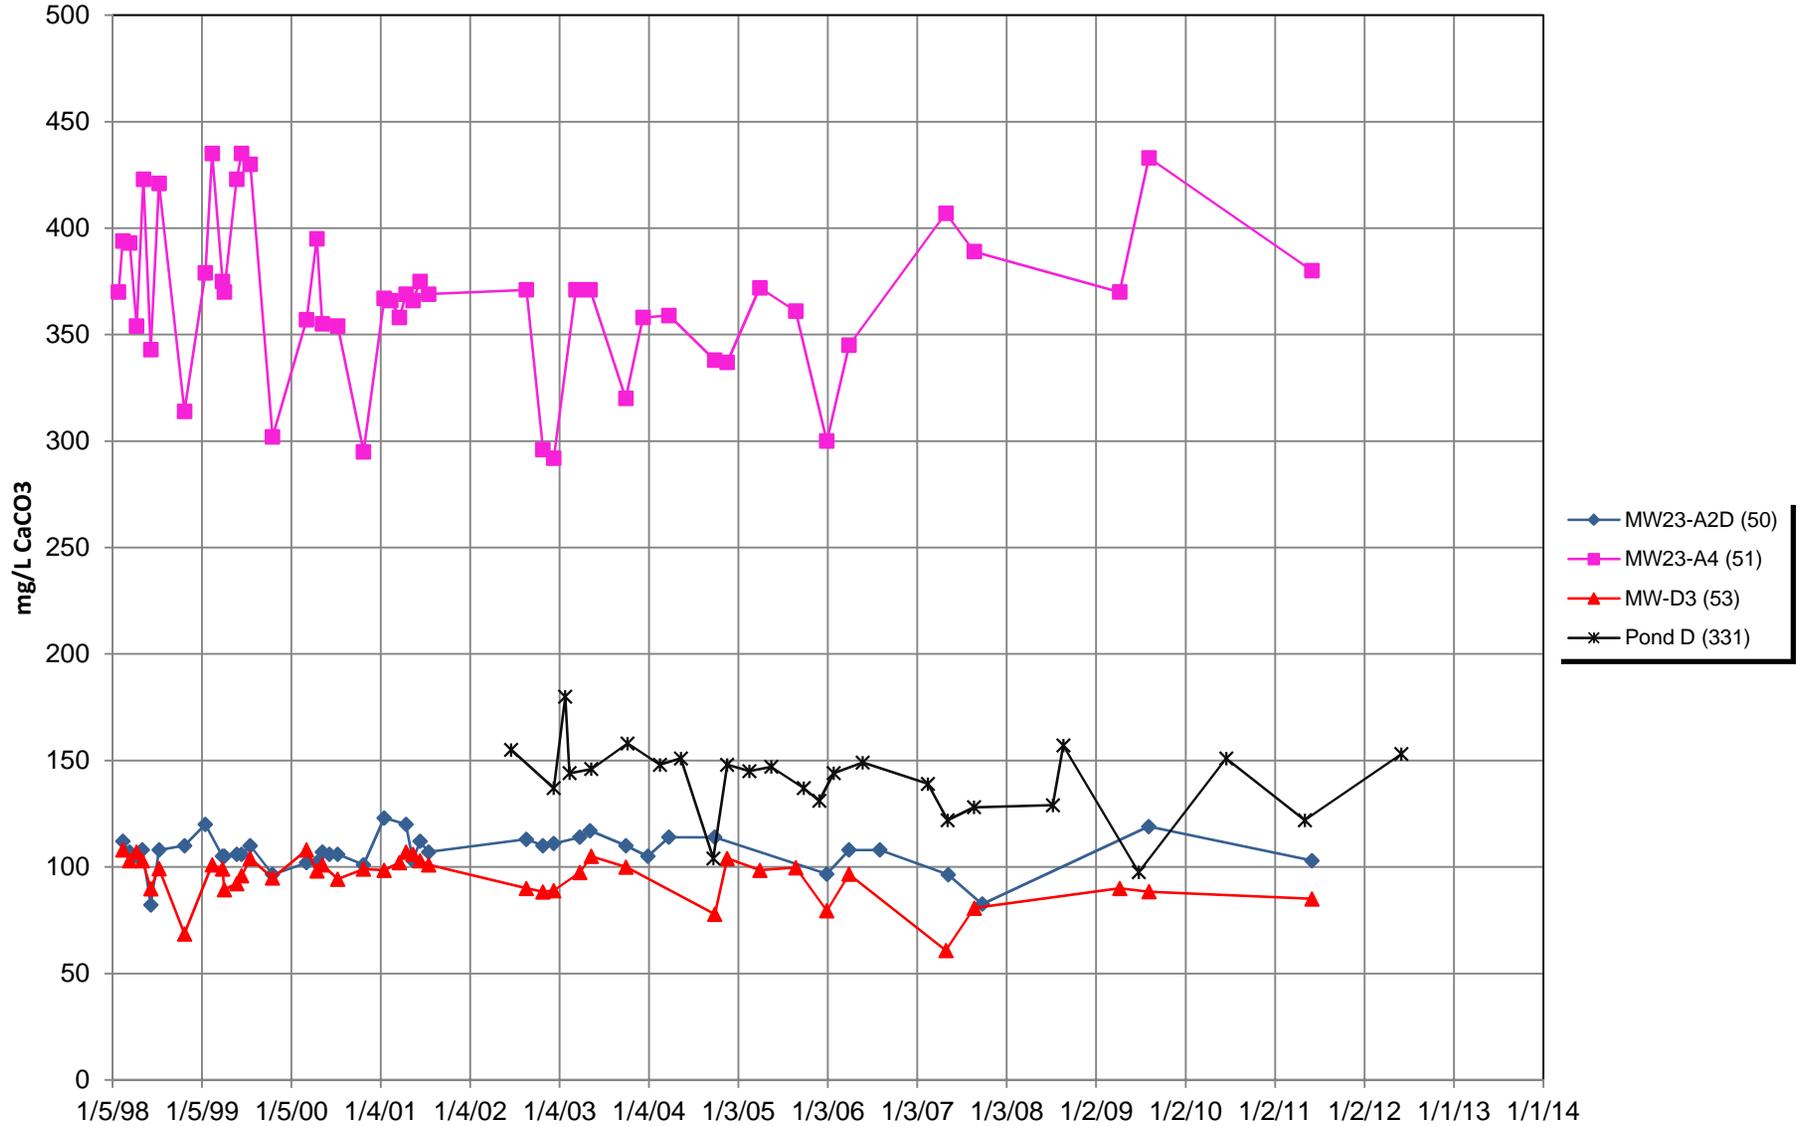
As with pH, high alkalinity values (Figures 3.15a and b) indicate that the waters are well buffered. Fluctuations in alkalinity correlate with those of other parameters, such as hardness (Figures 3.16a and b) and conductivity (Figures 3.17a and b), and also appear to be seasonal. Carbonate minerals in the production rock contribute to the high alkalinity of the drainage from the finger drains. Alkalinity is lowest in samples with the highest groundwater component (e.g. the monitoring wells, Pond D, 23FD-5 and 23FD-7). Calcium and magnesium are the primary contributors to hardness (Figure 3.16a) and reflect dissolution of carbonate minerals, such as calcite and dolomite. Carbonate dissolution neutralizes acidity formed by sulfide oxidation, which is also the source of sulfate shown in Figure 3.18a.

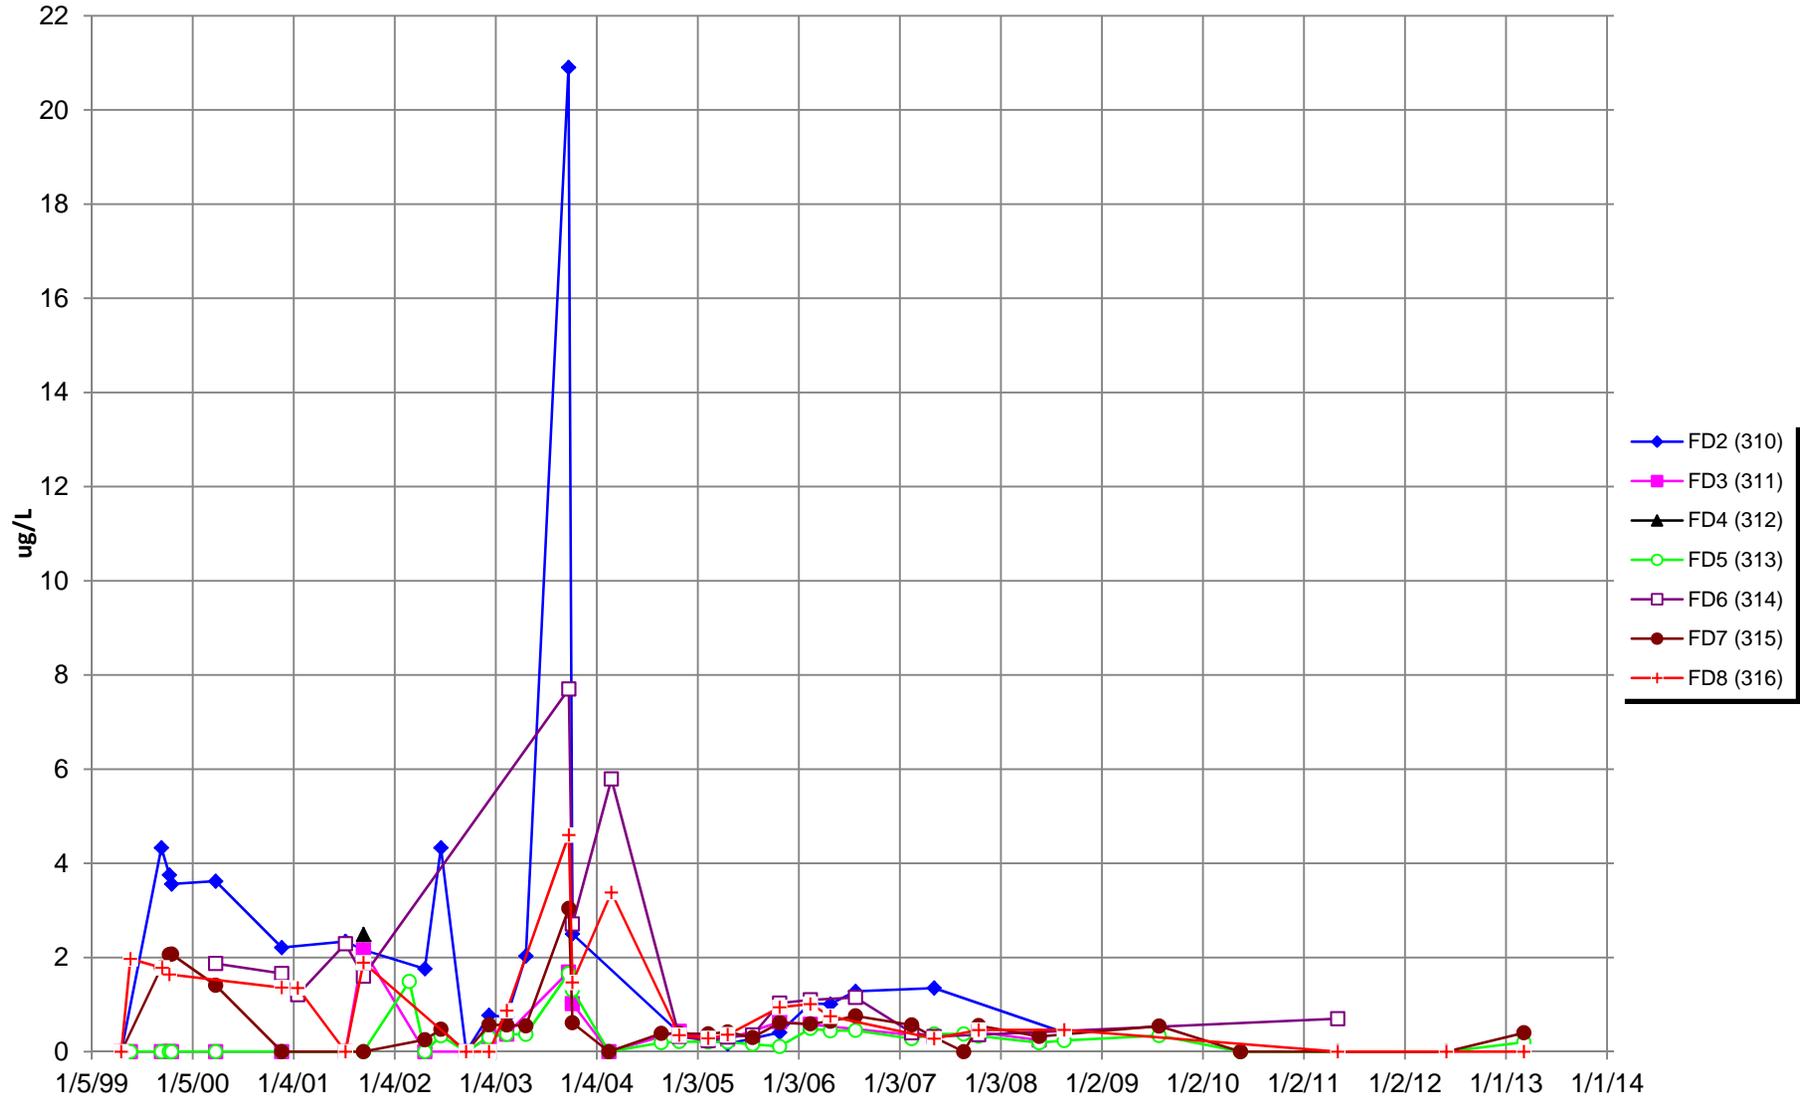
**Figure 3.19a GREENS CREEK SITE 23/D INTERNAL MONITORING SITES:
FINGER DRAINS ARSENIC DATA**
(Non-detectable analyses plotted as zero)

Arsenic data are presented in Figures 3.19a and b and are generally quite low. All finger drains and MW-23-A4 experienced increases in their arsenic concentrations in September 2003, with subsequent decreases back down to historical levels in October. The flows in the finger drains positively correlate with these changes. Fluctuations in arsenic values in 23FD-2 can be attributed to changes in redox conditions. Low arsenic and iron (Figures 3.25 a and b) concentrations indicate that these metals are precipitating as oxyhydroxides on rock surfaces in the pile.
