**TAILINGS AND PRODUCTION ROCK SITE
2013 ANNUAL REPORT**

Hecla Green Creek Mining Company

April 15, 2014

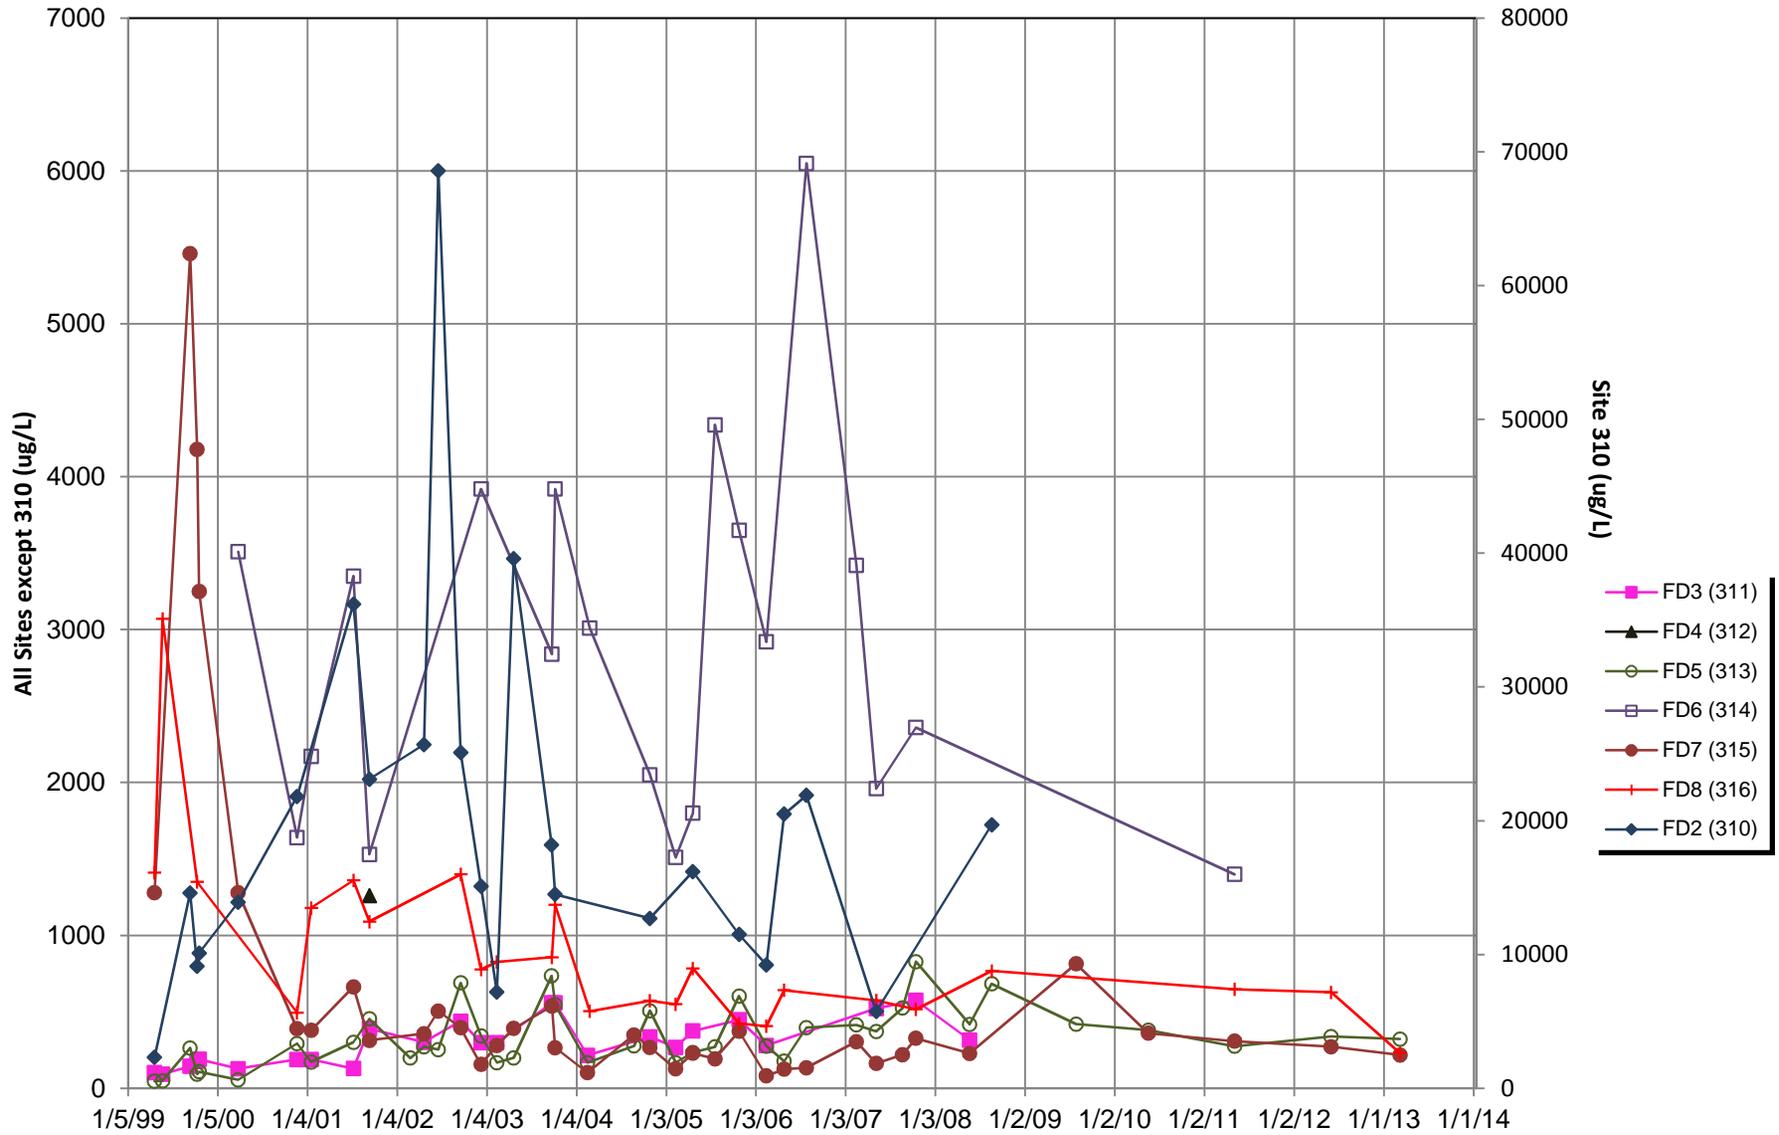
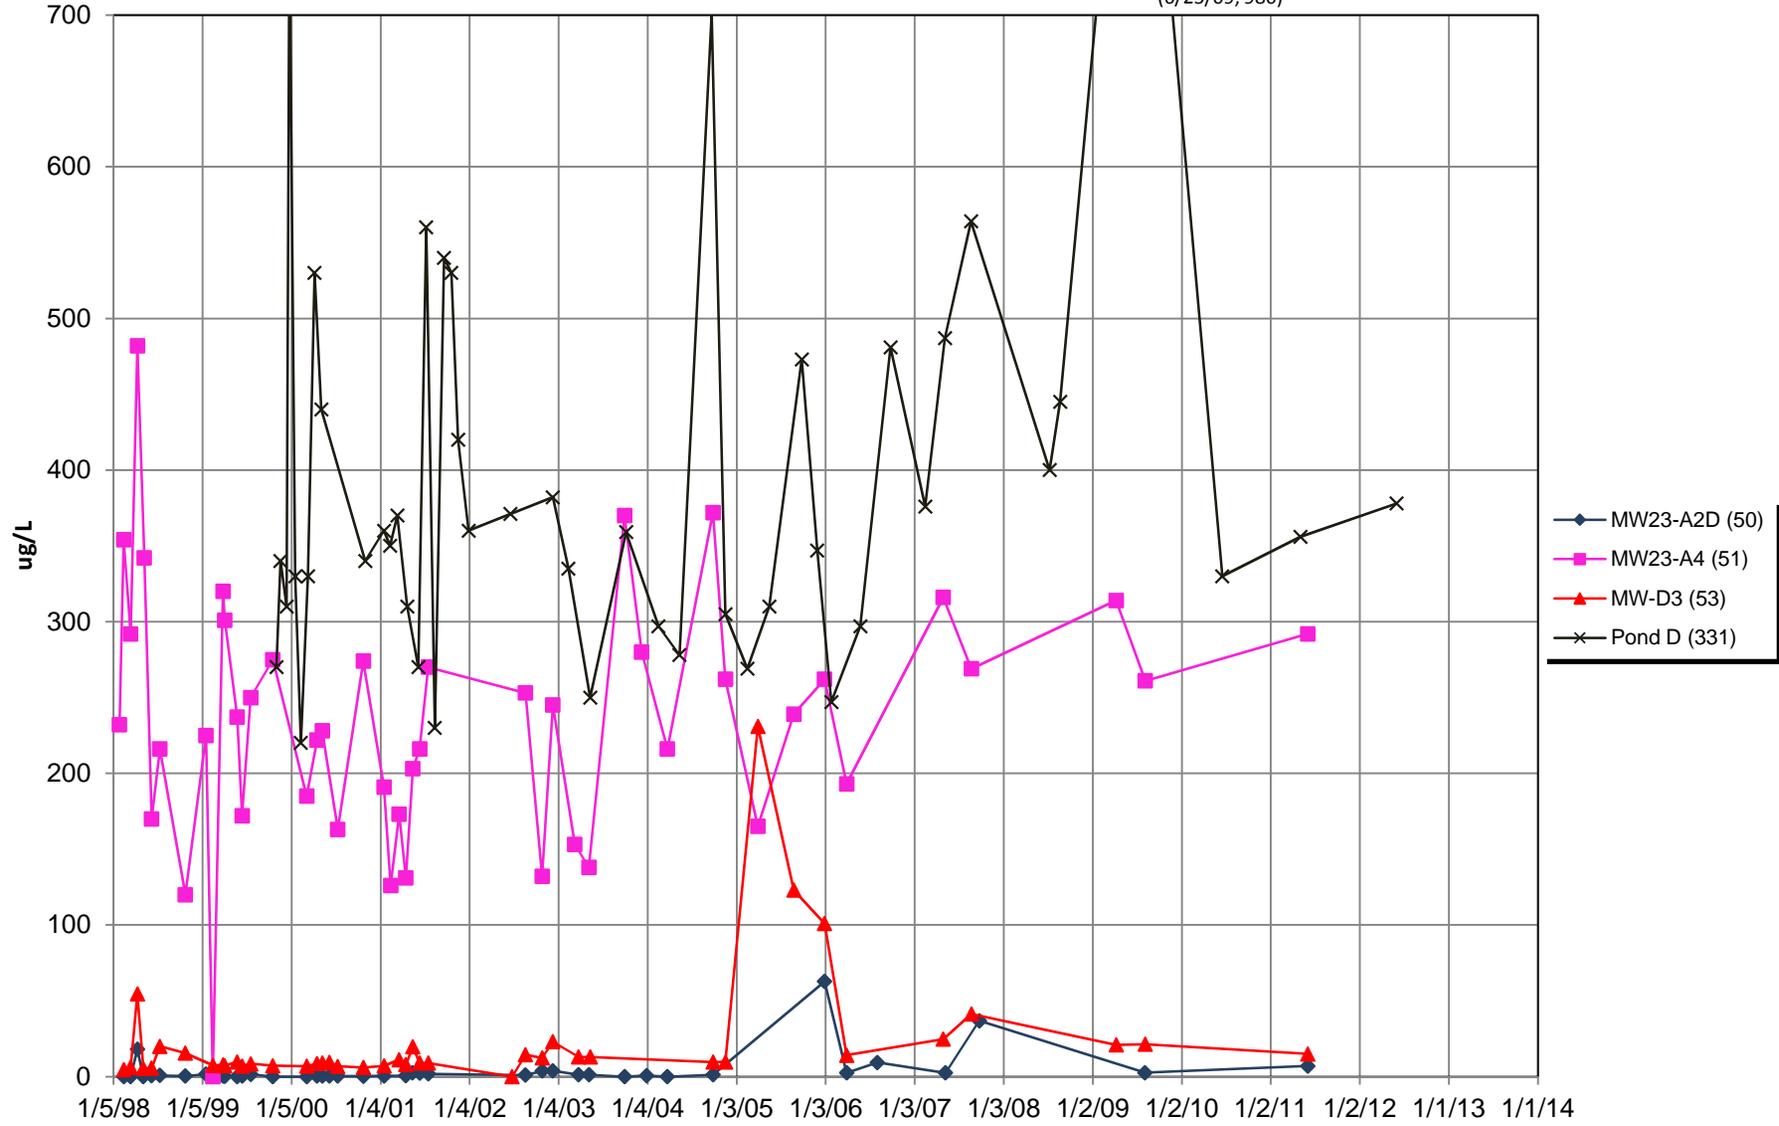
**Figure 3.20a GREENS CREEK SITE 23/D INTERNAL MONITORING SITES:
FINGER DRAINS - ZINC DATA
(Non-detectable analyses plotted as zero)**

Figures 3.20a and b show the concentration of zinc in the internal monitoring locations at Site 23/D. Zinc levels appear to be controlled by seasonal conditions. Zinc concentrations in the range of 20 to 70 mg/L are consistent with laboratory kinetic weathering tests performed on samples of argillite and serpentinite (Vos 1993). The zinc concentrations recorded for Pond D are generally below 0.9 mg/L and reflect contributions from several source waters. Pond D receives water from Site D surface runoff, seeps on the slope and at the toe of the site and the effluent from the curtain drain that HGCMC installed between Site D and Site 23.

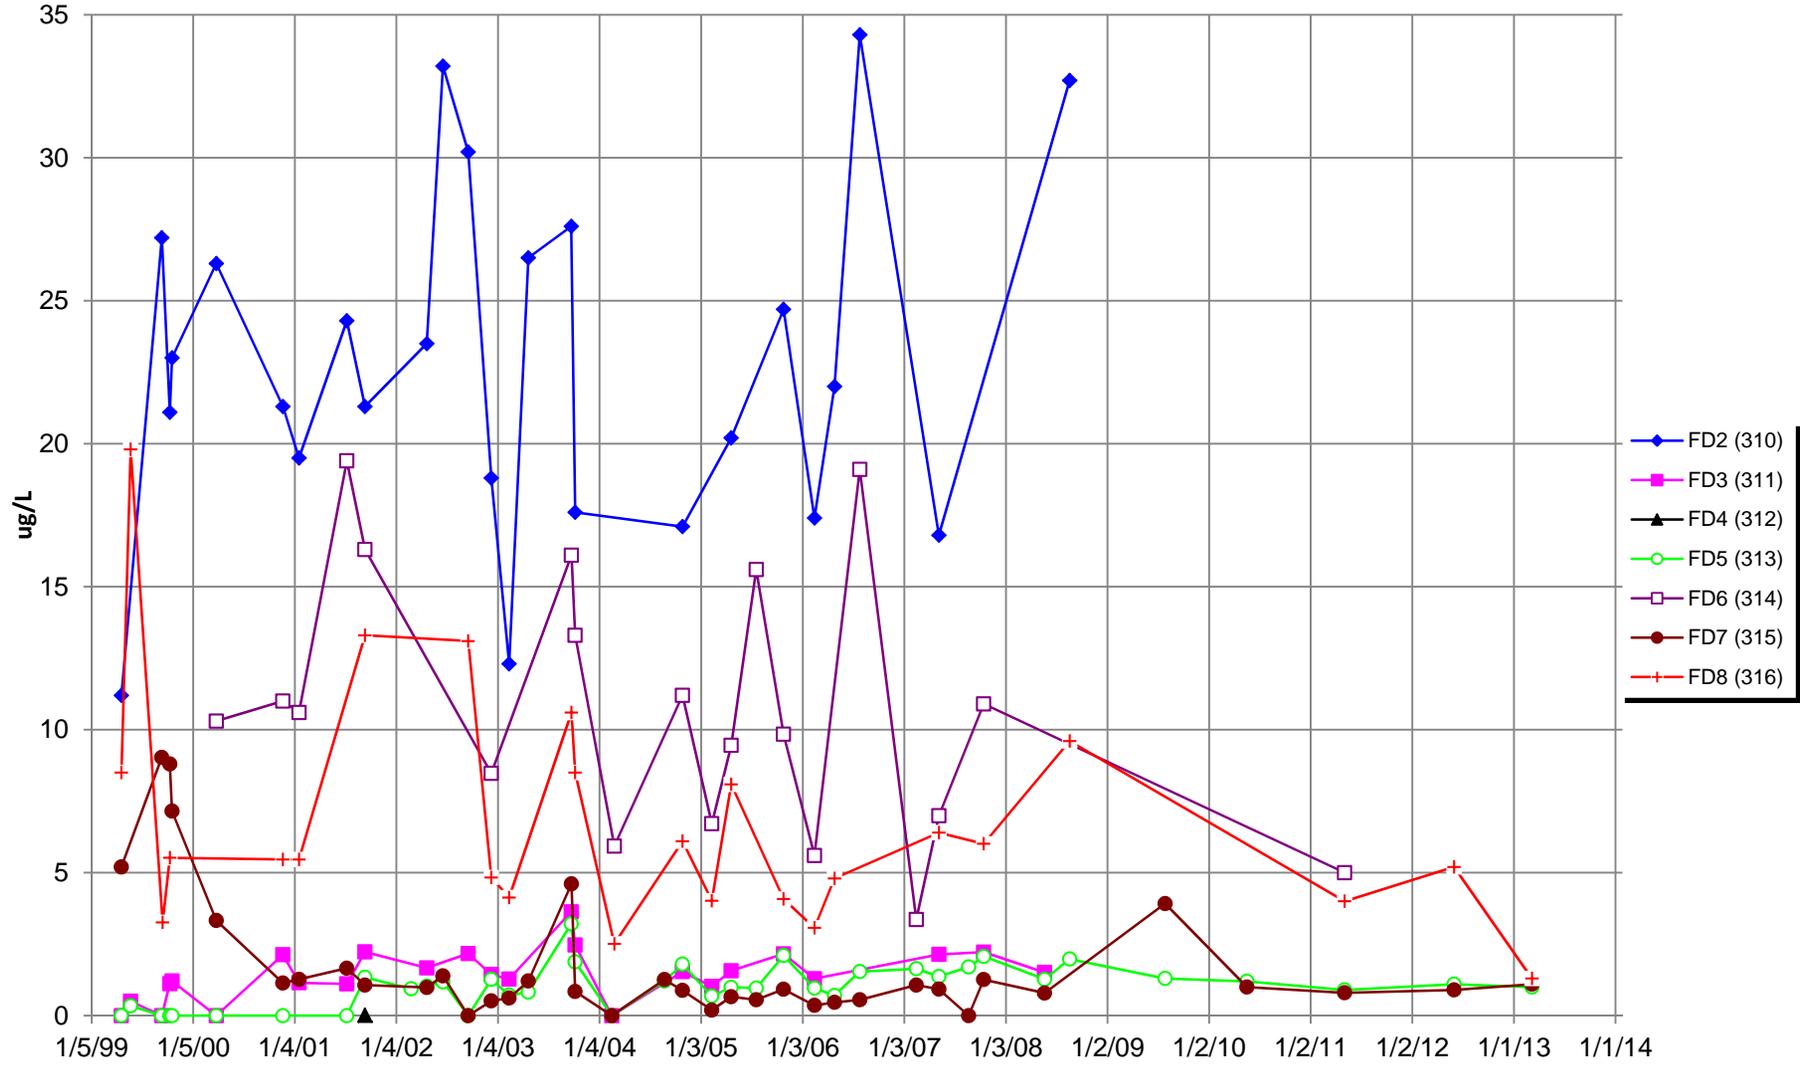
**Figure 3.21a GREENS CREEK SITE 23/D INTERNAL MONITORING SITES:
FINGER DRAINS - CADMIUM DATA**
(Non-detectable analyses plotted as zero)

Cadmium concentrations (Figures 3.21a and b) correlate well with those of zinc for the internal monitoring sites although at much lower values (0 to 35 ug/L).

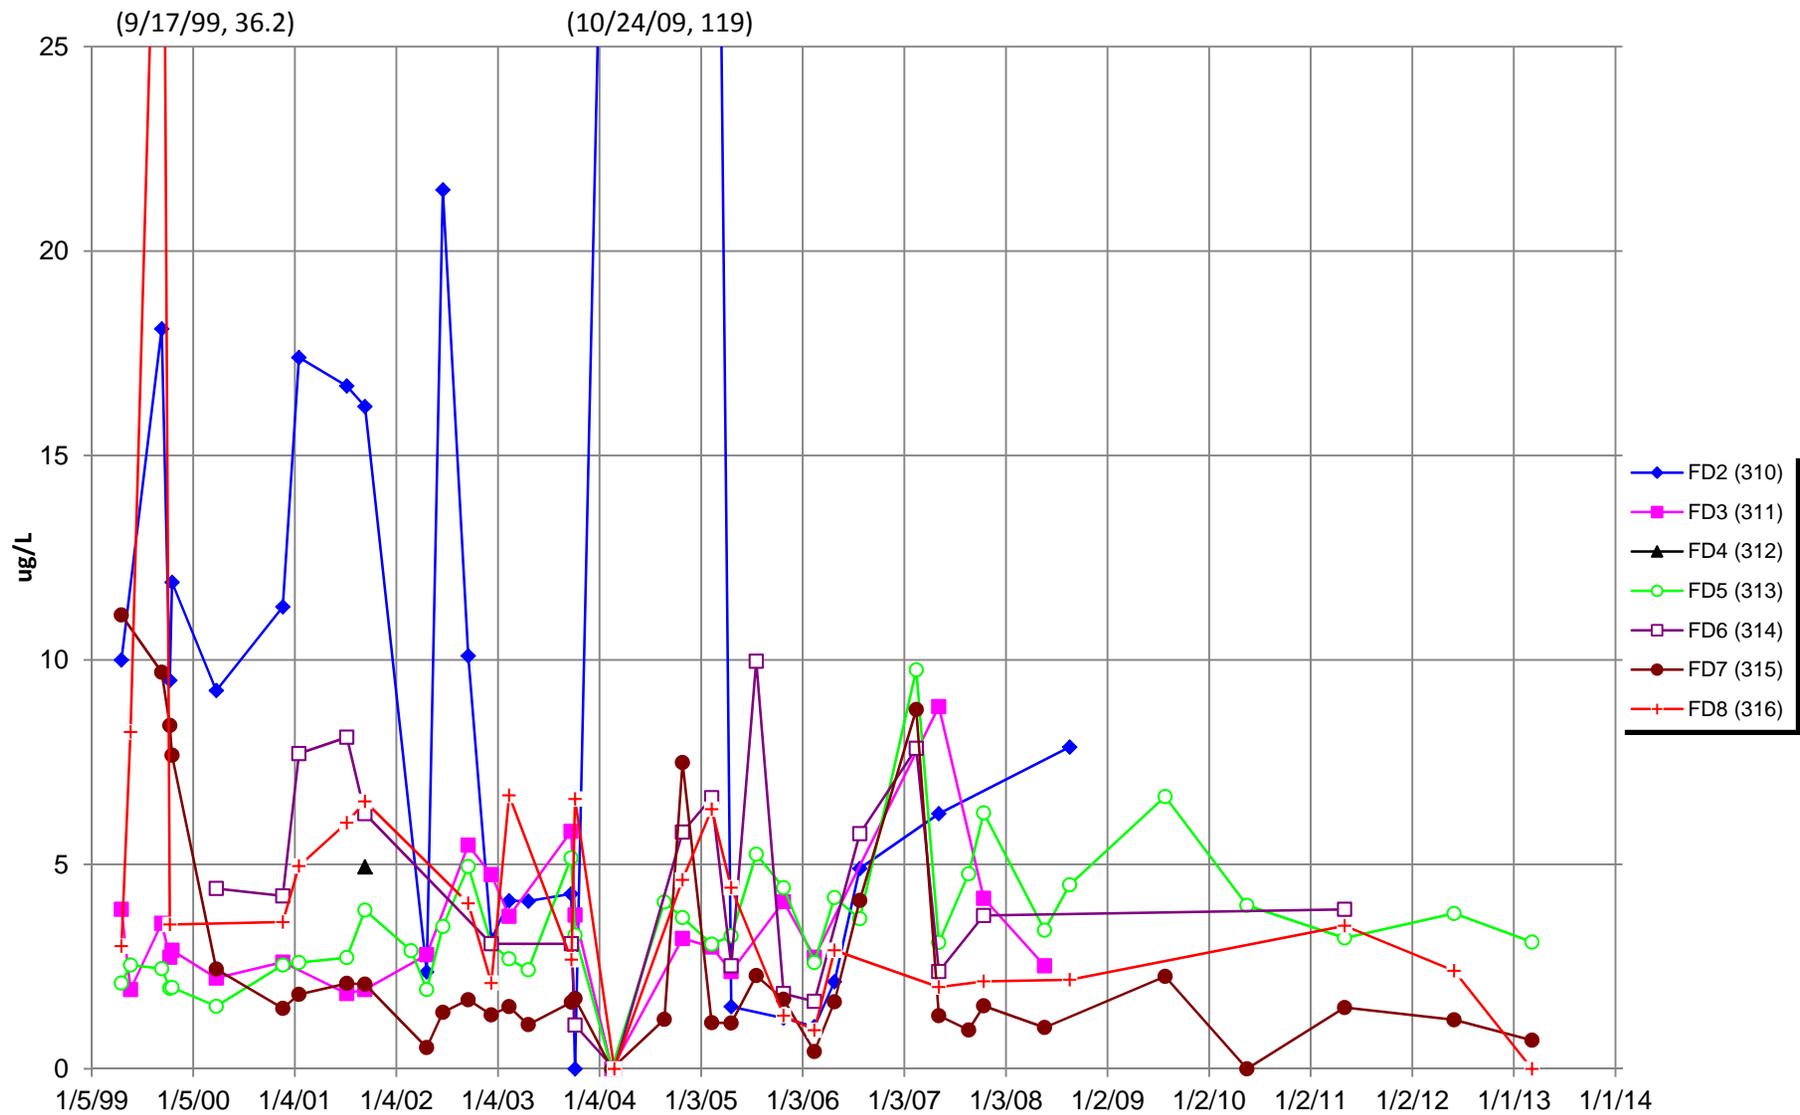
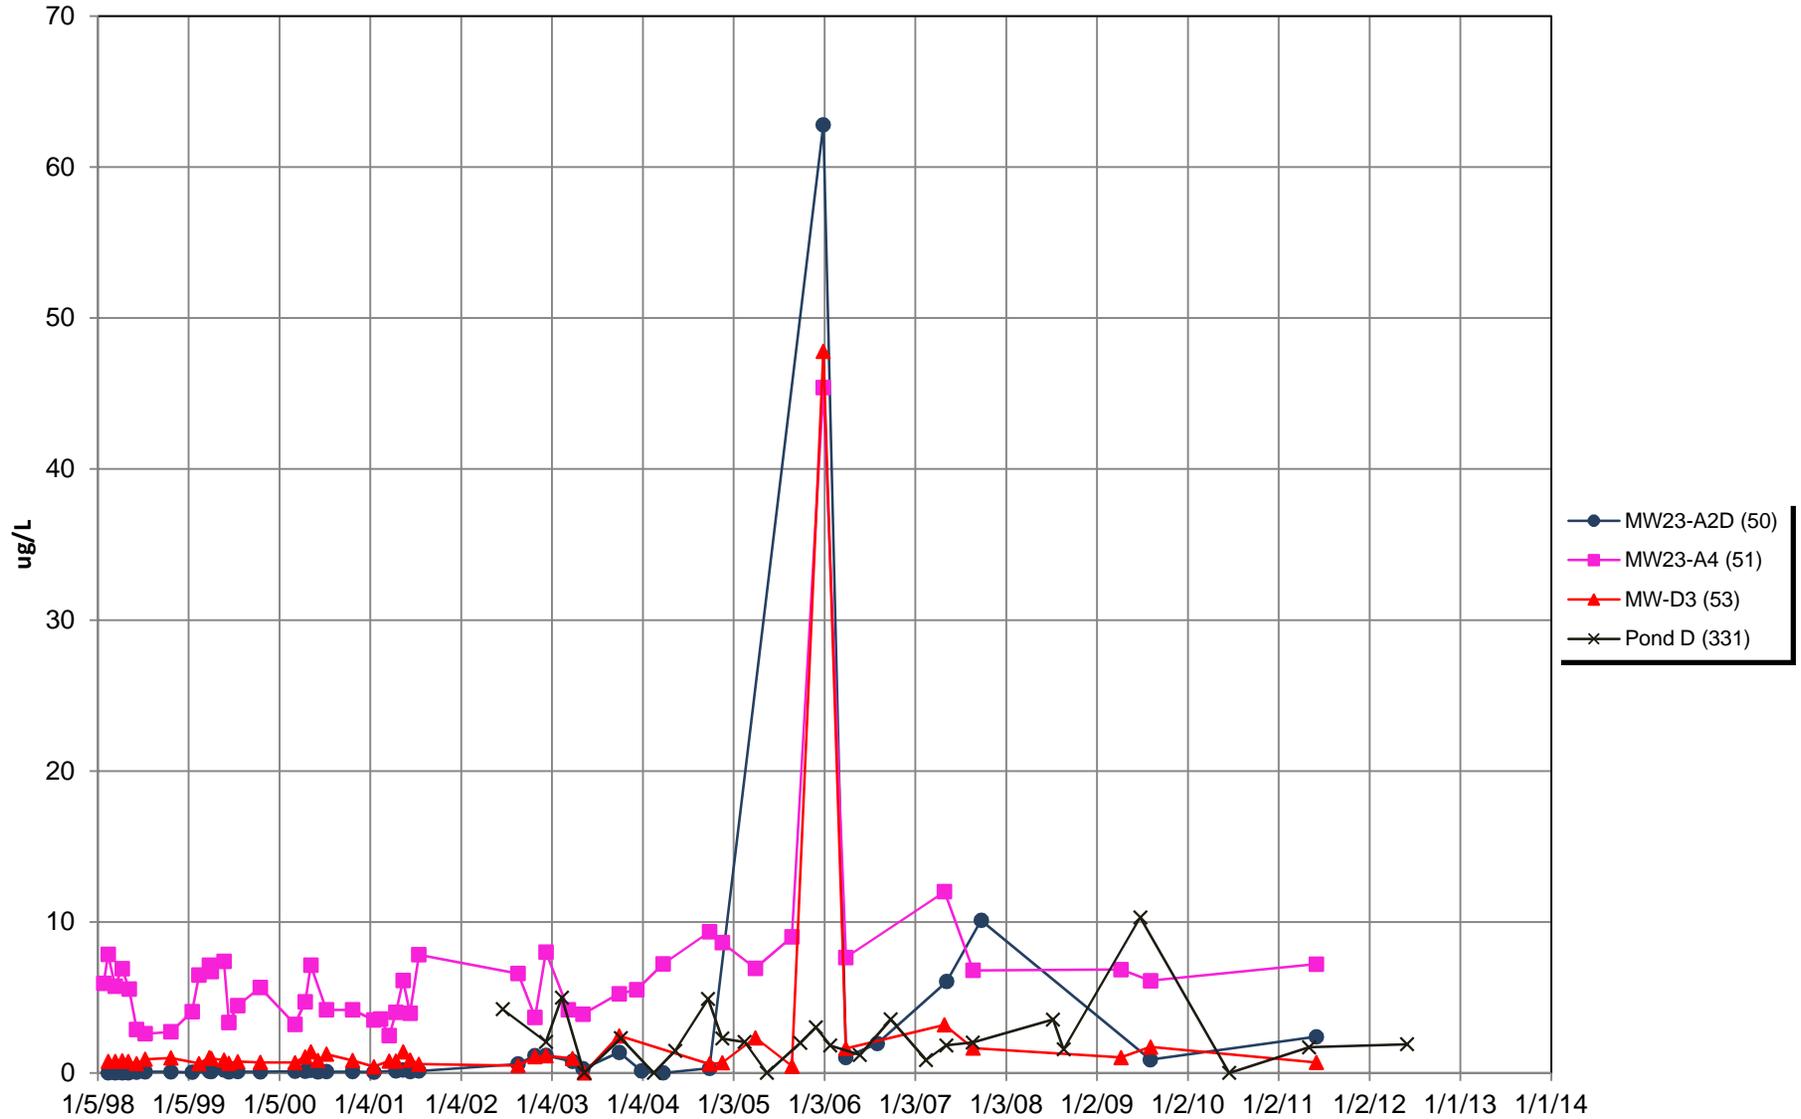
The concentrations of copper and lead (Figures 3.22a and b and 3.23a and b) are considerably lower than that of zinc in the Site 23/D internal monitoring sites. Both of these metals show the same general trends as zinc although 23FD-7 lead levels have increased recently but still remain below zinc levels and Alaska water quality criteria. The nickel concentrations presented in Figures 3.24a and b support the observation that the drainage from 23FD-2 is different than that of other drainages. It is possible that the material that supplies water to this drain has a greater proportion of serpentinite, which was shown to produce higher zinc and nickel concentrations than other rock types such as argillite and phyllite (Vos 1993). What appeared to be a linear increase in nickel concentrations in 23FD-2 prior to 2002 now appears to be decreasing or at least cyclical. The December 2005 sample from MW-23-A2D was an order of magnitude higher than

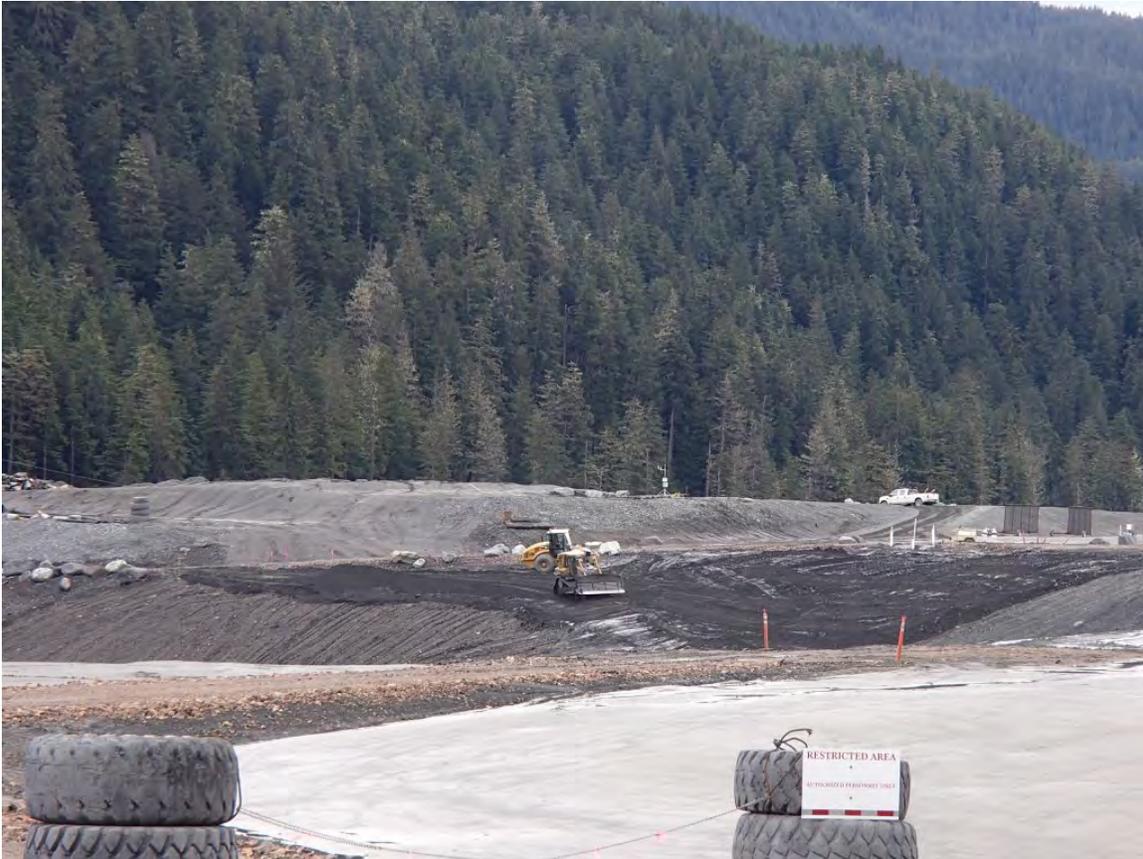
Photographs are presented in Figures 2.38 to 2.39 (Appendix 4). Figure 2.38 is a photo of the northwest area in the fall of 2013 with recently placed tailings, and Figure 2.39 is an aerial photo of the Tailings Facility in September 2013.

Figure 2.38 TDF northwest area in the fall of 2013 during tailing placement

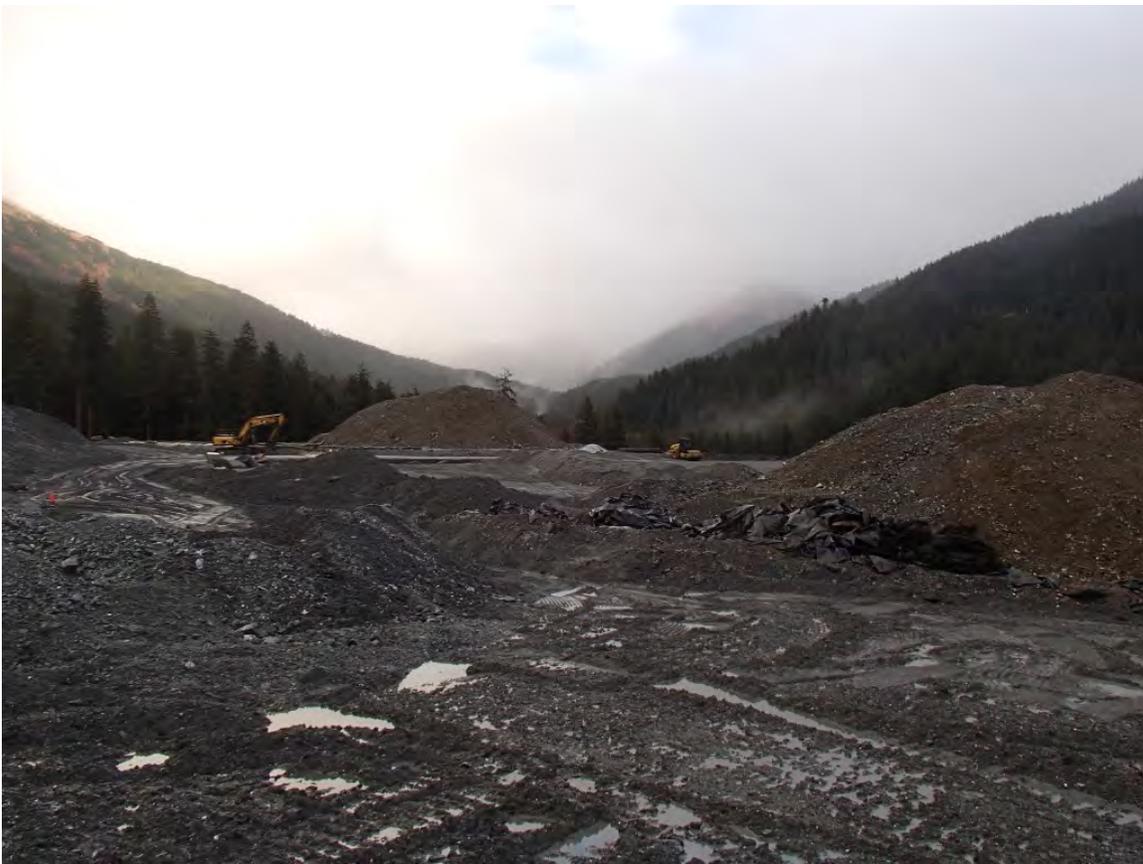
Figure 3.34 shows a photo of Site 23 in October 2013 with a pile of 1350 reclamation material placed on the eastern- pad. An aerial photo of Site 23 in September 2013 is shown in Figure 3.35.

Figure 3.34 Site 23 - October 2013 Reclamation material pile from the 1350 on the far (east) end
