APMA A20176118- FIELD SUMMARY REPORT

Inspection Date:	15 Sept 2017 – 17 Sept 2017
Weather:	Overcast, Intermittent Rain Squalls, Variable Wind up to 40 kt, Air Temp. Approx. 48° F
Agency Personnel:	Hollie Chalup (Mining Section), Renee Romsland (Mining Section), Katrina Chambon (Dept. of Environmental Conservation, 15 Sept only)
Operator Contact:	Tim Havey, Env. Manager, Pebble Limited Partnership
Pilot:	Archie, Soloy Helicopters
Inspection Objectives:	Annual Inspection and Follow-Up Compliance Inspection

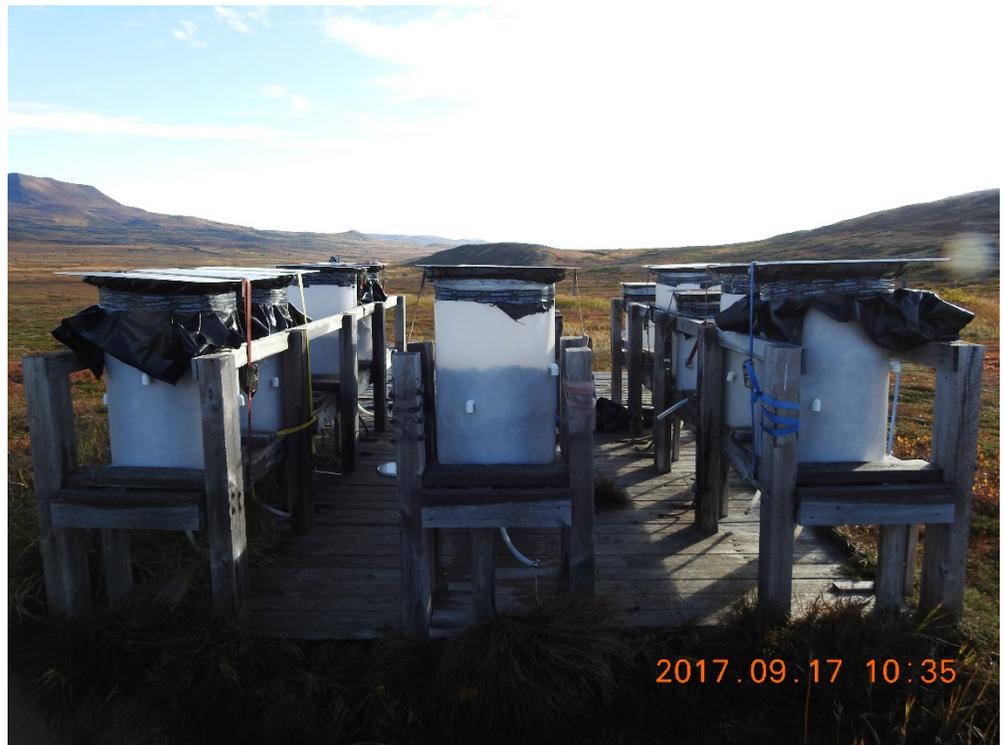
25. ARD Test Site
17 Sept 2017

Orange colored circle identifies hose without outlet plug. See Section 4.3.

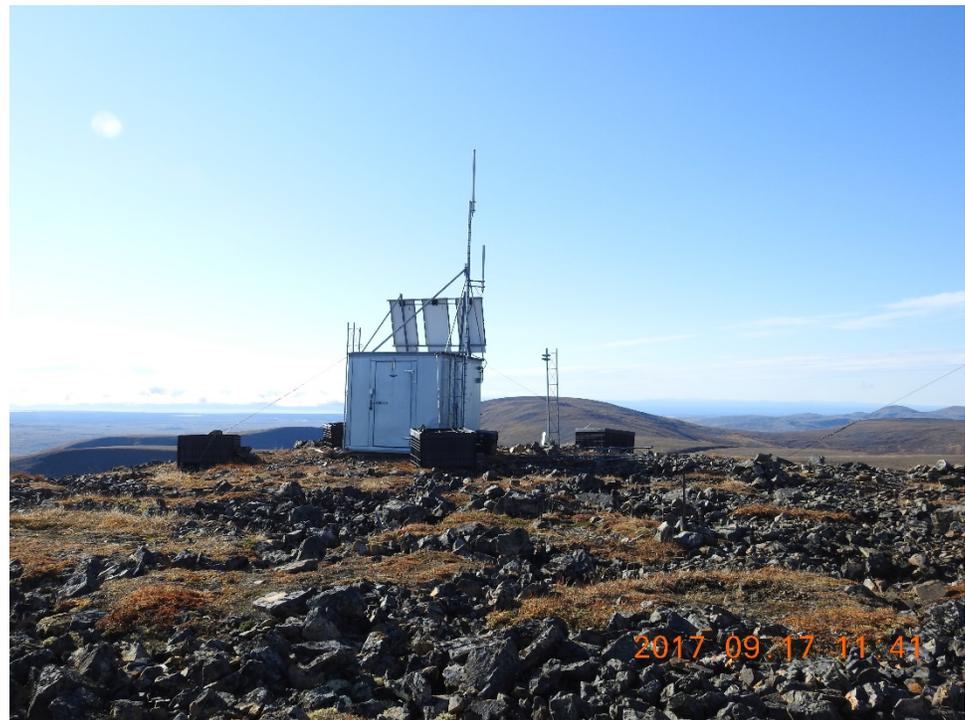
ADNR visited the Koktuli Mountain Repeater Station and found facilities to be in acceptable condition. PLP noted vandalism to solar panel and tower equipment in the winter of 2016-2017. The operator subsequently reported cable and tower replacement in the 2017 field season⁷.

**31. Kaktuli
Mountain Radio
Repeater
Damage**
17 July 2017
