**ENVIRONMENTAL MEMORANDUM**

**Red Chris Development Company Ltd.**  
200–580 Hornby Street, Vancouver, BC V6C 3B6

Re: Red Chris Monitoring Committee Environmental Report Oct 20 – Nov 3, 2015

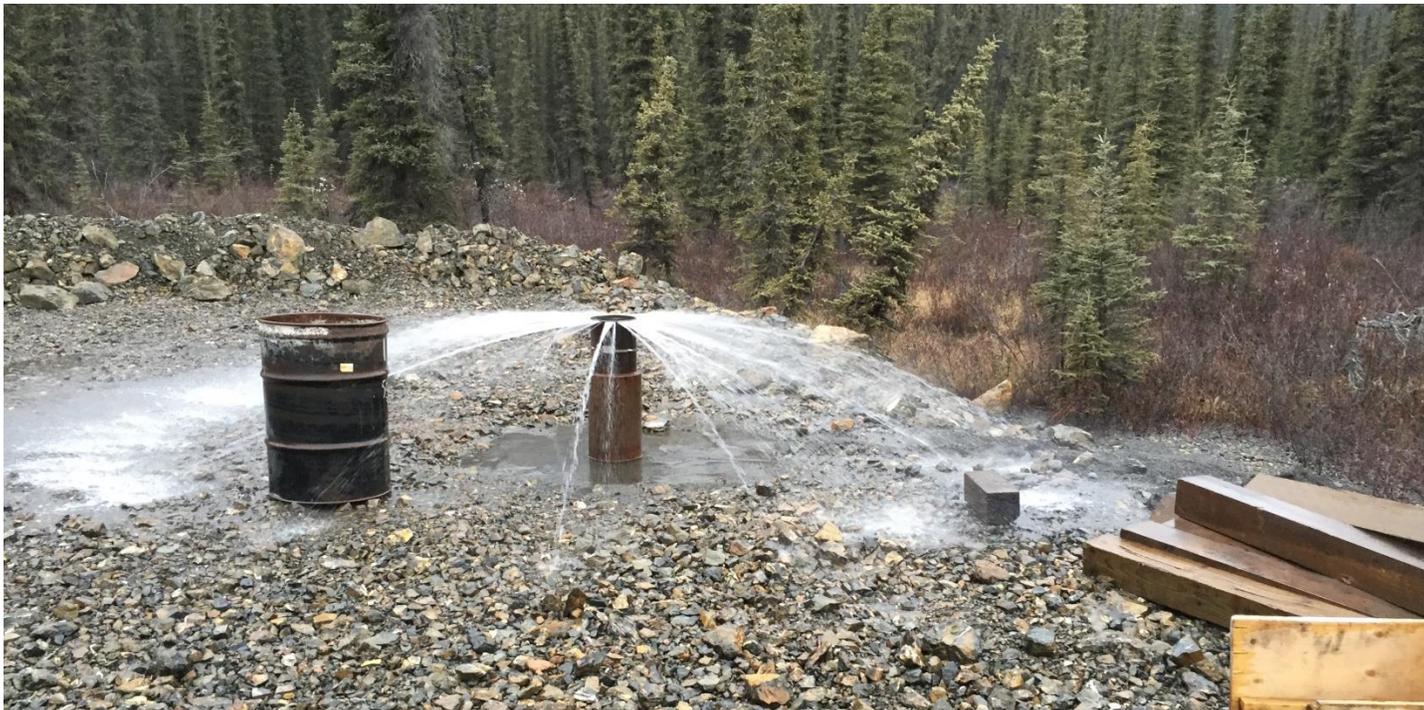
Oct 20 – Artesian pressures are high when the groundwater is not being pumped into the tailings pond. This is natural groundwater pressure.

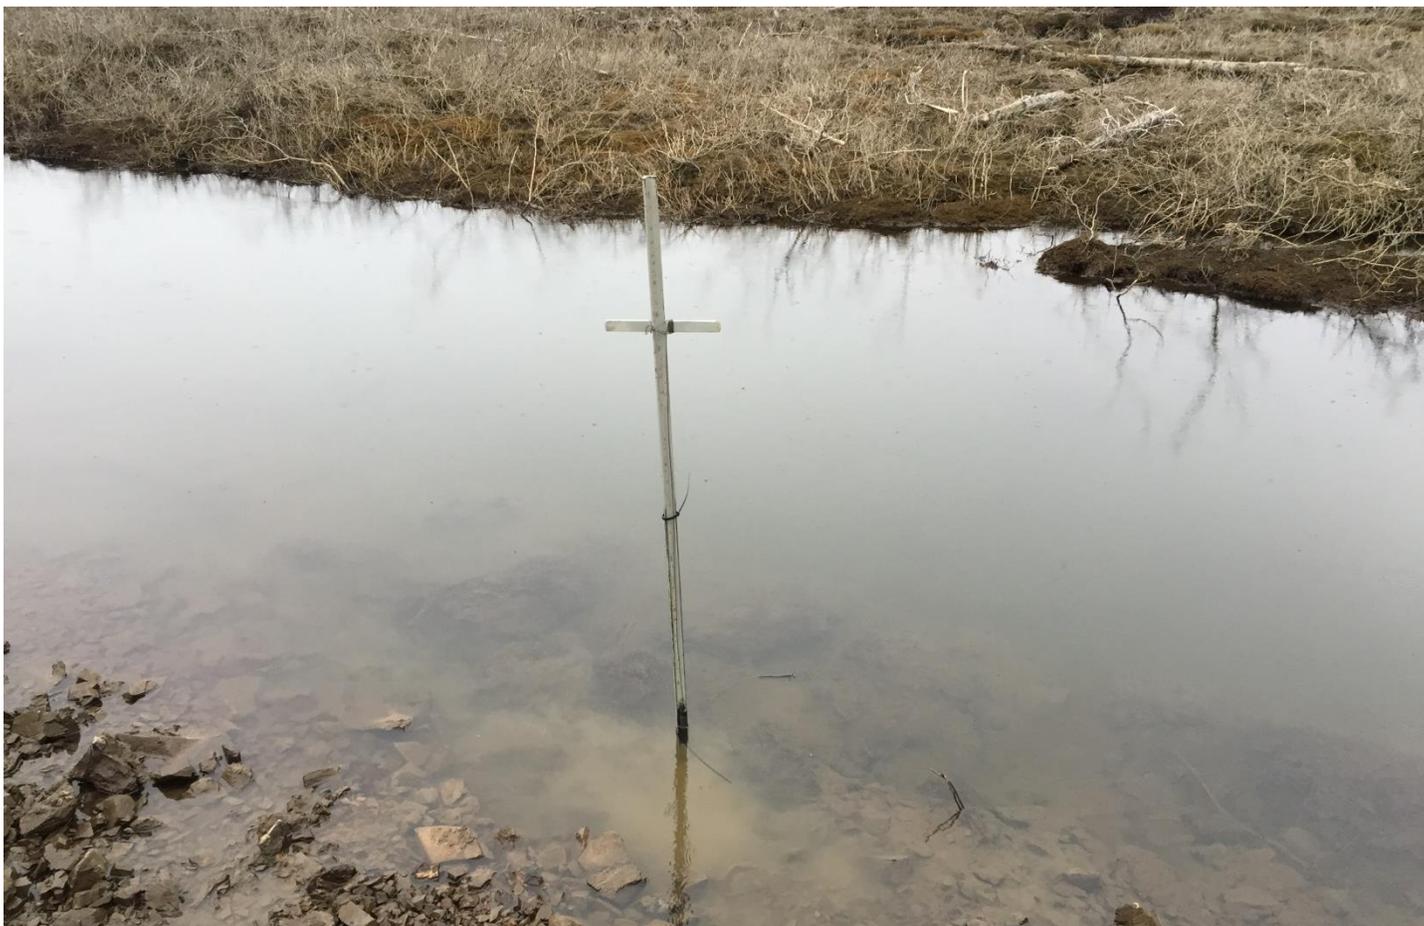
Oct 20 – A transducer has been installed in the tailings pond.

- Weekly water samples (5 samples in 30 days) for sites W3 and W69 were collected on the 21<sup>st</sup> and the 4<sup>th</sup>; the 28<sup>th</sup> was the last sample of the 5 consecutive weekly samples for those 2 sites. A five weekly samples in 30 day program for W4 as well began on the 28<sup>th</sup>.
- Biweekly surface water sampling was collected and sent out for analysis.
- Quarter 4 of groundwater sampling has begun.
- No North Reclaim Dam Discharge (NRDD) samples were collected, as there has been no discharge.
- Monthly phreatic data, i.e. groundwater levels, have been collected for November.
- The north reclaim dam pond has been added to the monthly sampling.
- A transducer was installed in the reclaim pond to measure water levels (see photo) during periods of pumping groundwater and the reclaim pond water into the tailings pond.

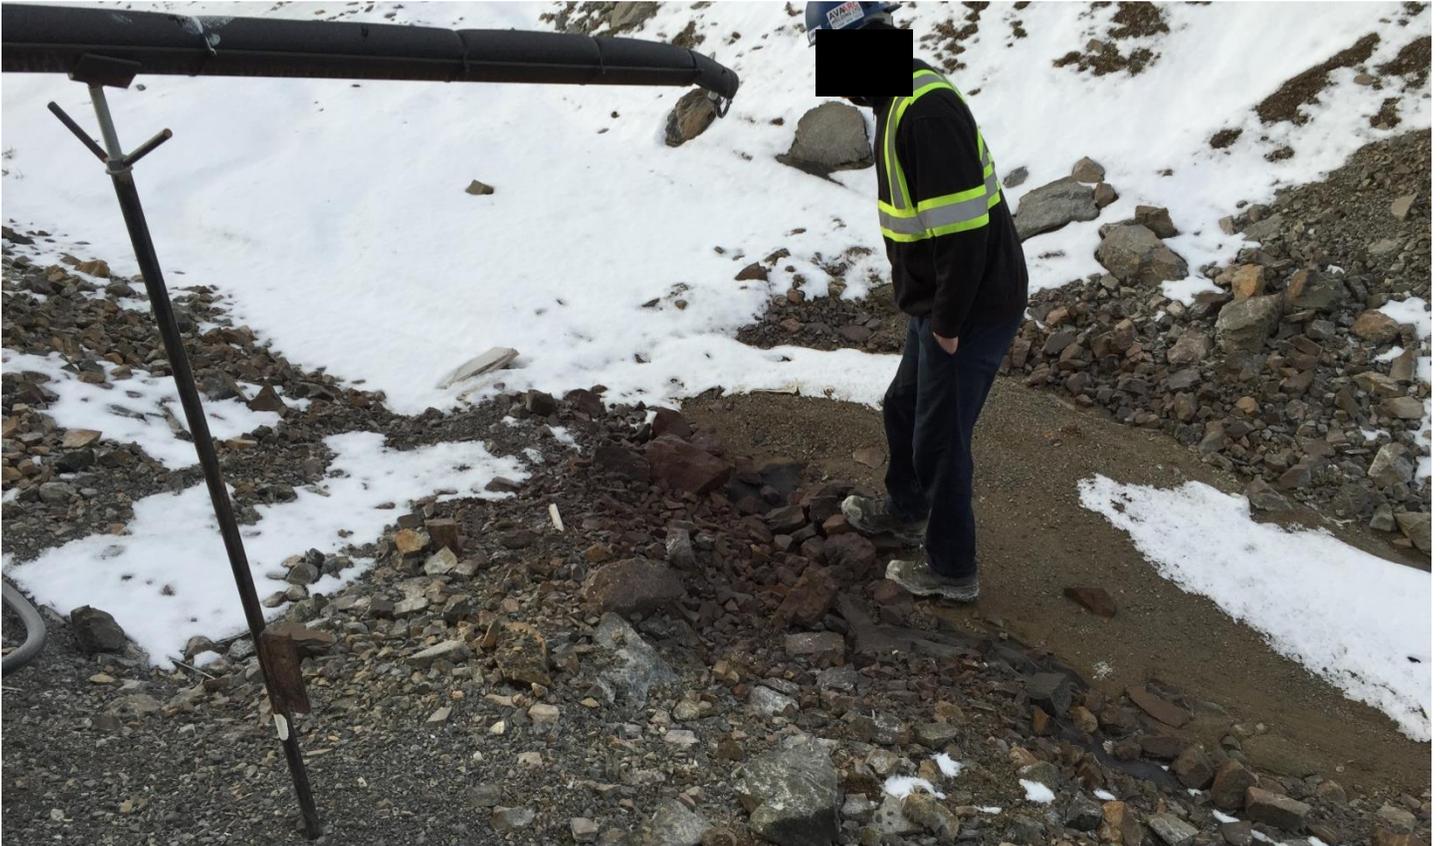
Oct 26 – Potassium Permanganate has been found to be leaking outside the water treatment plant for the truck shop.

- The General Waste Area (GWA) has been in good condition recently. People have been following the rules for the most part, and when they haven't, they rectified the situation after being notified.
- Potassium Permanganate has been found to be discharging outside the water treatment plant for the truck shop. A plan to get the discharge funneled into an empty waste oil cube, and deposited into the tailings pond when full, is being developed.

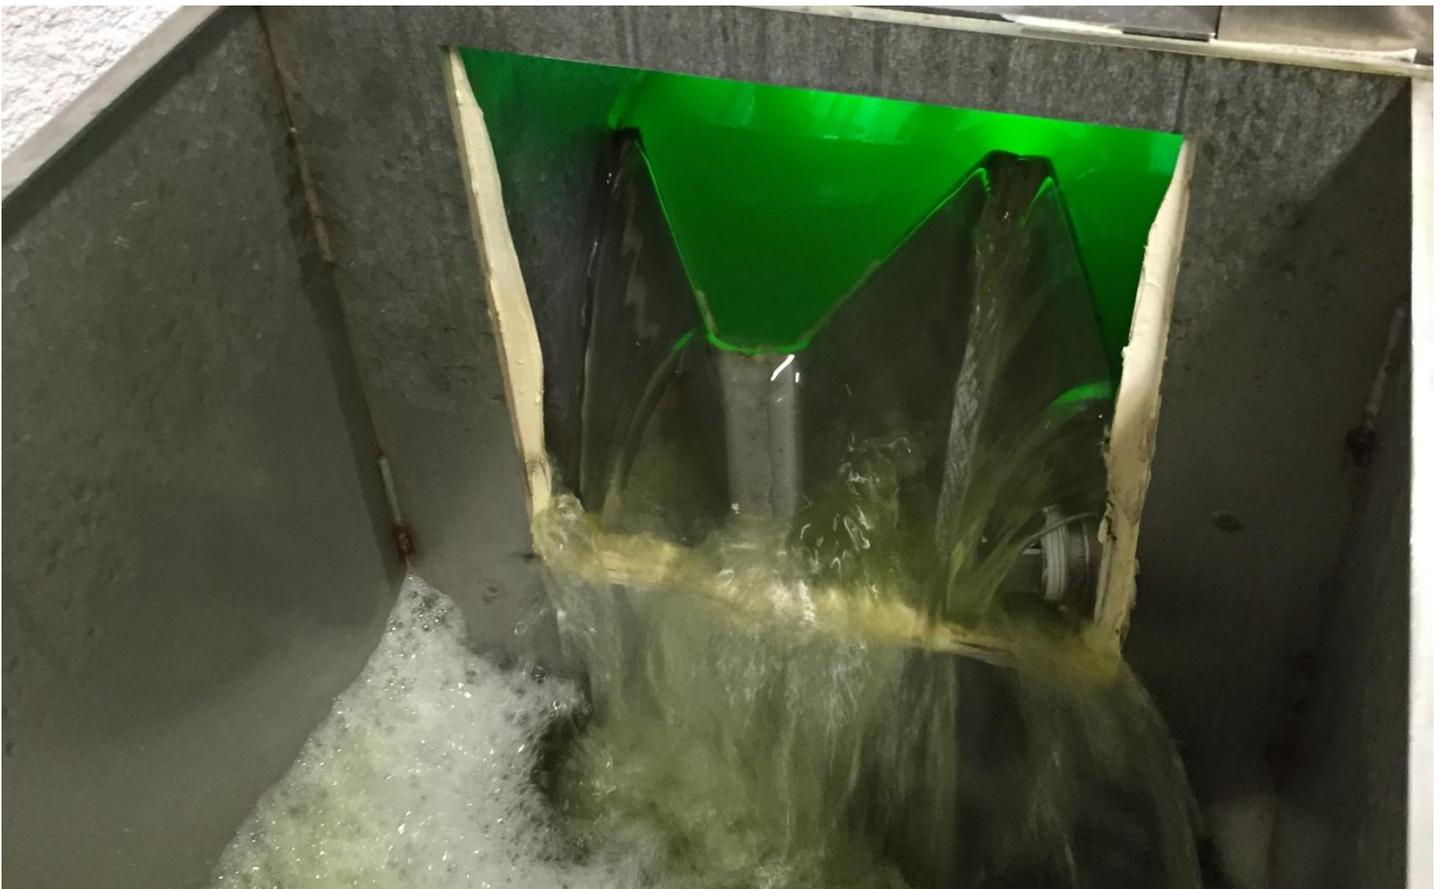
Oct 26 – The last stage of wastewater treatment. The green light is from the UV bulbs travelling through algae in the water. Water from the wastewater treatment plant is discharged at W74 into the environment, and eventually leads down into the tailings pond.

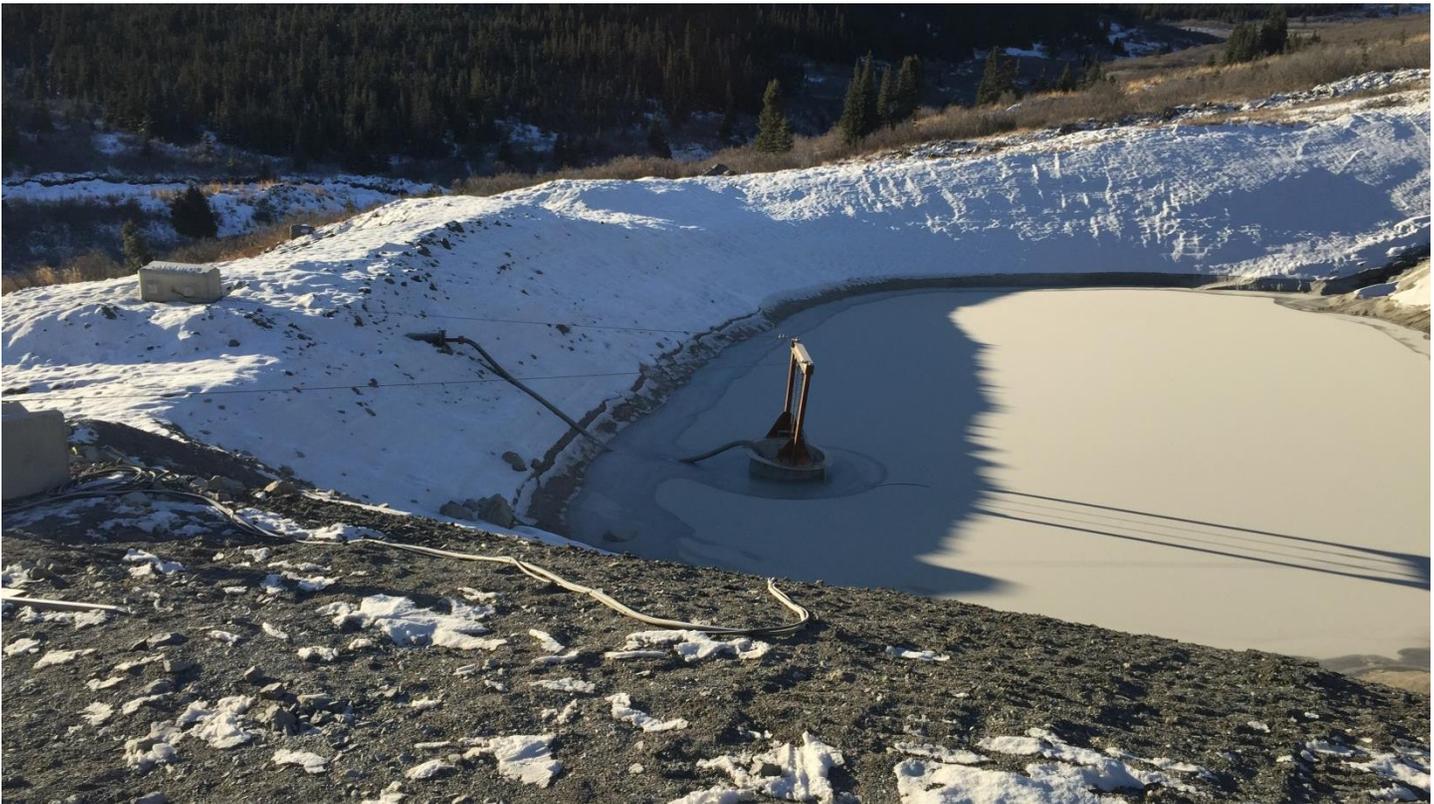
Oct 26 – A sump near the pit. There was an issue with containment, but pumping has been keeping it in check and upgrades were made

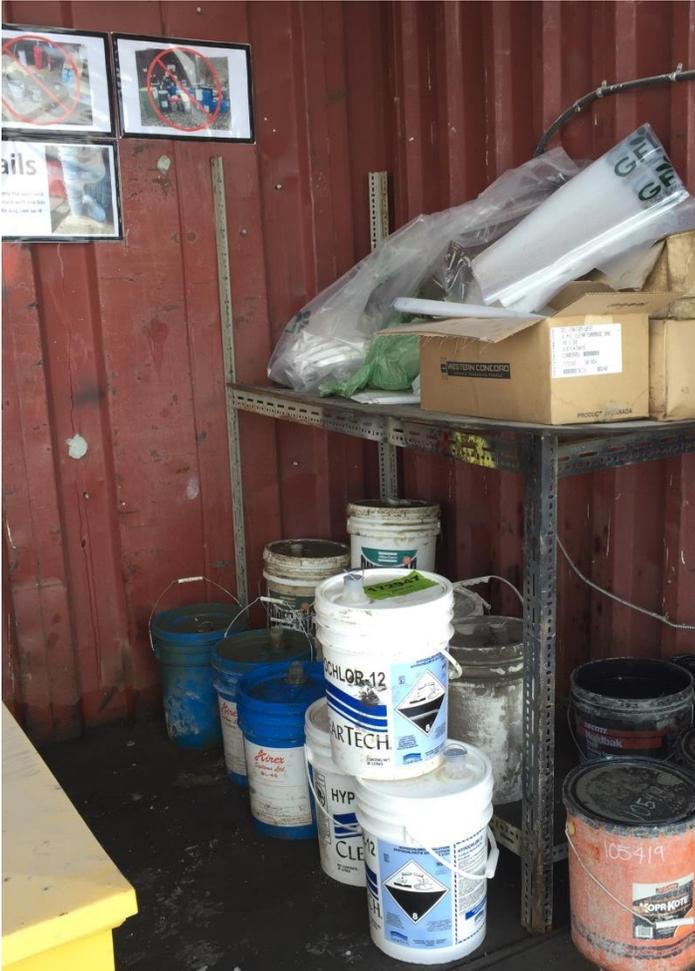
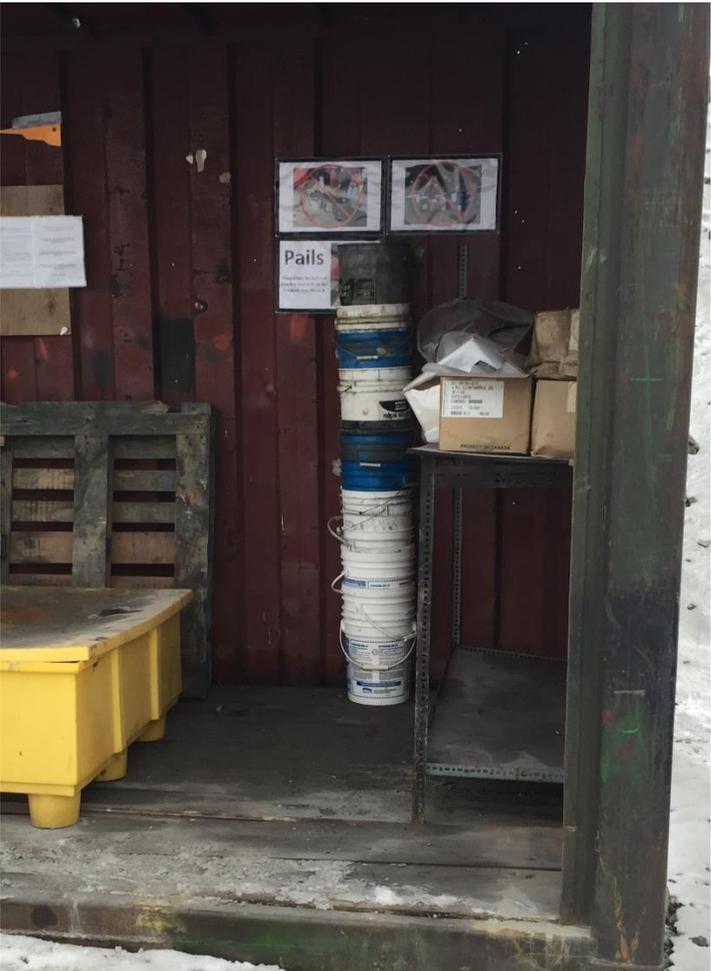
Oct 21/25 – Keeping on top of the waste area, before things get out of hand again, and having workers correct offenses as soon as possible has yielded good results.

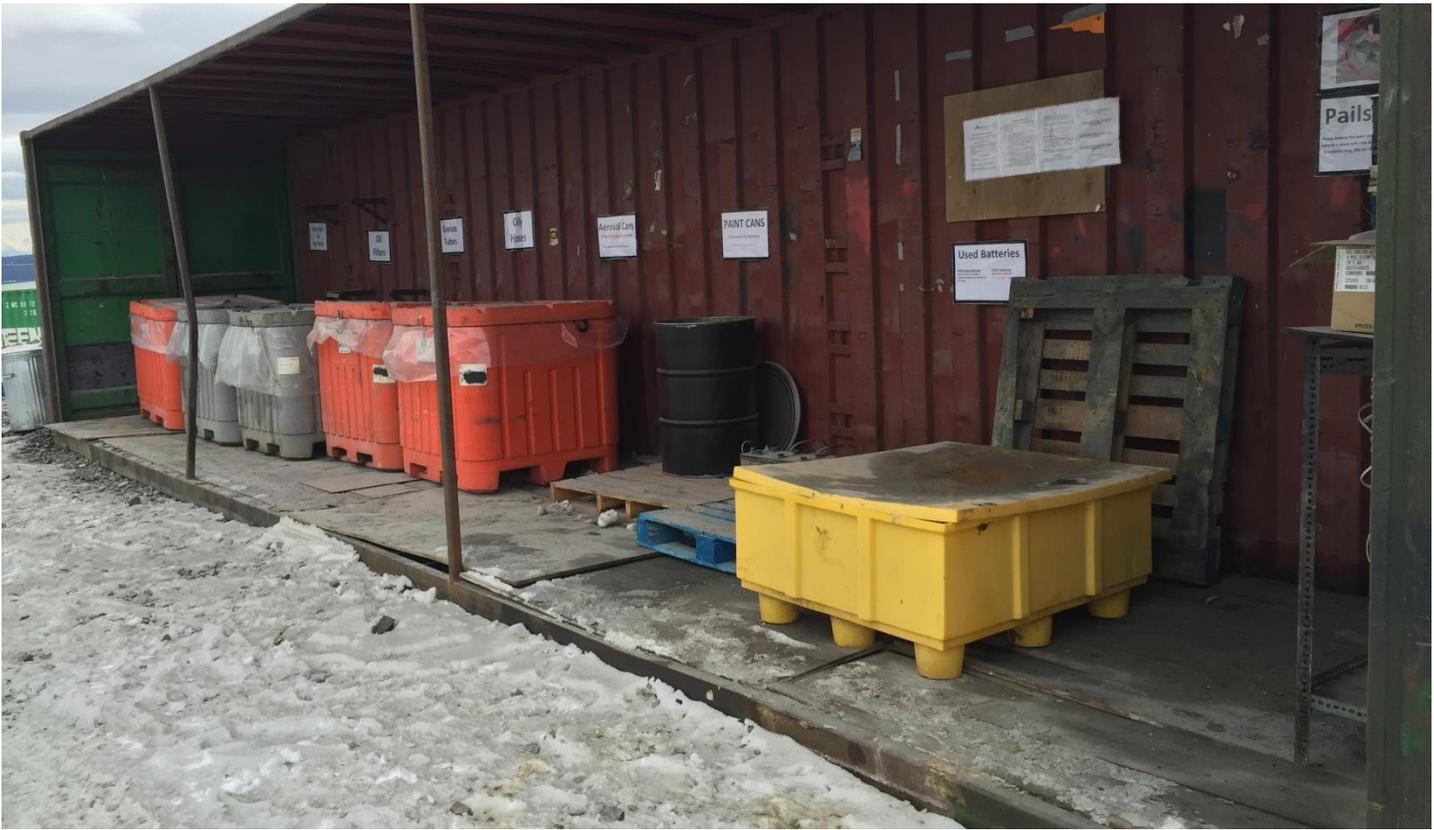
Oct 28 – The waste area is in excellent shape.

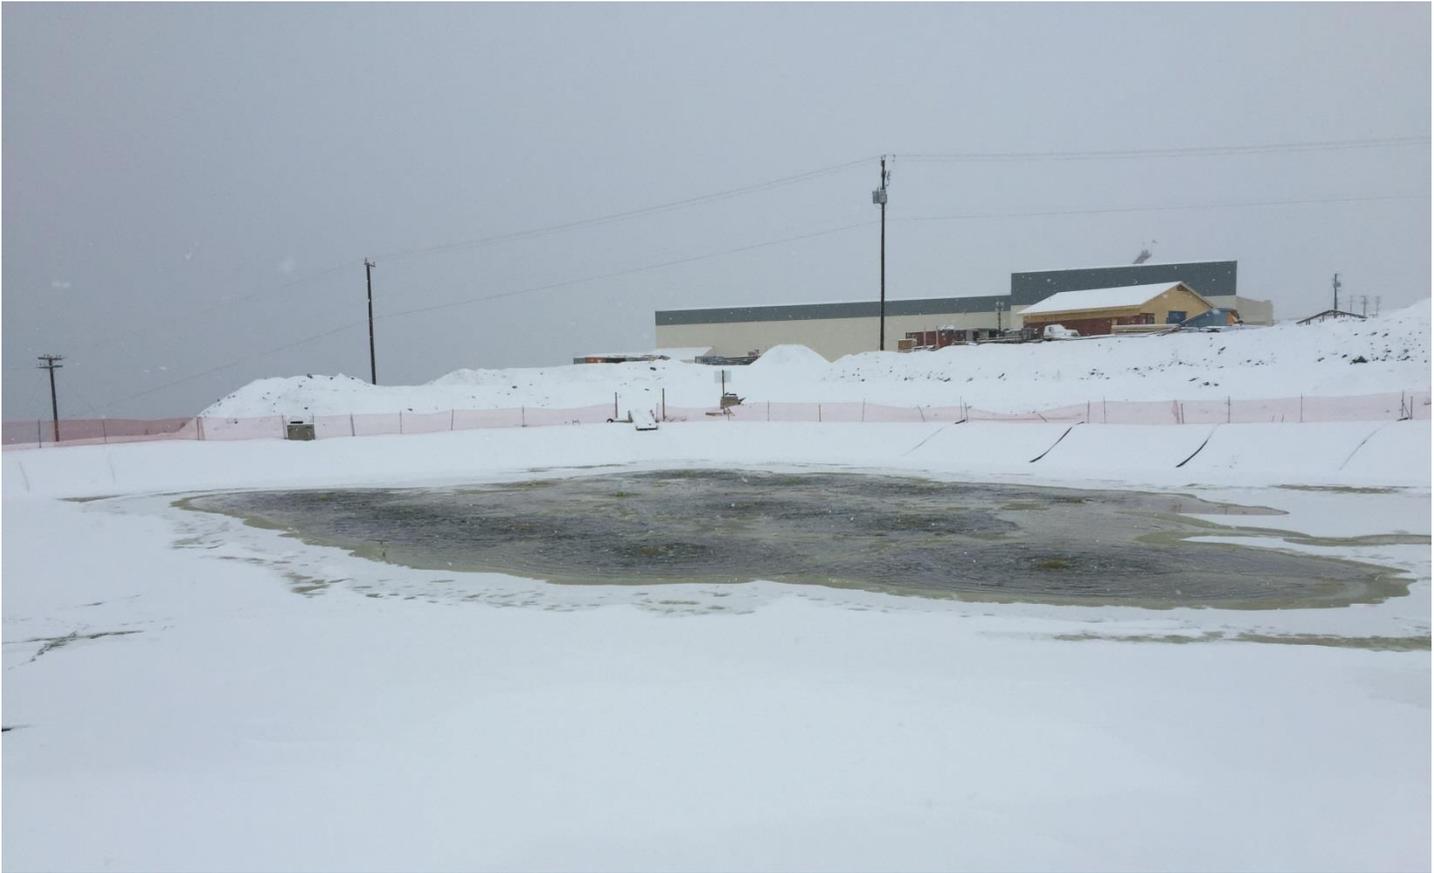
Nov 1 – Lagoon 1, of 2. There've been some technical issues with keeping the blowers running so the pond can be aerated, but for the most part it's been running smooth.

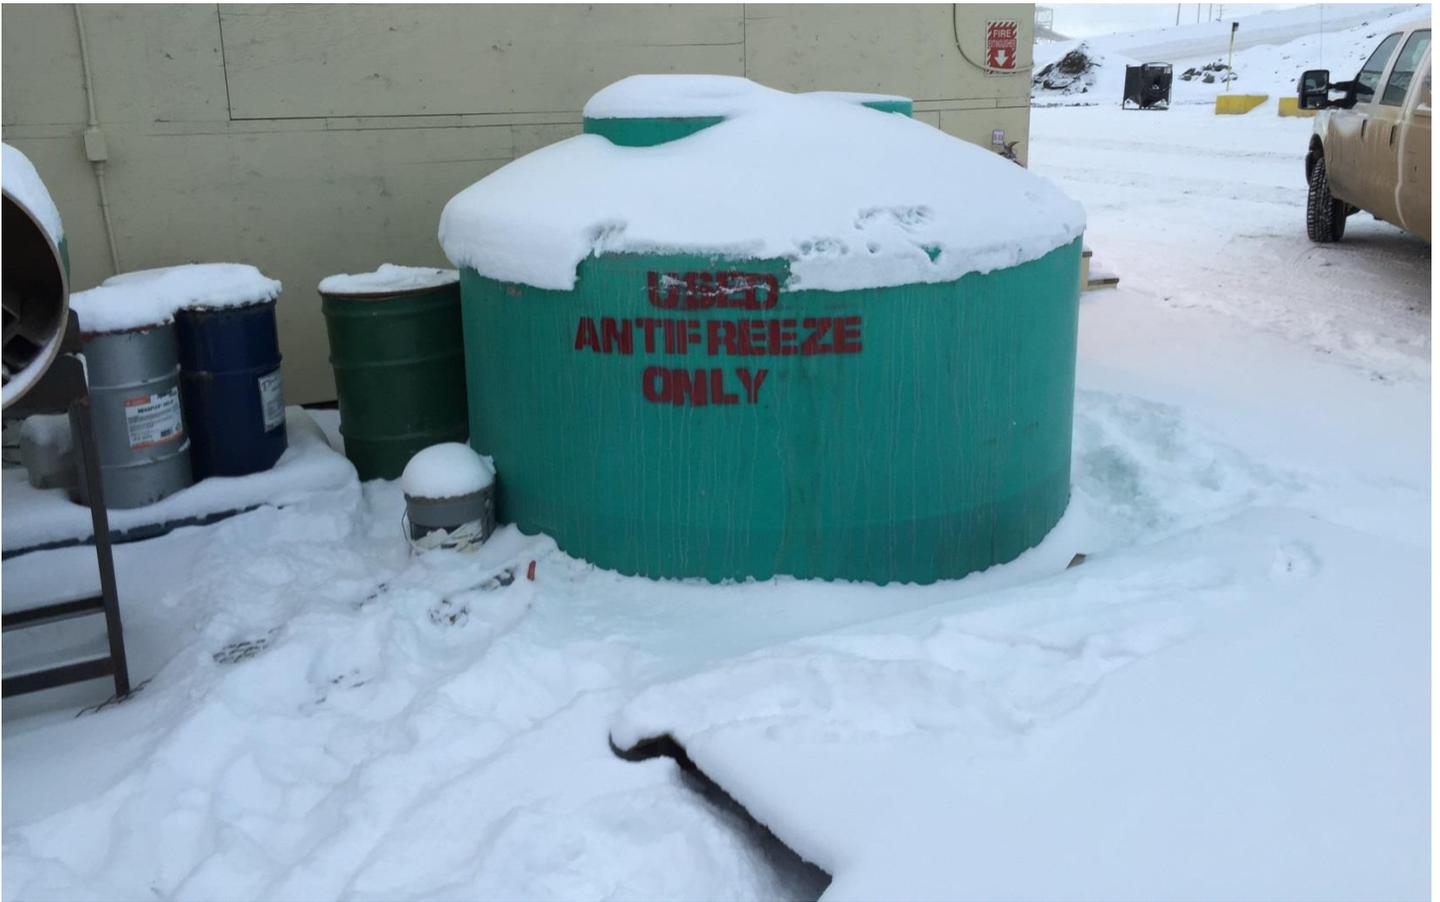
Nov 2 – A container for used antifreeze behind the pit shop. There's a plan in place to get the container into 110% containment.
